**Performance of Merado Suction Pumps
in Danida assisted
Integrated Rural Sanitation &
Water Supply Project
in coastal Tamil Nadu**

February 1995

Raj Kumar Daw

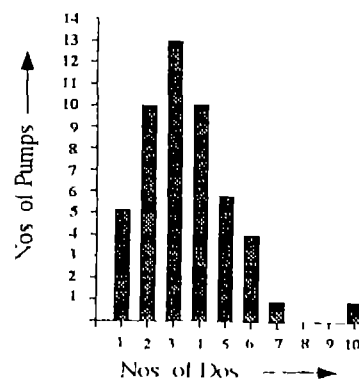
Fig. 1 : Frequency of Dates of Service

The information on Date of Service, presented in Annexures 1 and 2, is summarised in Fig. 1: Frequency of DoS.

It shows that all 50 pumps needed interventions, usually 2 to 4 times, through their average life of 1.3 years. Five pumps needed 1 intervention each; ten pumps needed 2 interventions each, thirteen pumps needed 3 interventions each and ten pumps needed 4 interventions each. One pump showed as high 10 instances of maintenance.

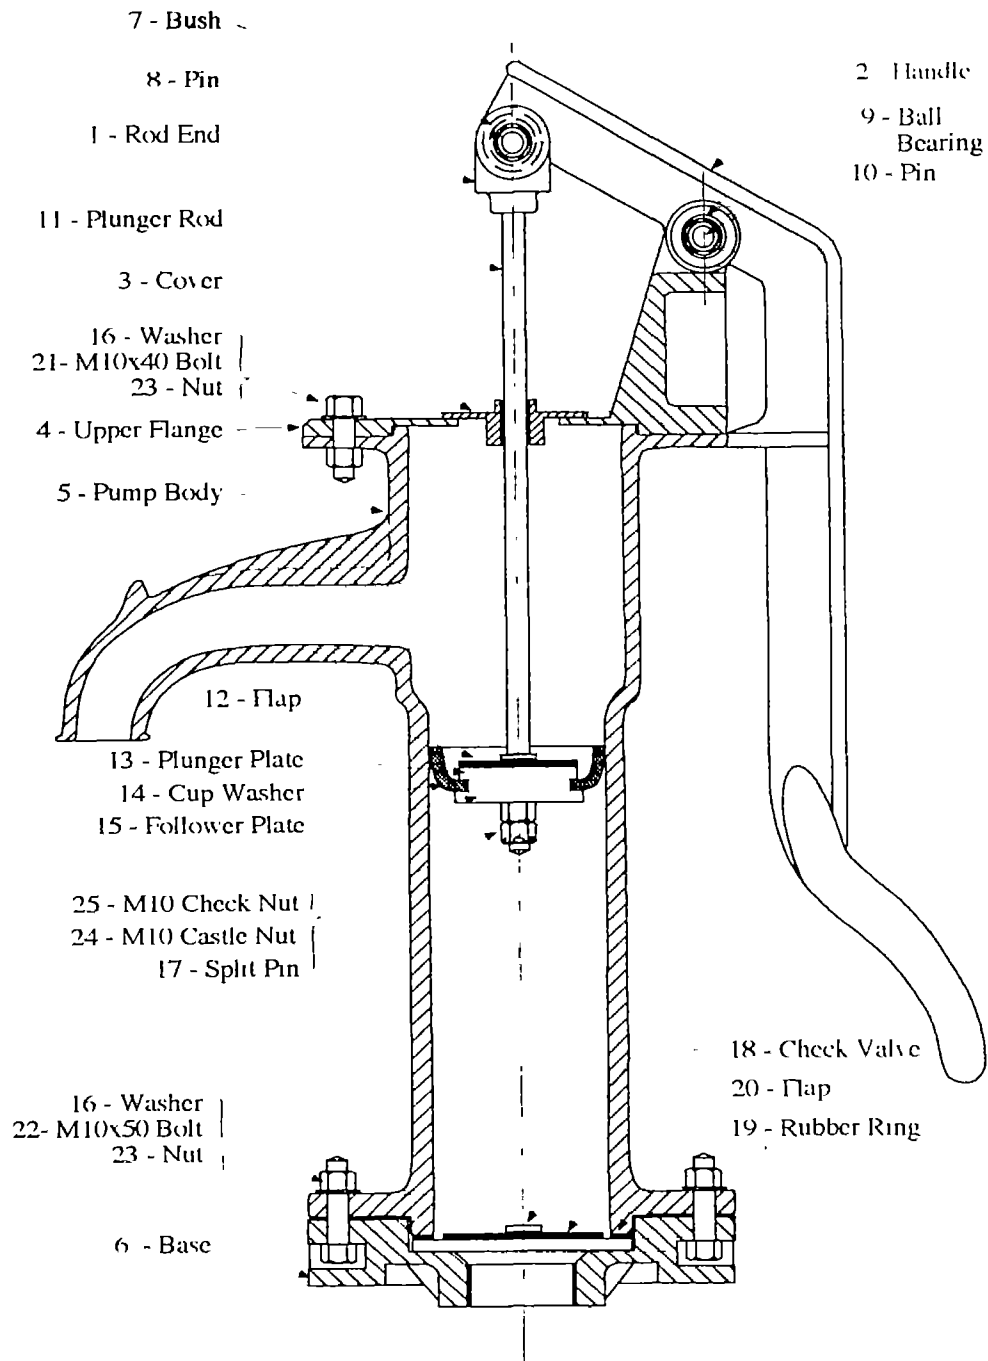
Fig. 3 : Components of the Merado Suction Pump

From Table 1, it is seen that the Merado design showed good performance of its some of its Valve (Plunger plate, Follower plate, Check valve, Flap), Pivot (Bush, Ball bearing, Pins) and Flange (Upper flange, Base) components.

From Table 2, it is seen that the Merado design showed poor performance (index values beyond acceptable limits, on either Intervention Index or Age Index) of its Plunger Rod components (Rod end, Rod, Cover), of the Plunger Flap valve, and its fastenings (various nuts, bolts, washers).

More significantly, on two very critical components, Handle and Cup Washers, the Merado pump shows "bad" performance, i.e., unacceptable index values on both Intervention Index and Age Index.
