EVALUATION ON THE SARVODAYA
SI-5 HANDPUMP
MATARA AND GALLE DISTRICT

by
Annemarieke Mooijman
Mariet de Savornin Lohman
N. Franklyn

Sarvodaya RTS
Moratuwa, august 1988

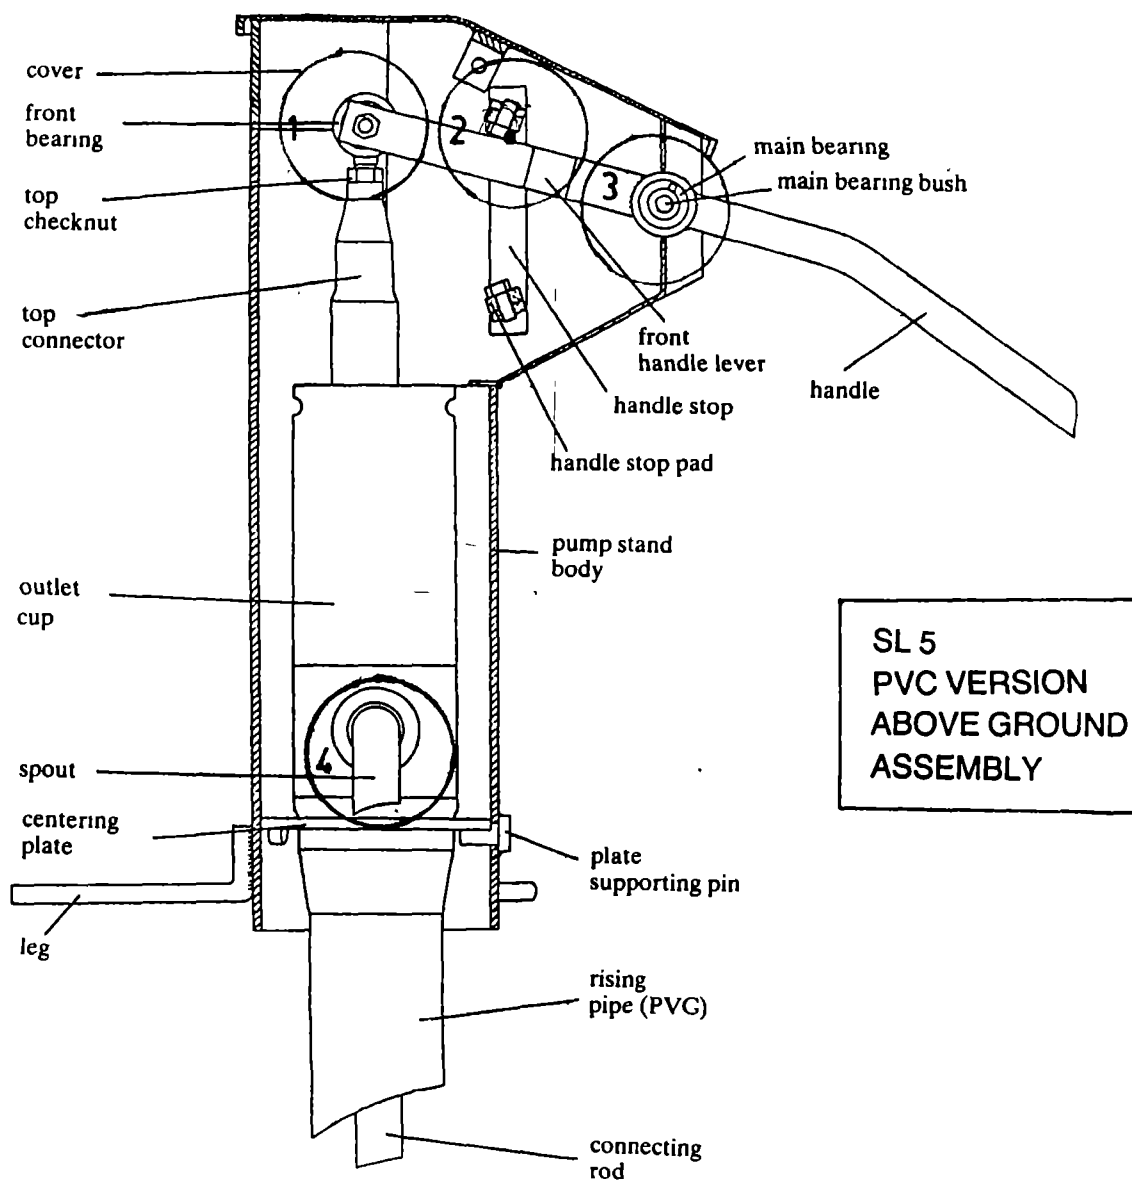
Design problems pointed out on drawing

1. Frontbearing bush too short.
The nylon bush inside the bearing has been manufactured wrong or becomes too short if it 's worn.
2. Handle stop pad above broken.
The pad will wear more quickly if the handle is too high.
3. Mainbearing
If the pump is well installed and manufactured no problems will occur, but if the handle stop pads are broken or the frontbearing bush is too short problems quickly arise.
4. Spout leaking
The rubber ring on the outletcup which seals the spout is sometimes worn. Especially when the centering plate is missing and the outletcup hangs on the spout.

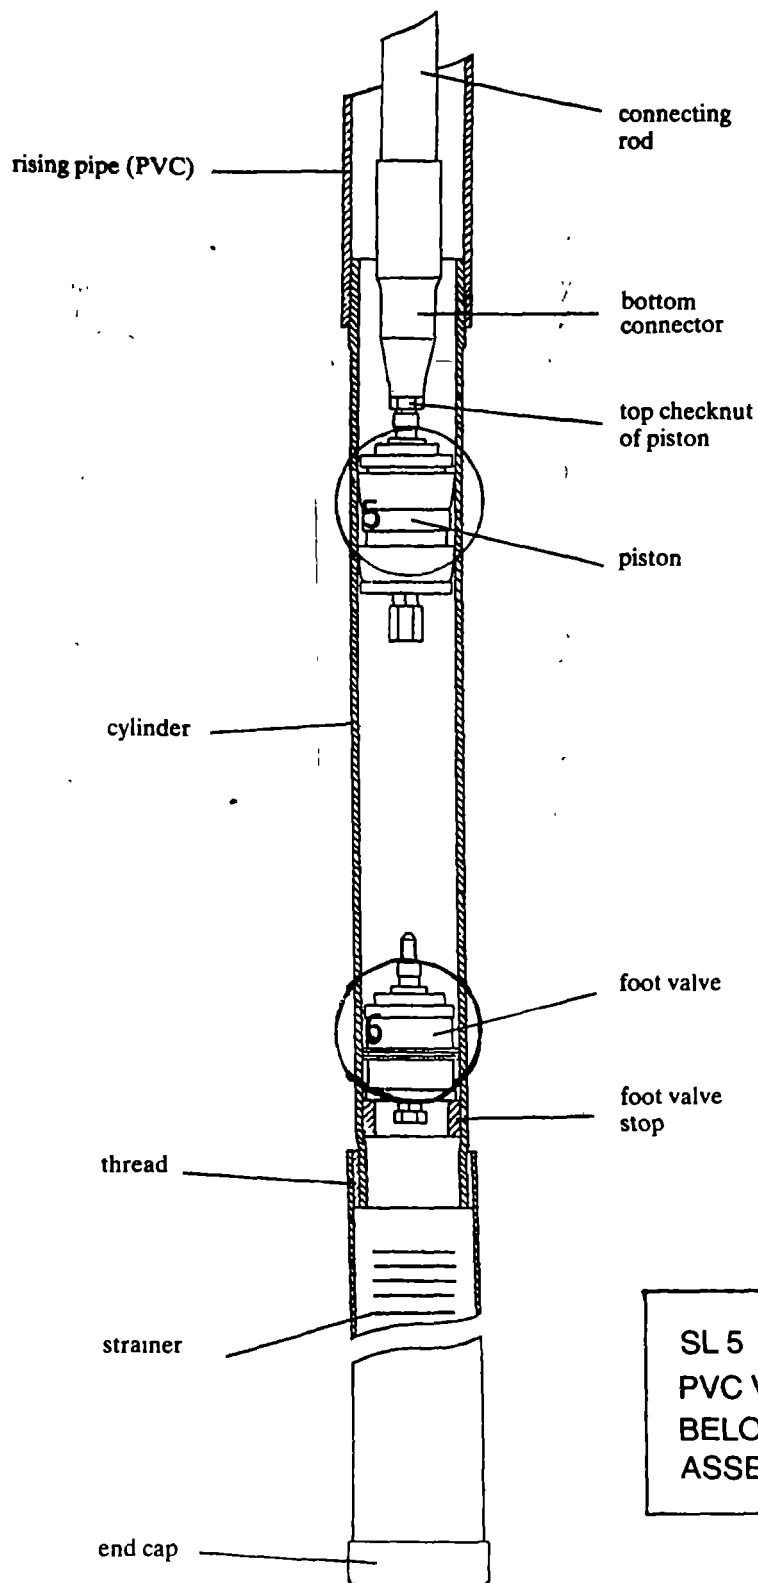
SL 5
PVC VERSION
BELOW GROUND
ASSEMBLY

5. Pistoncups worn out or too hard.
The cups are good but when the cylinder is not straight or other problems occur the cups are easily damaged and should be replaced.
If the cups are too hard the piston will be heavy to operate and give some shaky shocks when pumping.
6. Footvalve leaking
There is more than one reason for this problem. For example: brass quality not good, rubbervalve worn.
