FINAL REPORT ON THE UTILIZATION/ EVALUATION OF AN AID HAND-OPERATED WATER PUMP

The U.S. Agency for International Development under Contract No. AID/ta-C-1354

Office of International Programs
Engineering Experiment Station
GEORGIA INSTITUTE OF TECHNOLOGY
Atlanta, Georgia
January 1979

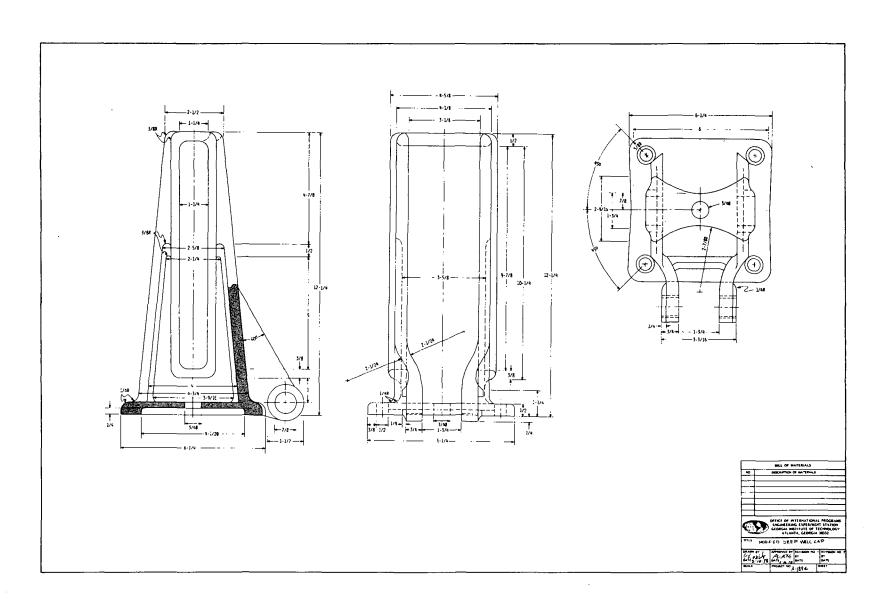
Figure 11
MODIFIED DEEP-WELL PUMP CAP IN NICARAGUA

was redesigned by lifting the pivot arm up and away from the pump body and positioning it so that it does not absorb so much of the stress caused by the downward force of the pump handle. The redesigned cap was put into production at the manufacturer's foundry, installed on the pumps in the field, and has presented <u>no</u> additional problems.

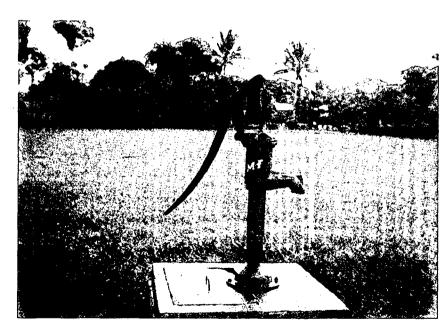
| Site | Location | Corrective Maintenance During Test Period |
|---|---|---|
| 26 | San Juan Grande | Replaced handle fulcrum (broken - casting defect) |

Site No. 26, located at San Juan Grande (AID deep-well pump).

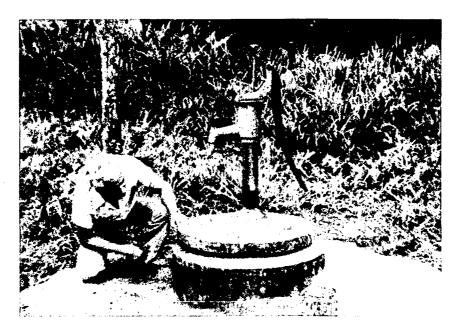
| Site | | Corrective Maintenance |
|---|---|--|
| 31 | Indiana Tres, Siquirres | Replaced handle (broken - casting defect) 2 cup changes (excessive wear) |

Site No. 31, located at Indiana Tres-Siquirres (AID shallow-well pump).

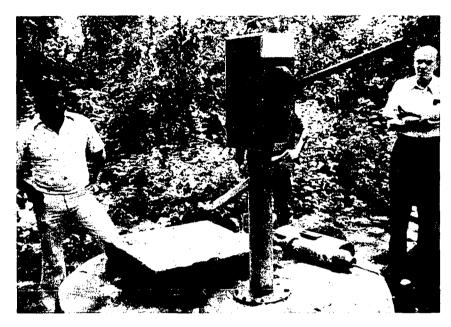
| Site No. | Location | Corrective Maintenance During Test Period |
|---|---|--|
| 7 | Llano Grande | NONE foot valve has tendency to stick and cause pump to lose its prime |

Nicaragua Site No. 7, located at Llano Grande (IDRC pump).
