ANNUAL REPORT
ON
HANDPUMP TESTING IN UPPER LIVULEZI PROJECT
IN MALAWI

K.G. Liyanage

March 1986

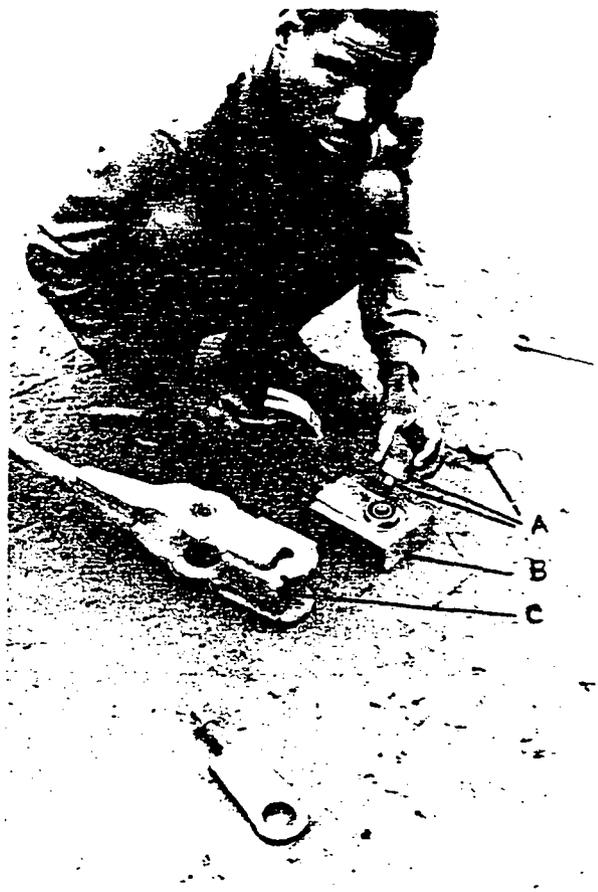
- P. 1 Using the new simple tool to install a new bearing in the hanger.
- A. The three circular cylindrical metal pieces.
 - B. The wooden block to hold the hanger.
 - C. The wooden block to place between handle forks.

I designed and fabricated some simple tools for this process. There are three circular metal pieces to remove the worn bearing. If the complete worn bearing is in place the appropriate piece (small one) is screwed on to the "base" piece and used.

When the bearing is badly worn the balls are lost and only the outer ring remains in the housing. In this case the larger circular piece is screwed on to the "base" piece and used. This tool is placed on the worn bearing and tapped with a hammer to remove it. The same process is used to install a new bearing. There are two wooden blocks, one to support the hanger and one for placing between the forks of the handle when removing the bearings. All these items can be carried in the maintenance assistant's bag of tools.

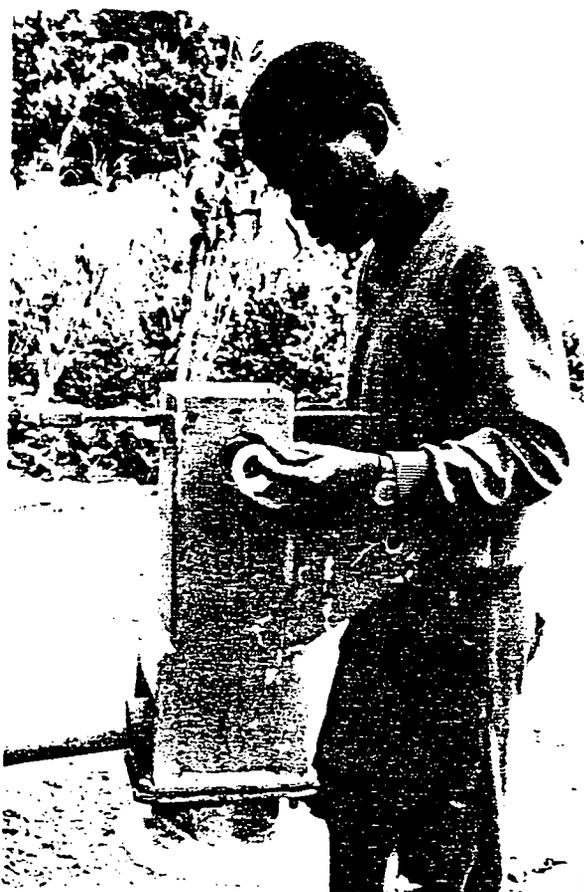
P.3 Replacing the plastic bearings of the hanger unit in the "Afridev pumphead.

When compared to ball bearings, plastic bushes are extremely cheap (cost of the four bushes is expected to be around 12 Kwachas) and easy to replace. With the modified Afridev pumphead shown in the photograph, replacing the four plastic bushes in the pumphead could be done by a person in a village. Therefore, development of the plastic bearings, assuming they prove to be successful, is a major step towards Village Level Operation and Maintenance of handpumps.

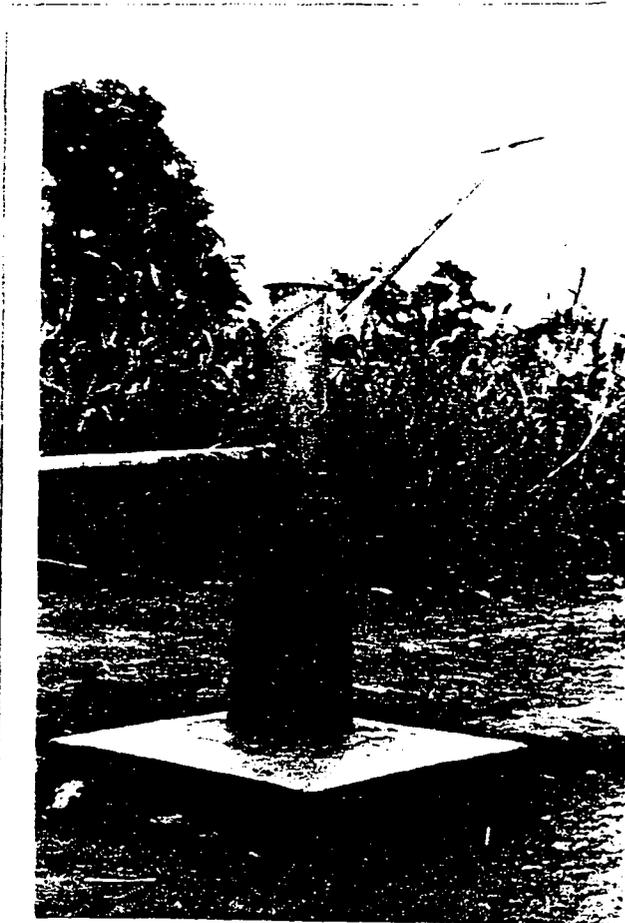
Two concrete pedestals were built in the Livulezi Project in August 1985. (The Photograph shows a Maldev pumphead mounted on a concrete pedestal). A metal frame made out of small angle iron sections or with a 6" m.s. pipe welded on to a square m.s. flange is embedded in the concrete and provides

P.4 Maldev pumphead installed on a 'Concrete' pedestal.

mounting for the pump head. The mixture of concrete used is 1:2:4. The cost of the concrete pedestal is around K40 (US \$25.0) and the present price of the steel pedestal for the Maldev pump is K88 (US \$52.0). Therefore a large saving can be made if these concrete pedestals prove to be successful in the tests.

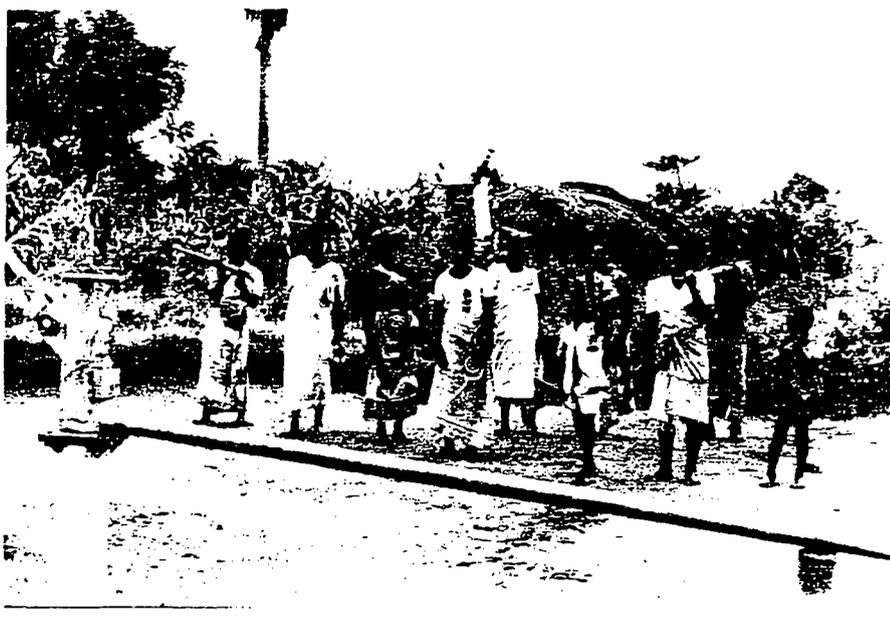
P.5 Woman and children carrying spare parts and tools needed to maintain their pump from maintenance assistant's house.

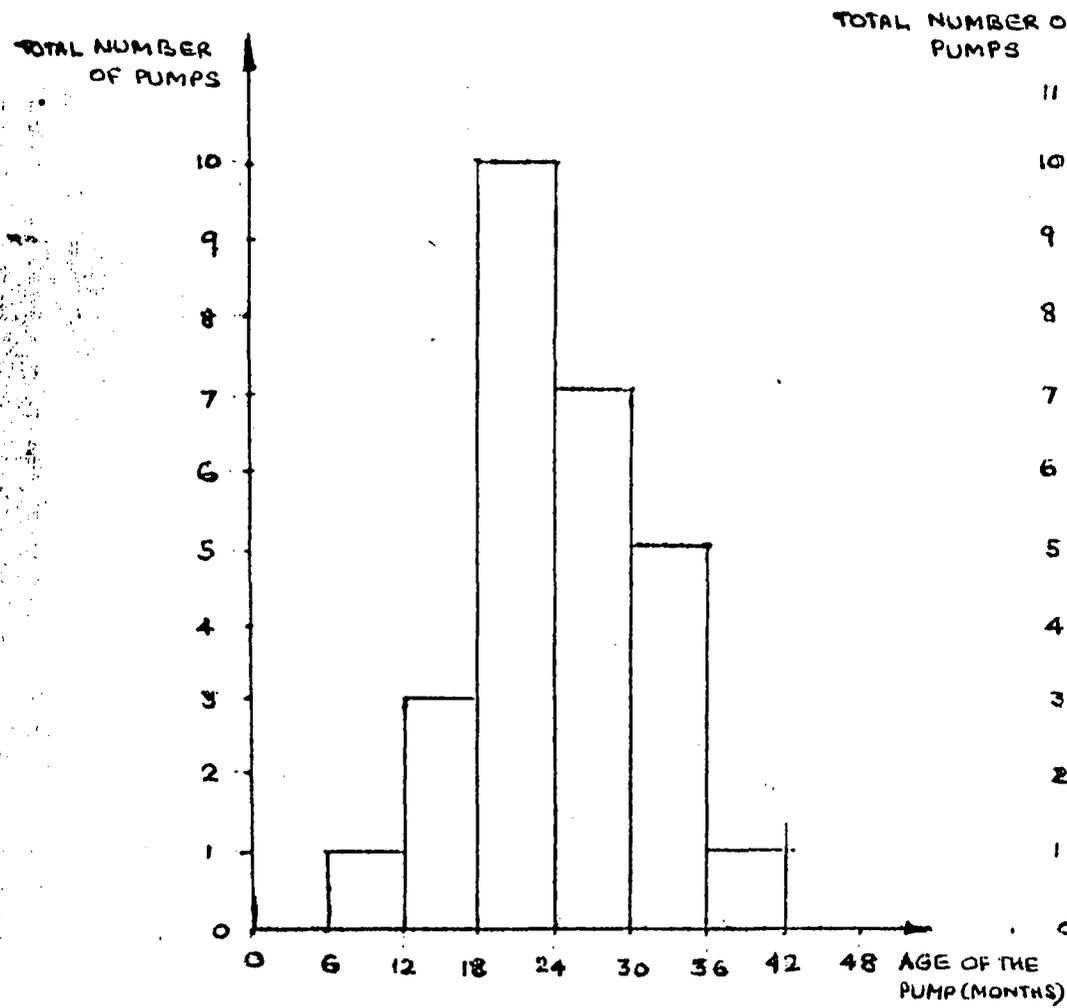
FIG 1. FIRST FULCRUM BEARING(S) REPLACEMENT OF MALDEV HANDPUMPS.

According to figures 1 and 2, the fulcrum bearings had to be replaced in about 10% of the pumps and in another 10% of the pumps the hanger bearings had to be replaced during their 18th-24th month operation. Fig 5 shows that 20% of the total number of pumps have had either hanger bearings or fulcrum bearings replaced in their 18th-24th month of operation. As shown in Fig.6, by the end of the 36 months of operation, 52% of the total number of pumps had either hanger or fulcrum bearings replaced for the first time. When analysing the breakdown records there were only two occasions where all three bearings (one hanger and two fulcrum) had to be replaced at the same time or within the same period of six months taken for plotting the histograms. Therefore Fig. 5 is the addition of Fig. 1 & 2 and Fig. 6 is the addition of Fig. 3 & 4.

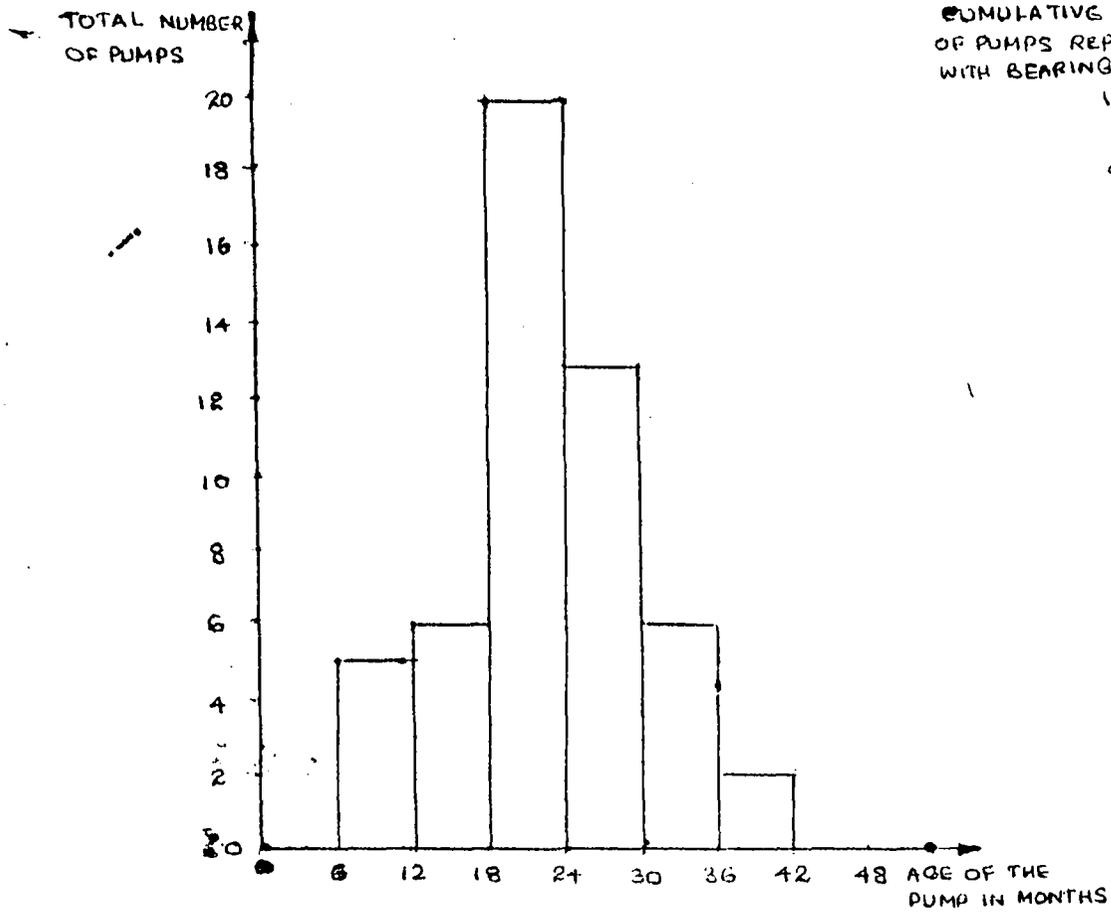
FIG. 5. FIRST BEARING(S) REPLACEMENT
IN MALDEV HANDPUMPS (HANGER & FULCRUM)

As indicated in Fig. 5, there is a peak between the age of 18th-24th month of the pumps showing 20% of the pumps needed bearing replacements. At the age of 36 months only 52% of the total population of the pumps have had bearing replacements. It would be interesting to draw the histogram for the first bearing replacement of the other 48% of the pumps with the information collected in future. These data could be used for maintaining stocks of bearings in projects.

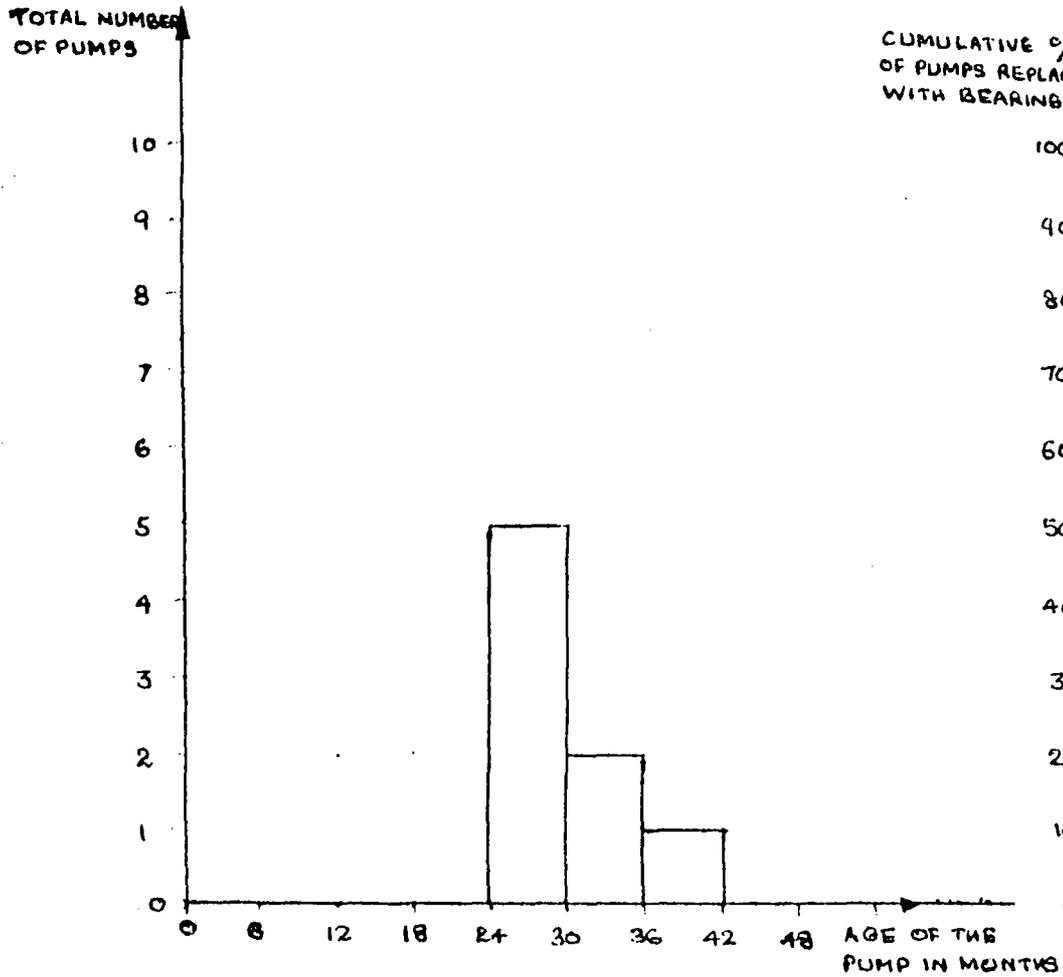
FIG. 7. SECOND BEARING(S) REPLACEMENT IN MALDEV HANDPUMPS

Fig.7 shows that five pumps had to have either hanger or fulcrum bearings replaced (3 with fulcrum and 2 with hanger) for the second time during their 24th-30th month in operation. According to Fig.8 only 7% of the total number of pumps had to be replaced by either hanger or fulcrum bearings (2nd time) before completing an operational period of 36 months (3 years). All of these eight bearings which had to be replaced for the second time were fitted on site.

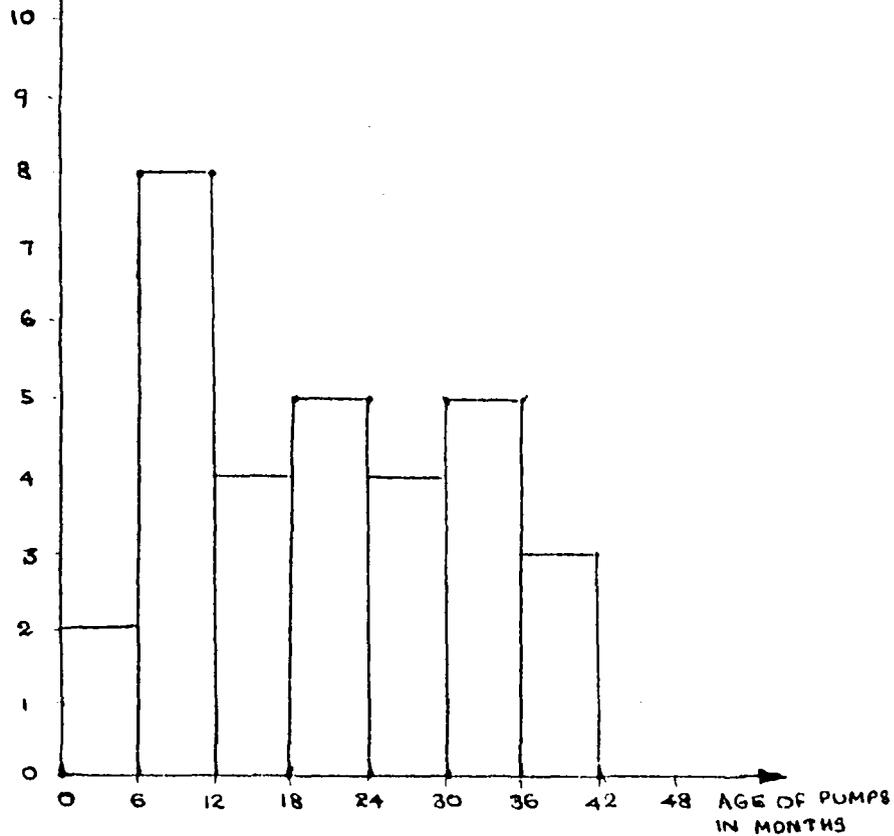
FIG. 9 FIRST PISTON SEAL REPLACEMENT
IN MALDEV HANDPUMPS.

Fig. 9 shows the first piston seal replacement in the Maldev pump. It shows a fairly equal distribution over the different ages of the pumps and according to Fig.10. 30% of the pumps had to have the seals replaced within the first 36 months of use. Second piston seal replacement in the pumps, shown in Fig. 11, has a similar distribution as for the first (Fig.9).

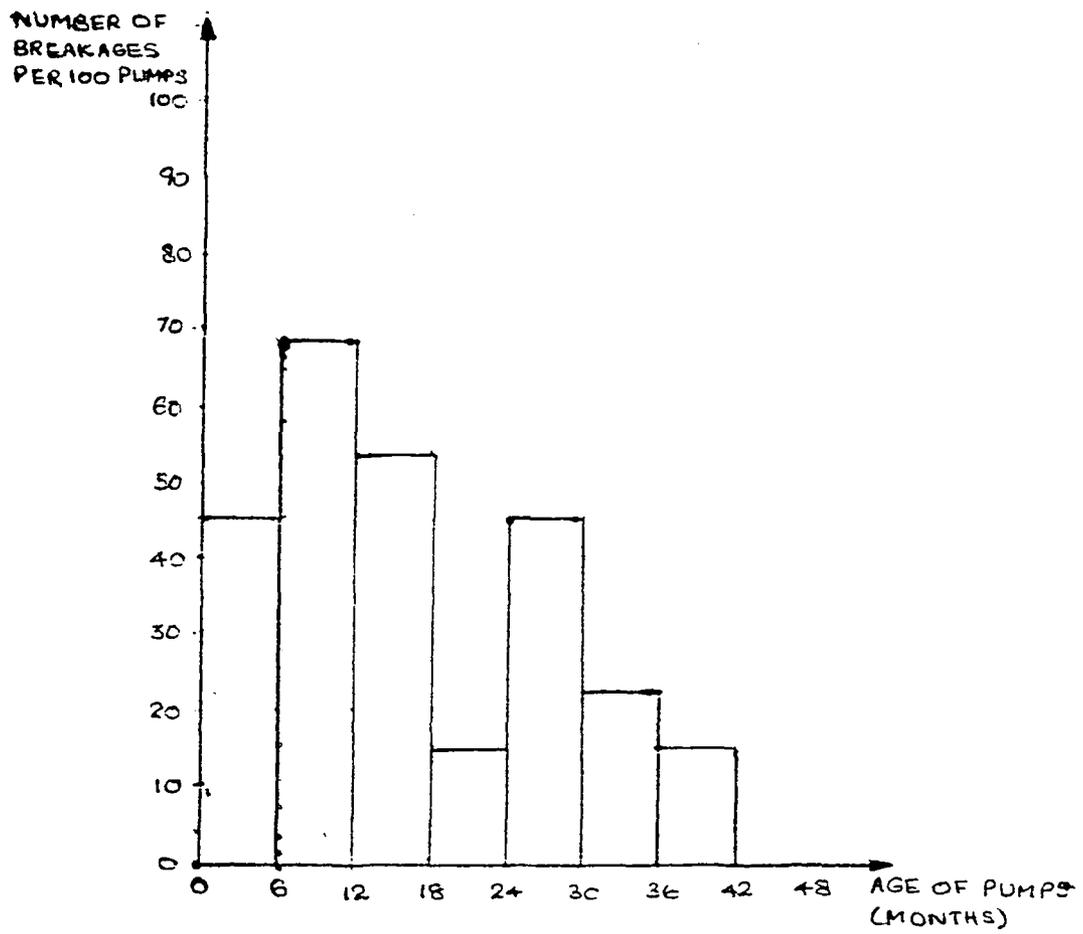
FIG. 13 NUMBER OF RISING MAIN BREAKAGES PER 100 CONSALLEN PUMPS.

Consallen pumps have given a lot of problems in connection with their plastic rising main. The breakage of the rising main pipe at its threads has been the most common cause of breakdown. As shown in Fig. 13 this type of breakdown had occurred at a maximum rate of 70 breakages per 100 pumps during the 6th to 12th month of operation of the pumps. This rate had fallen with time to 22 breakages per 100 pumps at the 30th - 36th month of operation of the pumps.

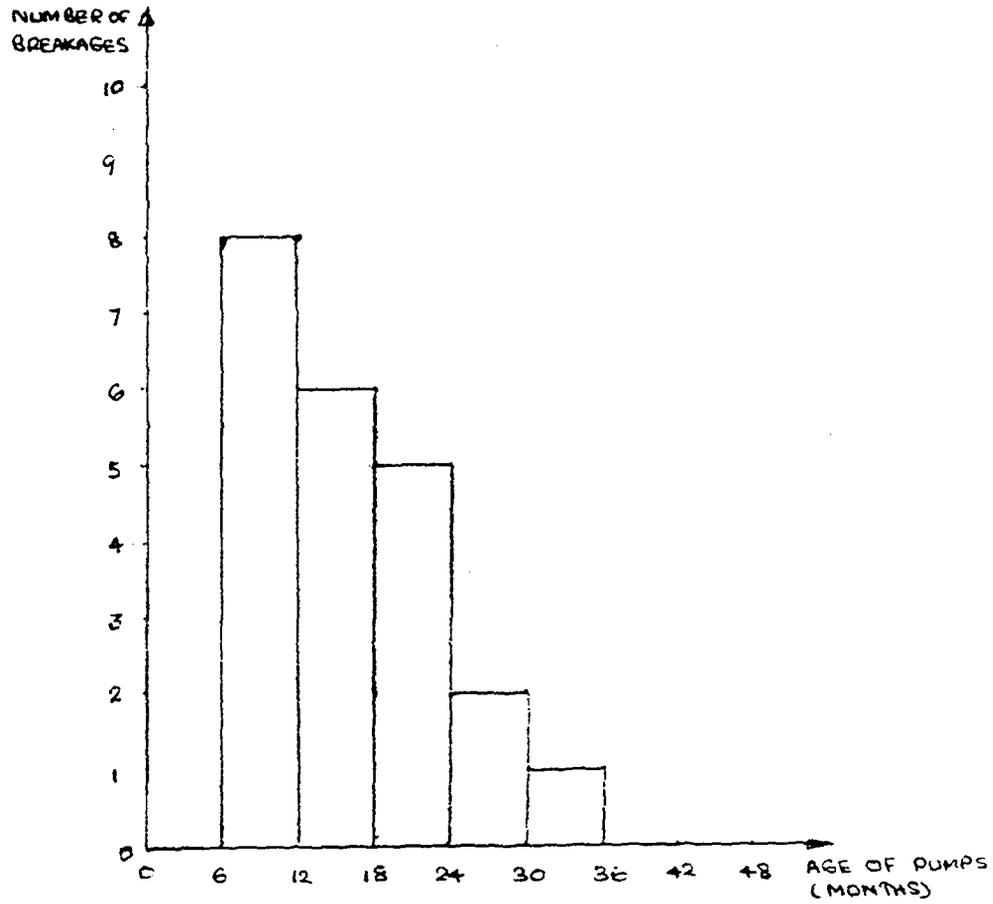
FIG. 15 TOP RISING MAIN TO HANDLE CONNECTION
BREAKAGES IN 'MADZI BLAIR' PUMPS.

The most common failure in this pump is breakage of the rising main near the handle. During 1985 this occurred three times on the pump at water point No. GP 12 and once on the pump at water point No. SW60. The other significant failure was breakage of the outer uPVC pipe at its top threads where it is screwed to the adapter union on the slab. This occurred twice on the pump at water point No. GP 19. Fig. 15 shows how often this common failure of breakage of the rising main at it's connection to the handle has occurred with the ten Blair pumps tested. From the declining pattern of the graph it shows that the frequency of the failure has decreased with the age of the pumps.

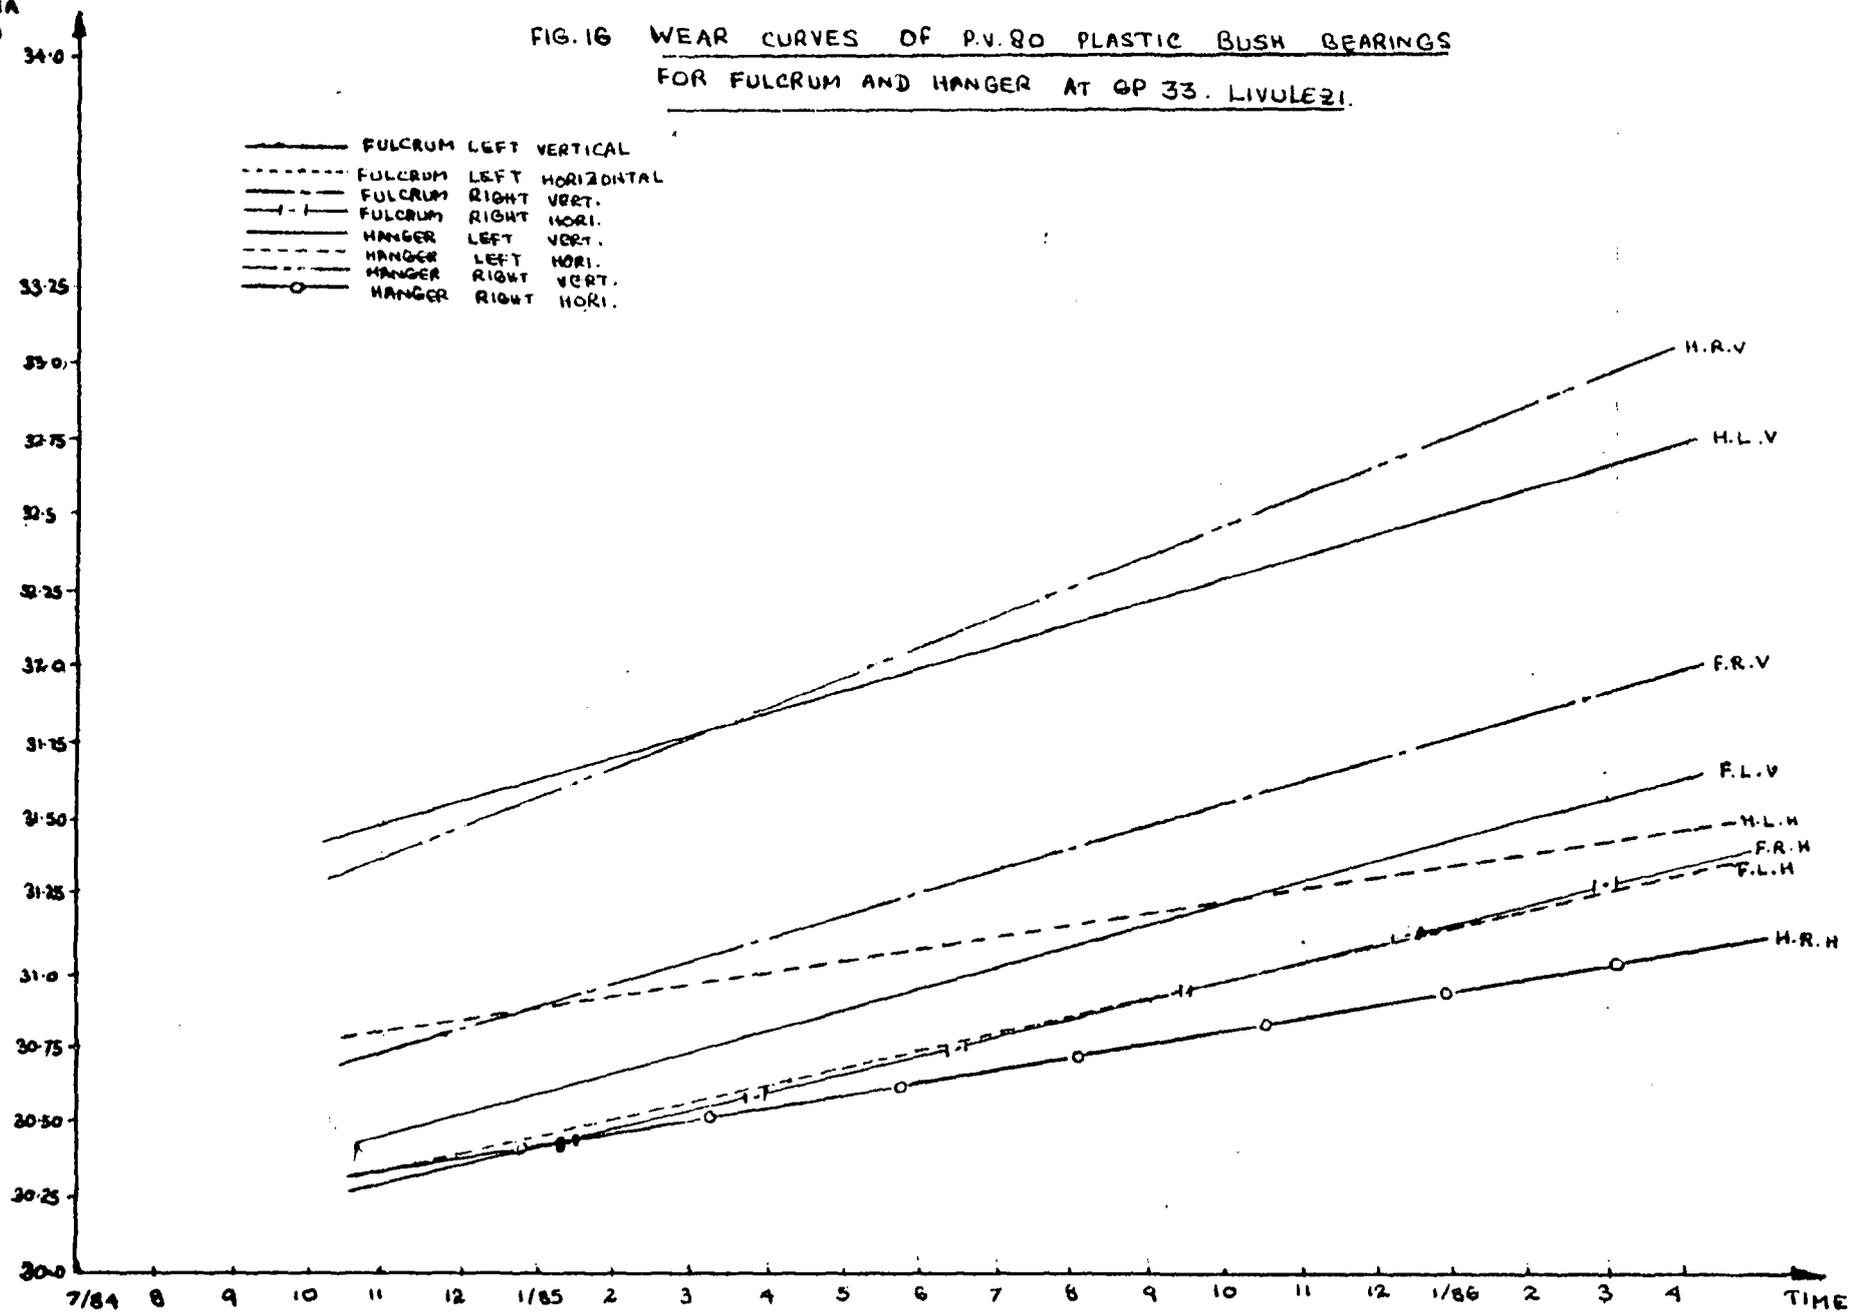
FIG. 17 WEAR CURVES FOR PV 80 PLASTIC BUSH BEARINGS
AT GP 22 LIVULEZI.

When the wear curves for GP 33 and GP 22 are compared (Fig. 16 & Fig. 17), the rates for the fulcrum bushes are quite similar, but the rate for hanger bushes on GP 33 is much higher than for those in GP 22. But it would be expected to be the other way round, because the load on the hanger bearing of GP 22 is much higher than on the same in GP 33, due to a deeper water level and cylinder setting.

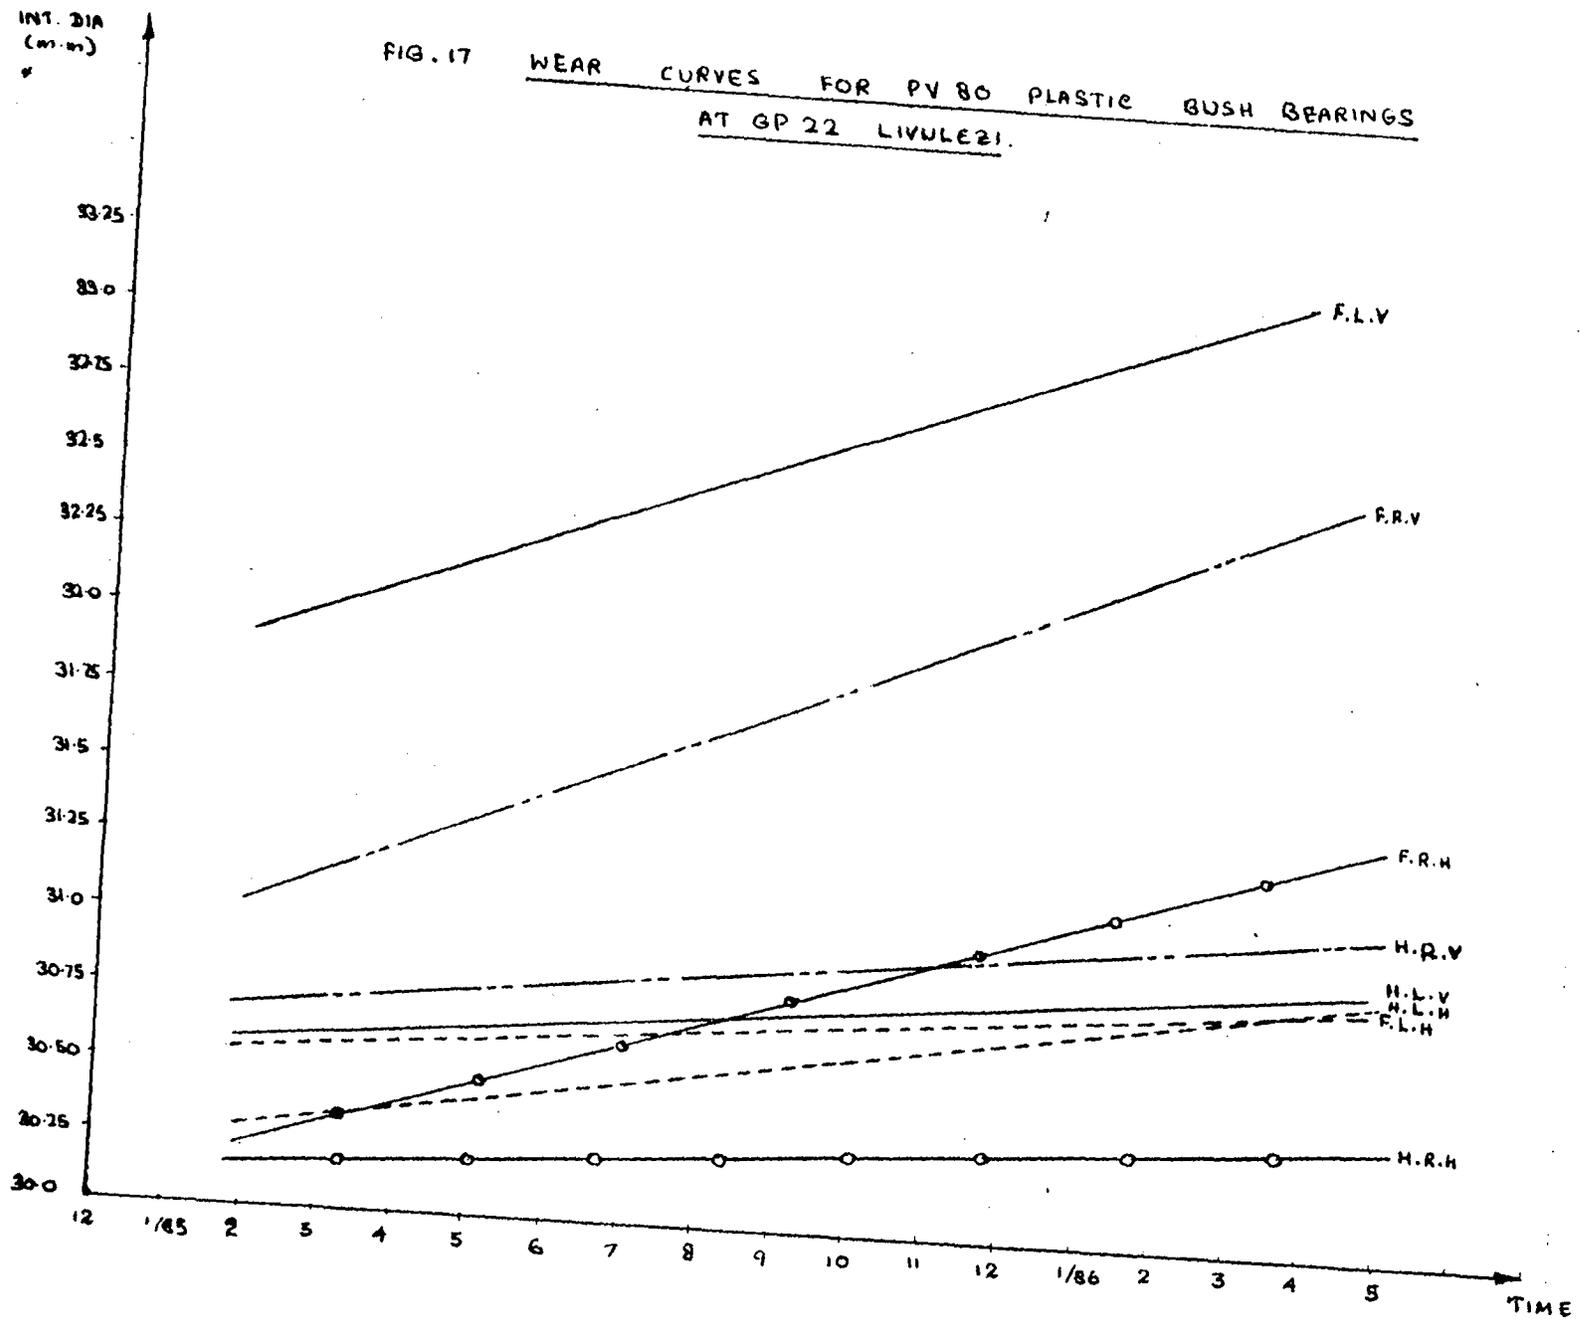
FIG. 1 WEAR CURVES FOR PV.80 BUSH BEARINGS

Earlier it was suspected that the dust collected inside the bush accelerates the rate of wear of the bush. The grooves provided can accumulate the dust so that the working surfaces can remain free of dust particles. Fig. 18 shows the wear rate of these new bushes on the hanger. Fig. 19 shows a comparison of the wear rate of the earlier (without grooves) and current (with grooves) polyacetal bushes on the hanger unit in GP 111. It certainly shows an improvement in performance of the current, grooved bushes.
