CD/HELVETAS CO-OPERATION IN CAMEROON  
1964 - 1989

INTERNATIONAL REFERENCE CENTER  
COMMUNITY WATER SUPPLY AND  
SANITATION PROGRAM

EVALUATION OF  
WATER SUPPLY SYSTEMS,  
CONSTRUCTED FROM 1964 TO 1989

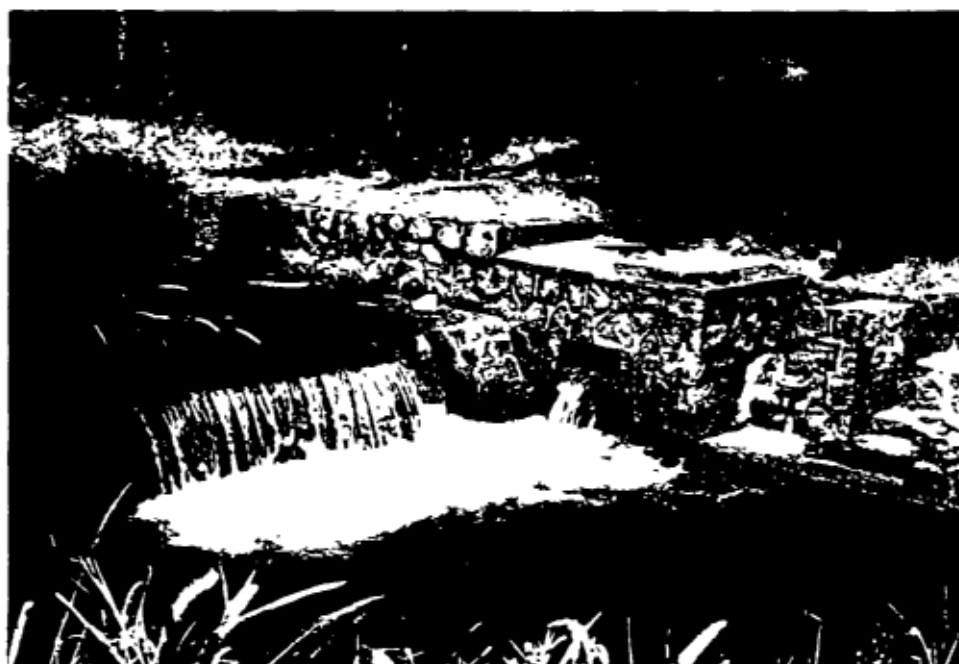
Water intake NKAR: WS system constructed 1969-77;  
Project well maintained by population (gen.rating 2; ref.no. 55).

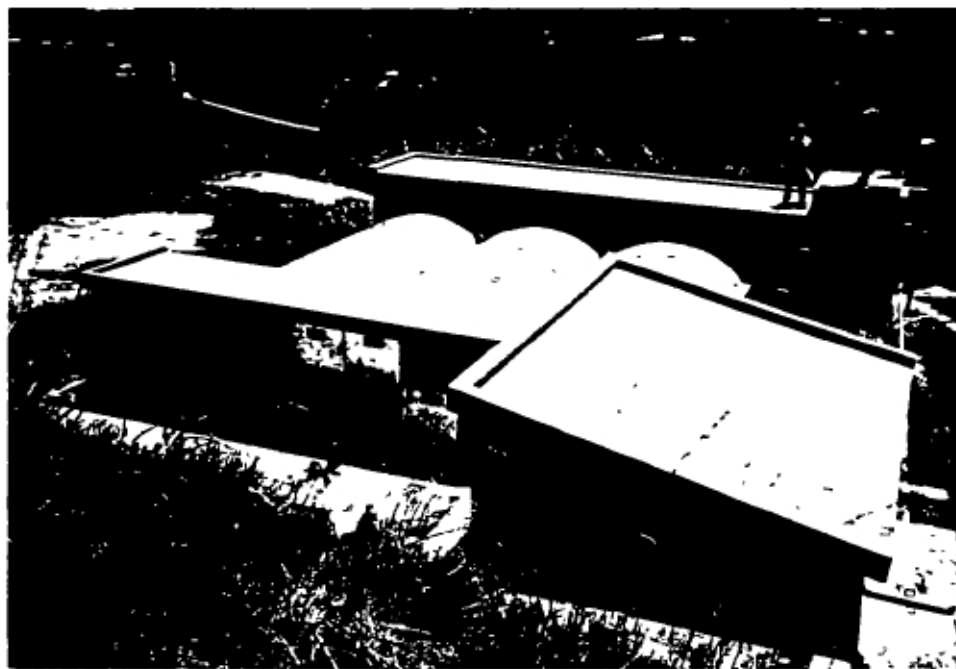
NSEH water treatment station: Constructed 1977-87; gen.rating 2; ref.no. 61.  
Rapid sand filter (front), 3 slow sand filters and project store room.

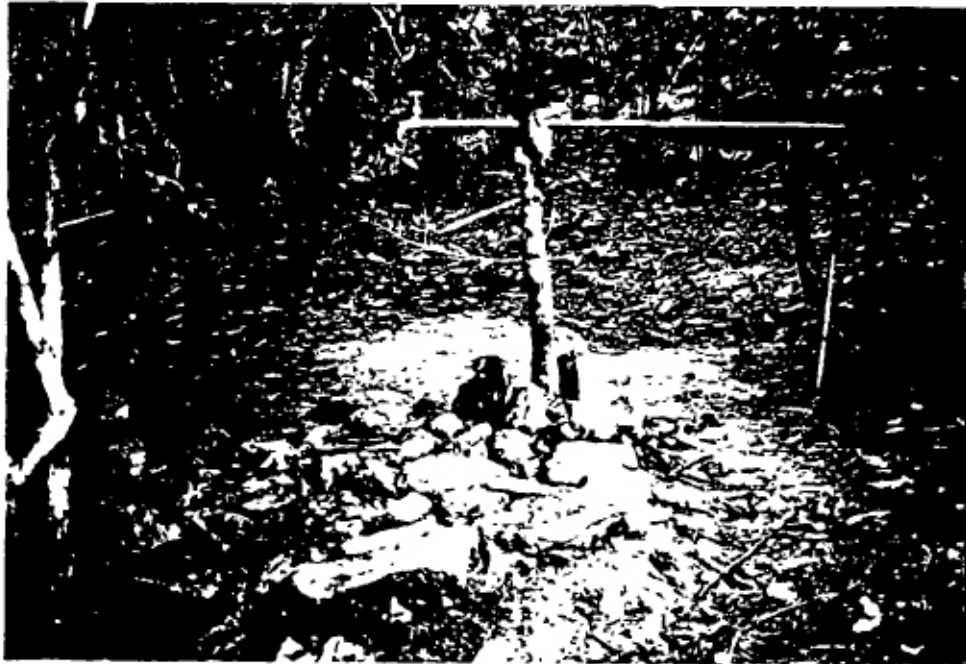
BELO/NJINIKIJEM: Standpipe of extension (done by population). One of the largest CD/HELVETAS WS systems; constructed 1971-80; gen.rating 3; ref.no.52.

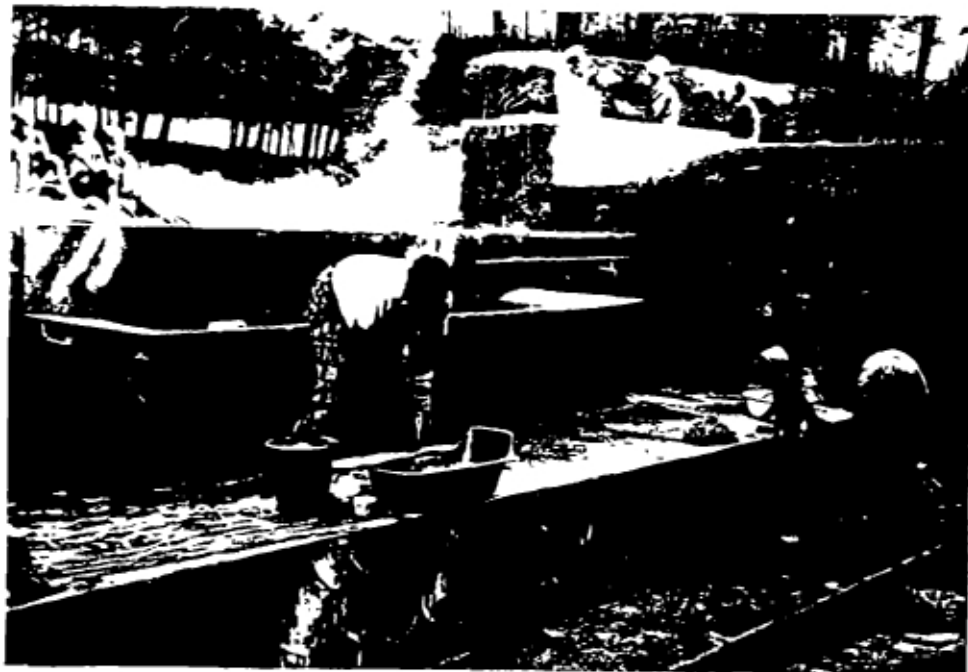
Washplace near filter station in NDU town.  
Constructed 1967-70; gen.rating 3; ref.no. 72.
