CD/HELVETAS CO-OPERATION IN CAMEROON
1964 - 1989

EVALUATION OF
WATER POINTS AND WELLS,
CONSTRUCTED FROM 1964 TO 1989

Yaoundé, 2/6/89 by OG

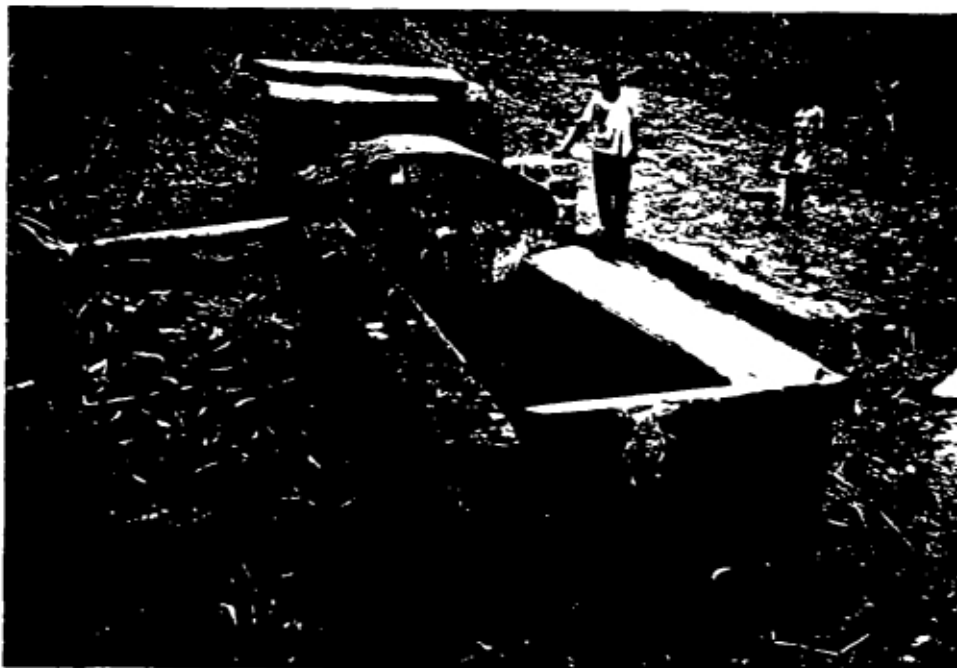
BAFUT NFOYA: Built 1966; gen.rating 3; ref.no. 63

WVEM: Built 1971; gen.rating 3; ref.no. 91.
Both WPs are widely used and should be overhauled.

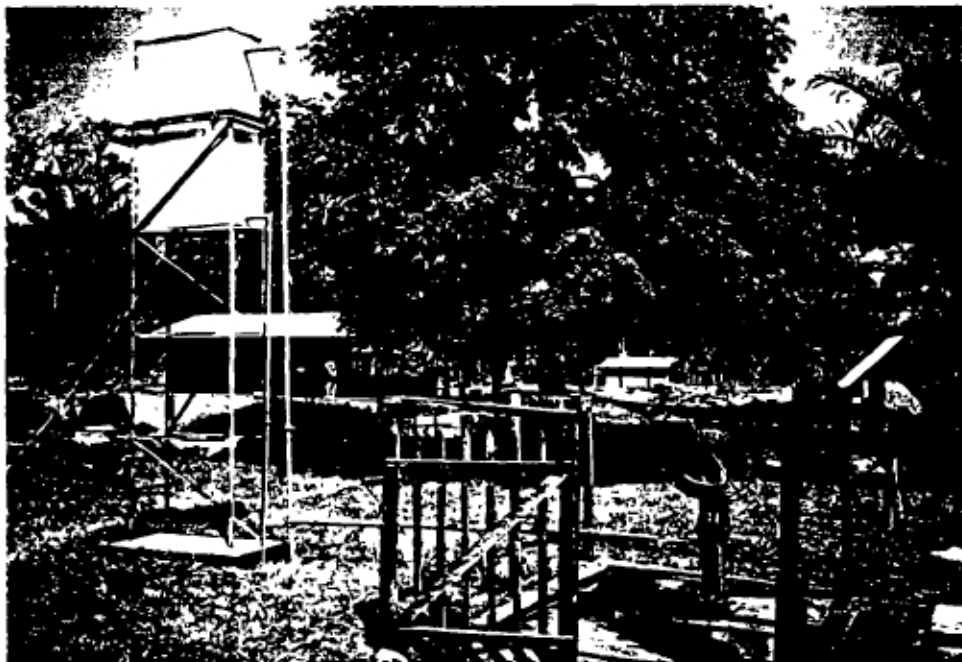
Out of the 9 handpumps working in 1988, eight were installed between 1985-88. The handpump for BANGOLAN project was installed in 1982 and always maintained by Bansoa Babtist Hospital (only handpump working over 5 years; ref. No.57).

BANGOLAN WELL: Built in 1982; gen.rating 2; no.57.
Only handpump working over 5 years; maintained by mission.
