Ministry of Lands, Minerals Resources and Energy
Mineral Resources Department

**Water Resource Investigations
on
CICIA**

Prepared by
B. J. Lewis and L. J. M. Mourits
Centre for Community Water Supply and
Sanitation Studies

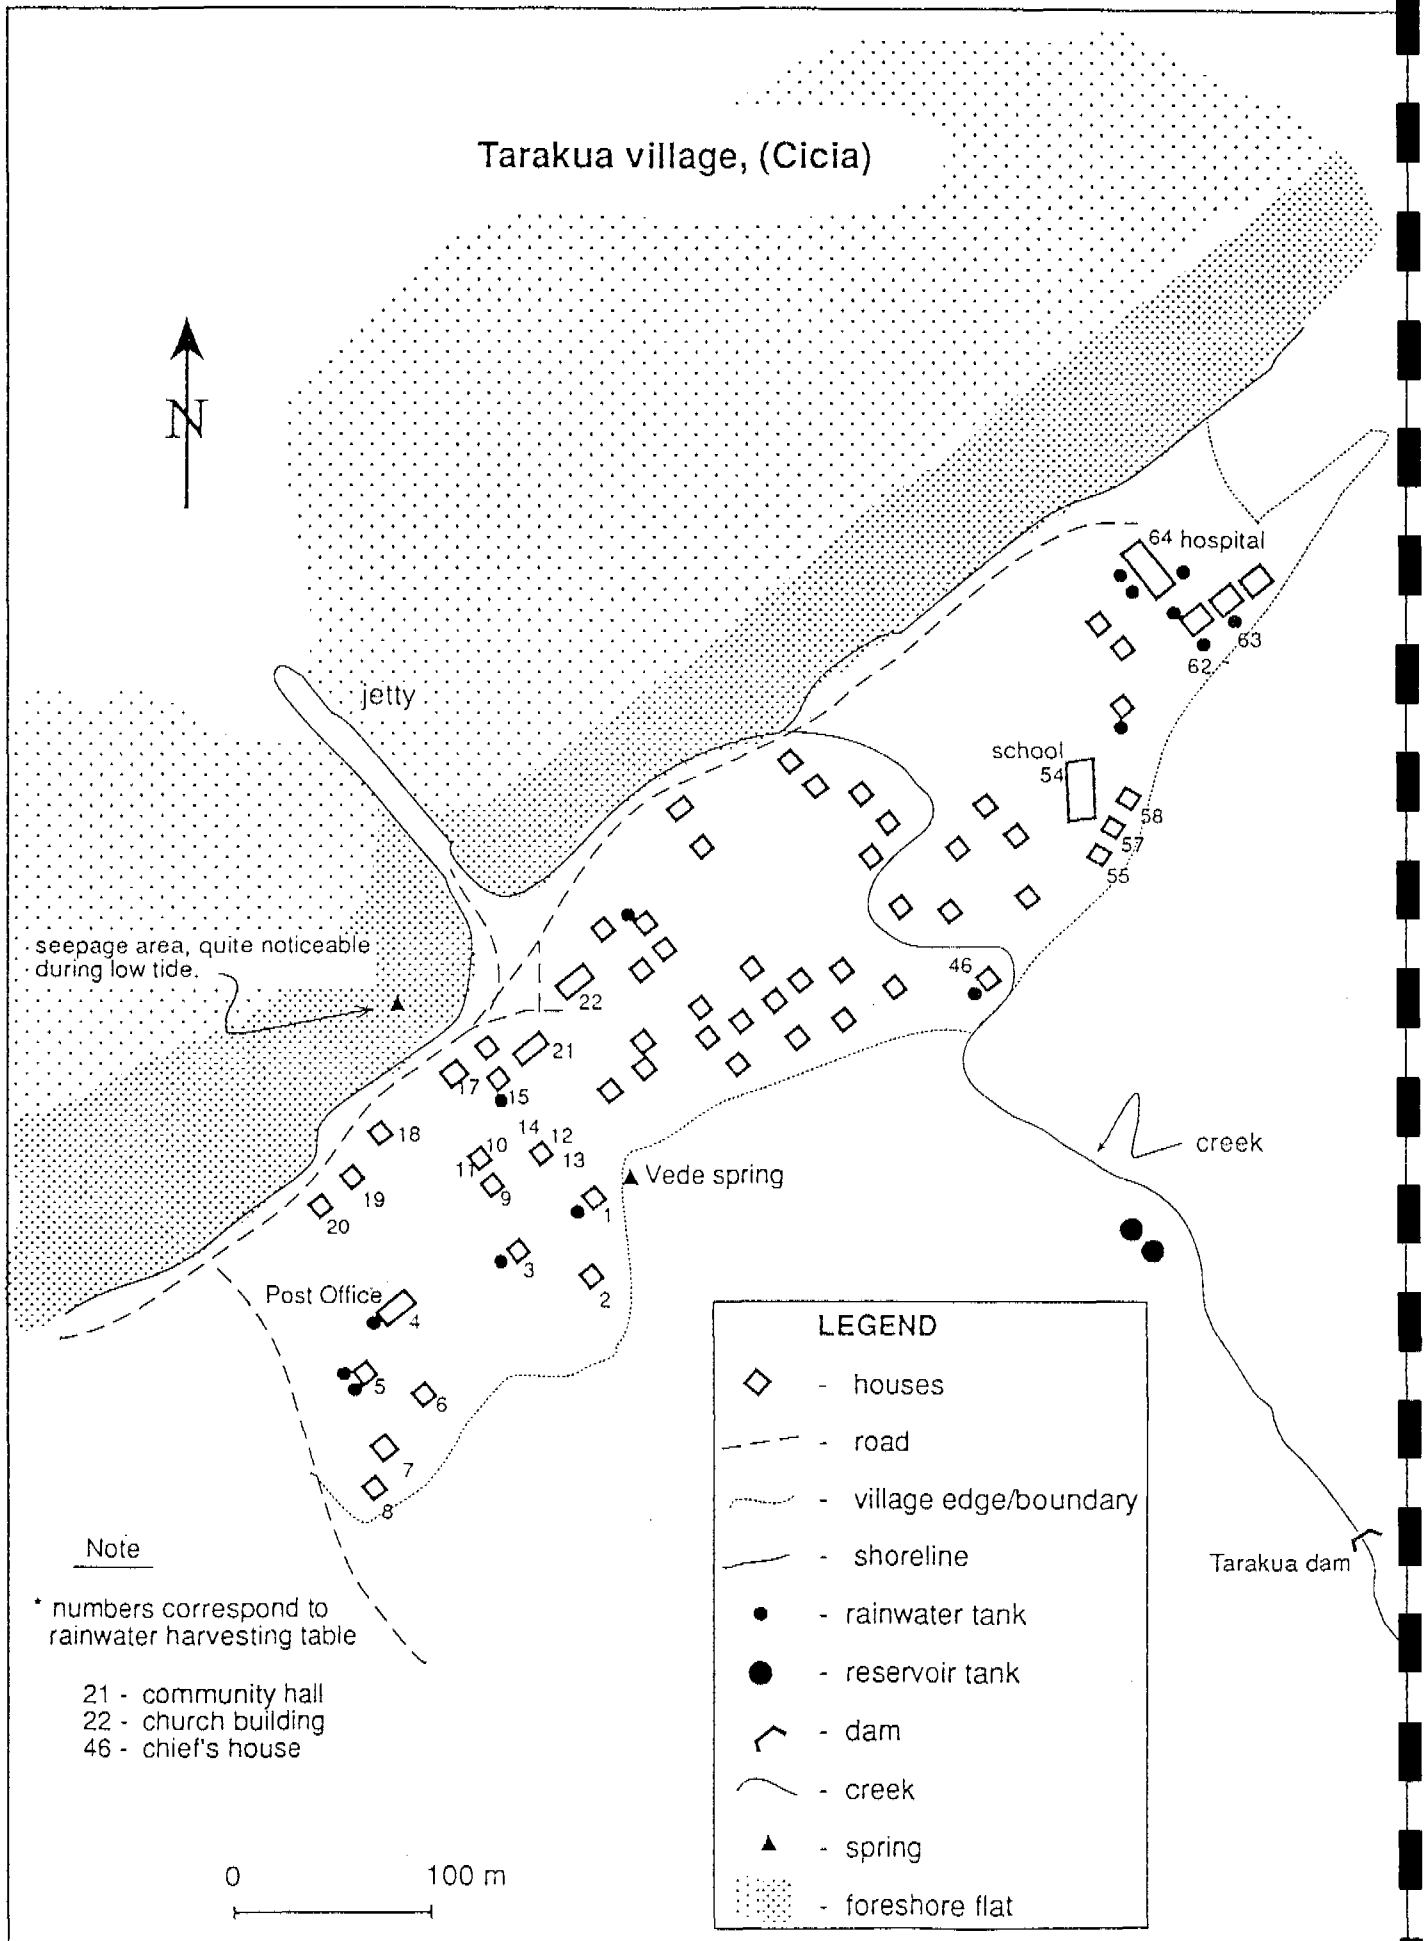
Figure 4: Tarakua village map, Cicia

Pipes and tanks The pipes and dam are over 20 years old. Pipes are rusting through and have many repaired parts. They are leaking at several places. The village has two tanks, an old 6500-gallon Humes tank from the 1970's and a 6600-gallon ferro-cement tank from the 1980's; both are leaking. Water in the tanks is dirty because dirt from the dam collects inside the tanks and the tanks are not periodically cleaned nor disinfected.

Vede spring Vede spring is located on the slope of the hill south of the village. The spring is an open hole (1x0.7 m wide) filled with boulders, about 0.6 m deep. The spring is inadequately fenced with some corrugated iron sheets allowing surface

runoff to enter the spring. Electrical conductivity was measured as 285 $\mu\text{S}/\text{cm}$; pH was 6.5.

1. Leaks within the two main water tanks need to be repaired.
2. Since the existing piping is in very poor condition, replacement of the 20 year old system is needed.
3. The village needs to better use their rainwater-catchment potential, for water quality reasons as well as to supplement their reticulated stream water. Currently only 28.6% of the available roof area is being used and current rainwater storage capacity is 80.7 m³.
4. Water treatment of the reticulated water is recommended.
5. A borehole has been sited in one of the valleys adjacent to the airport. This source is expected to have a maximum potential yield of 0.63 l/s (268 l/p/d).
6. Additional groundwater can be abstracted from the shallow coastal aquifer near the airport. This water source could be used for cattle production on the Tabuta Estate.

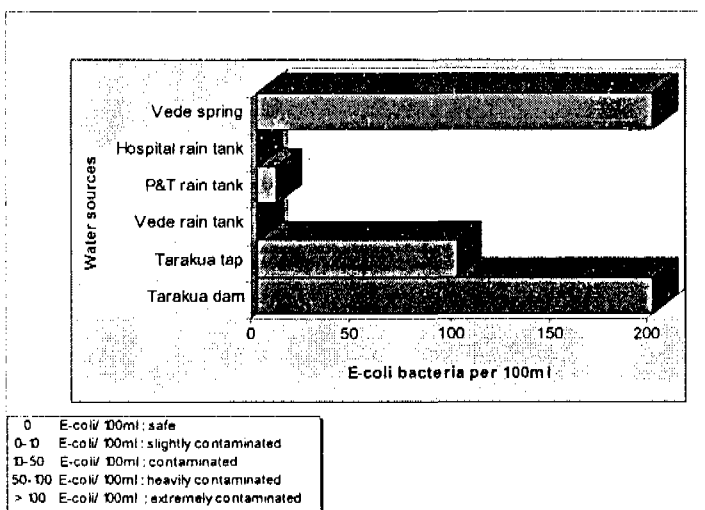
Figure 5: Biological water quality, Tarakua

The water becomes very dirty, especially during rainy season due to surface runoff entering the dam reservoir and consequently the tanks and taps. Some women mentioned that "the tap water is sometimes so dirty that small eels (worms?)

Vede spring was also extremely contaminated with over 200 E-coli bacteria per 100 ml. The rainwater tanks were much better, with 0 E-coli bacteria per 100 ml in the hospital tank, 1 E-coli bacterium per 100 ml in the household tank near Vede and 10 E-coli bacteria per 100 ml in one of the rainwater tanks from the P&T station. This last tank needs to be cleaned as well as the gutters and roof.

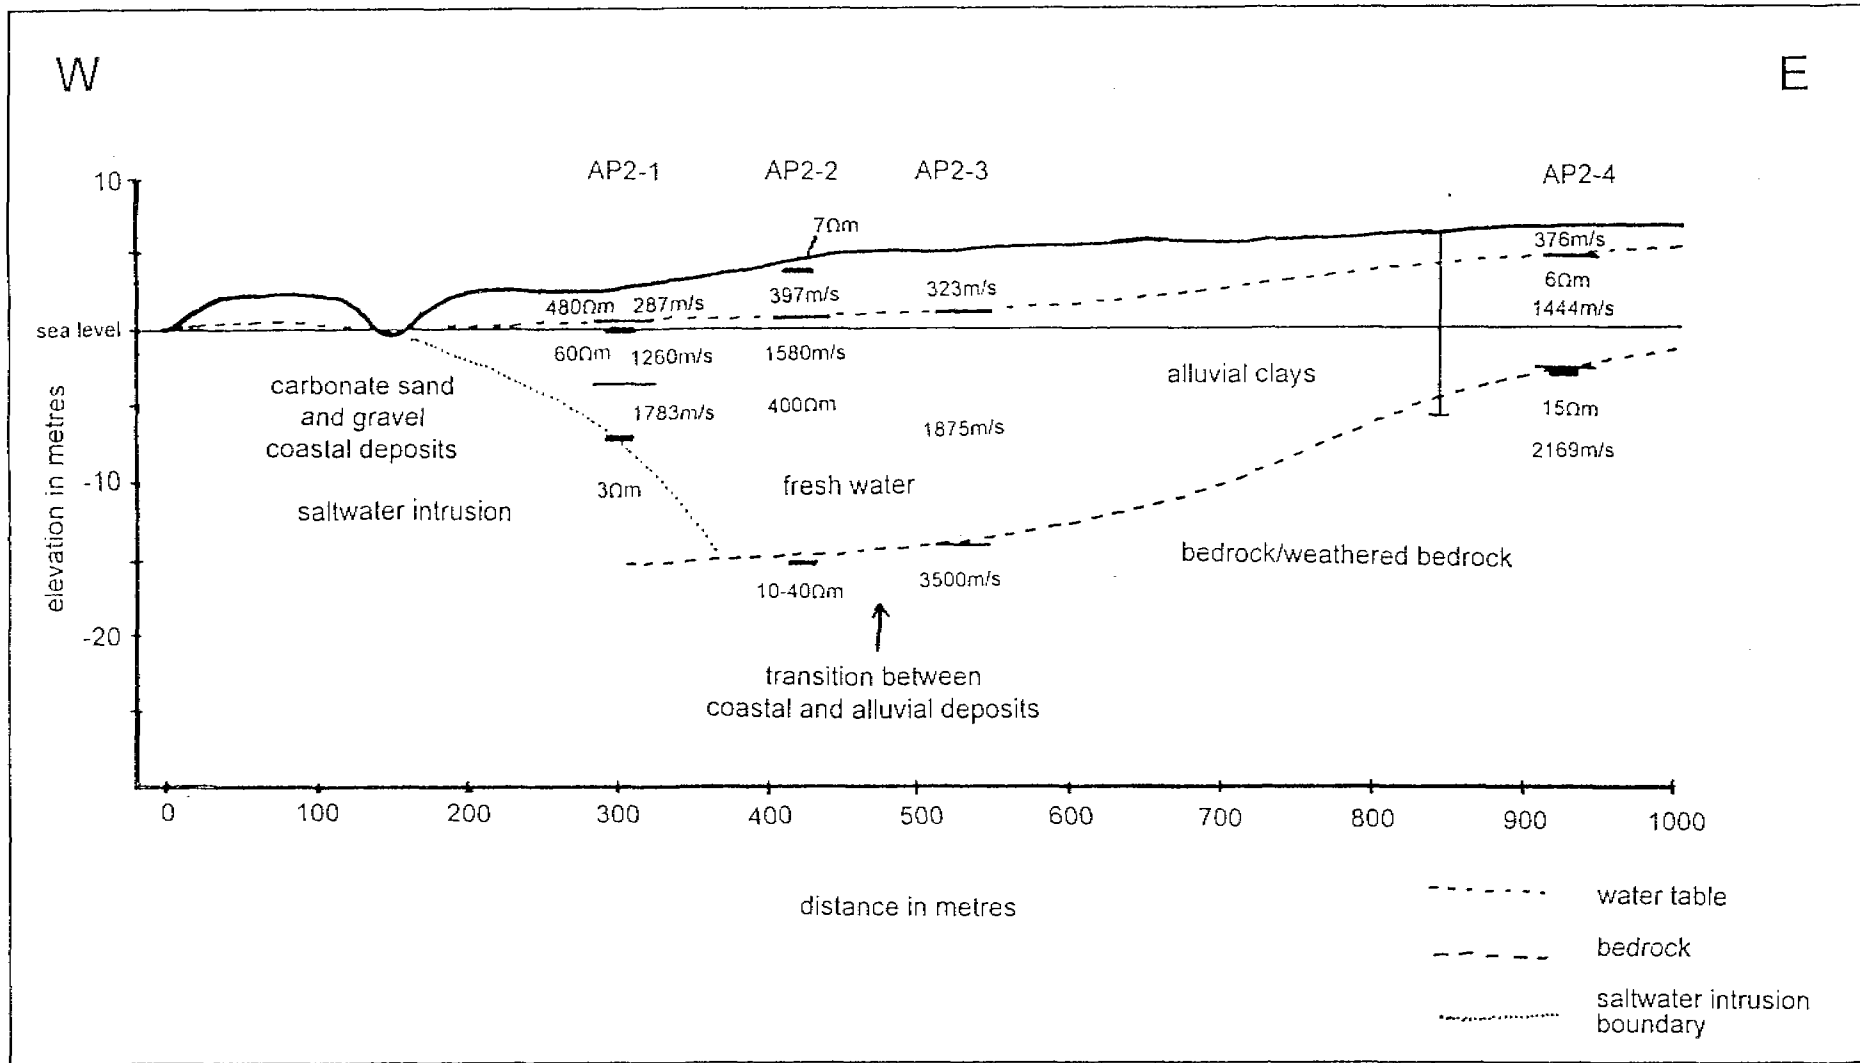
Figure 6: Geophysical profile, Valley AP2, Cicia

Site AP2-3 is located about 520 metres inland from the coast. The data from the electrical resistivity soundings at site AP2-3 were not interpretable. This result can be attributed to inhomogeneities in the subsurface layering caused by the transition between coastal and alluvial deposits. The alluvial deposits in this area probably contain some degree of residual salinity as found by augering in valley AP3. The seismic sounding indicates that the top of the water table was at 4.6 metres and bedrock at 19.6 m below the surface.

Site AP2-4 is located about 930 metres inland from the coast. The electrical resistivity sounding indicates about 10 metres of 6- Ωm alluvial/colluvial clays overlying 15- Ωm weathered bedrock. The seismic sounding indicates that the top of the water table was at 2.7 m below the surface and weathered bedrock at 9.6 m.

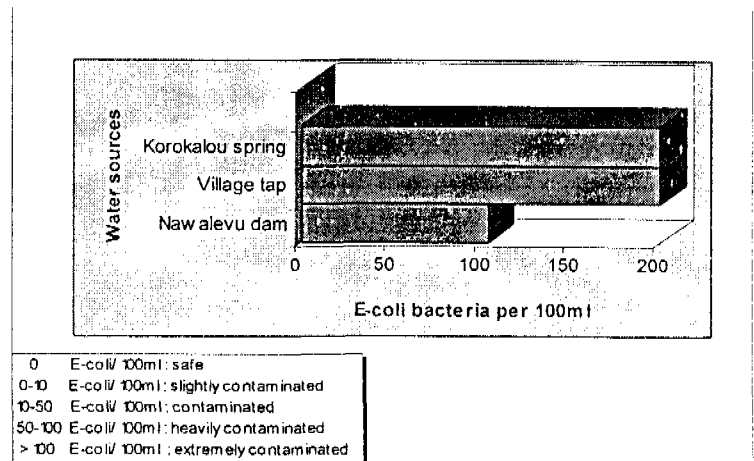
Figure 9: Biological water analysis, Lomati

All the sources in Lomati were found to be heavily contaminated. Bacteriological tests revealed over 100 E-coli bacteria in 100 ml water at Nawalevu dam, and even more in the tap water at the village. Thus water becomes contaminated either from inside the system or from water with a greater degree of contamination entering the system during the previous rainfall.

Korokalou spring was found to be extremely contaminated as well.

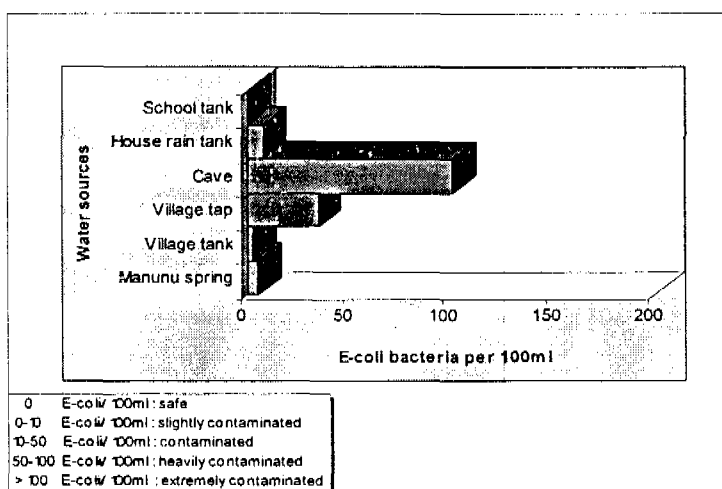
Figure 12: Biological water quality, Natokalau

Manunu spring has the lowest E-coli count of all the springs on Cicia (1 E-coli bacteria in 100 ml). Although the spring water was fairly clean, the tap water in the village was found more contaminated. Thus the water becomes contaminated inside the system (tanks and pipes) or contaminated water entered the system during previous rainfall.

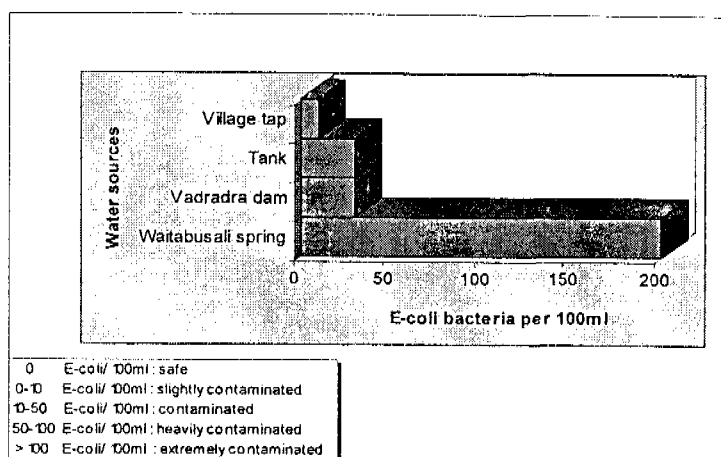
Figure 15: Biological water quality, Naceva

Vadradra dam and tank water both had a count of 30 E-coli/100 ml, indicating biological contamination. During rains the water gets contaminated from surface flow entering the dam and pipes.

Waitabusali spring water was extremely contaminated at the time of the survey. The source of this contamination needs to be identified and remedial action taken.

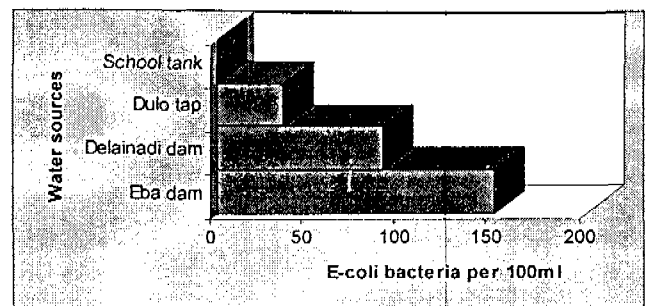
Figure 18: Biological water quality, Mabula

Both dams supplying the village taps were found to be grossly contaminated.

The Dulo spring water was also contaminated.
