## PHOTOGRAPHIC ALBUM

# PAPUA NEW GUINEA WATER SUPPLY AND SANITATION SECTOR PROFILE

ASIAN DEVELOPMENT BANK

September 1987

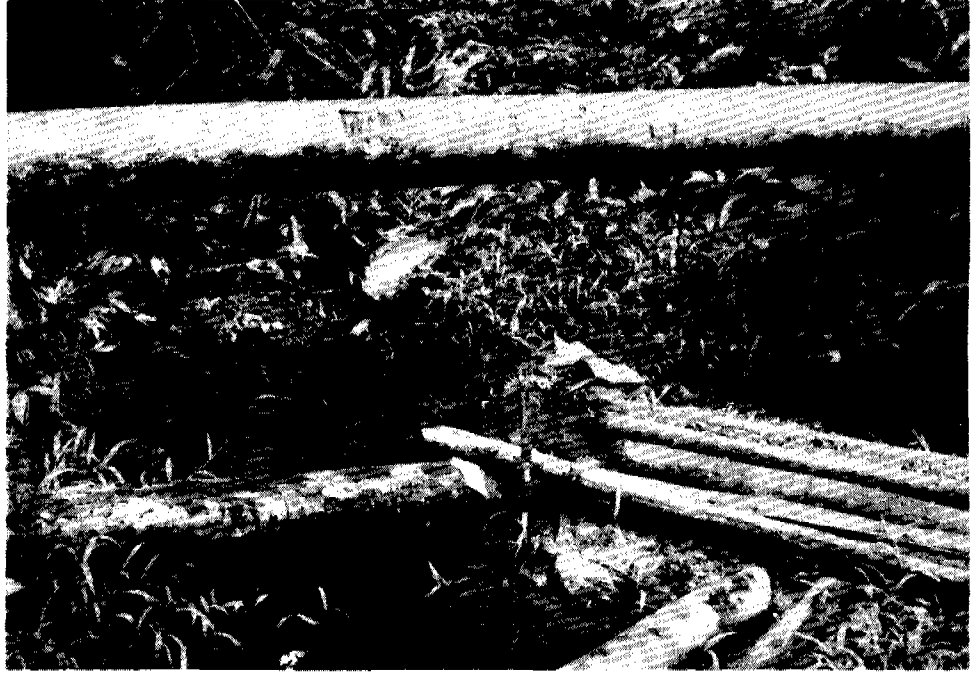
Fig. 1

Fig. 1. Western Province. Unprotected spring, at the right side of the picture. This spring is located on a shore of a stream. It never dries and is a very important source of drinking water to the whole village. It is a rather typical village water source. Such spring could be protected to prevent contamination with fecal matter normally present in streams. If equipped with a handpump, it will not be contaminated by users. Such protective work could be carried out by self-help. However, villagers would have to be convinced by health education that such work would be beneficial to them particularly to their children.

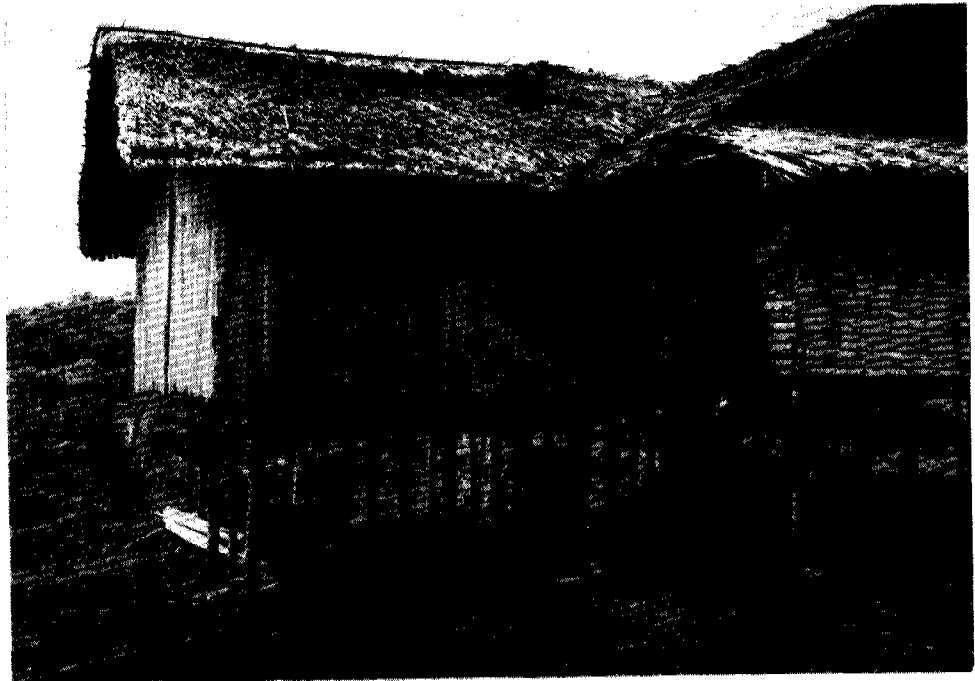
Fig. 2

Fig. 2. Western Province. Rain water is being collected even from thatched roofs of village houses. Storage is inadequate and can be contaminated by users. This is not an ideal solution of the water supply problem. Such system can be improved by construction of larger storage tank, e.g., ferrocement tank, and by metal covered roof.

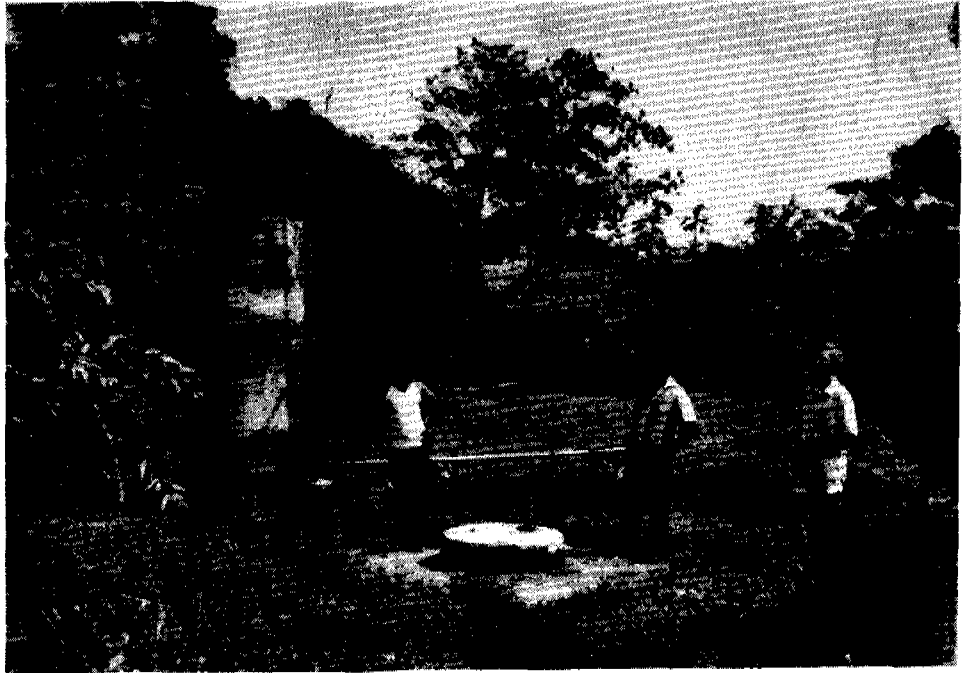
Fig. 3

Fig. 3. Morobe Province. Protected well with two handpumps. One of the pumps supplies water to the tank from which it gravitates to the household. Second pump (on the right) is a PNG Blair handpump.

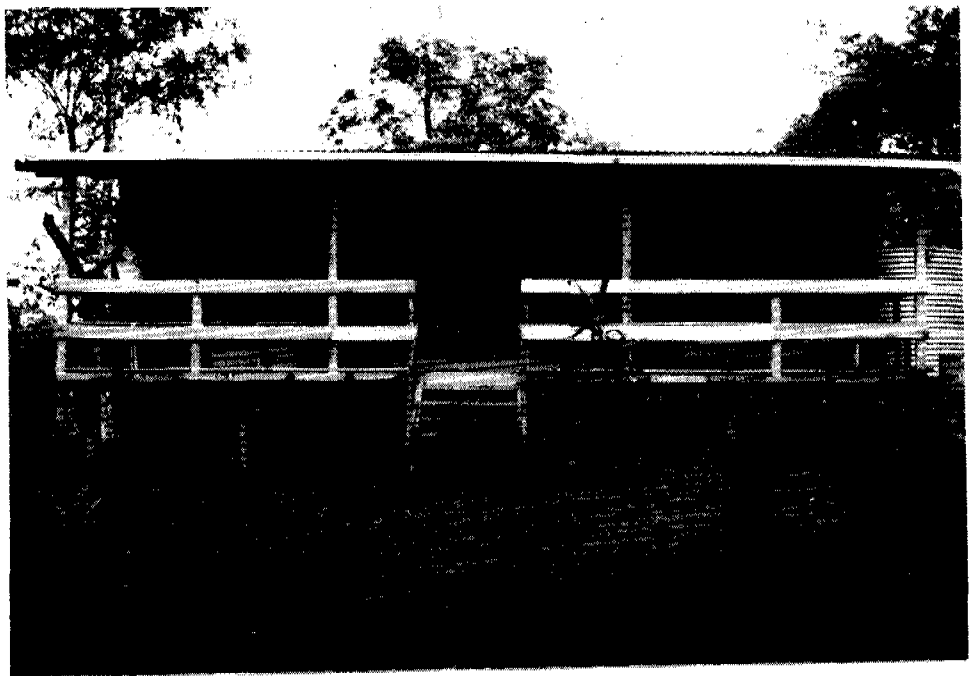
Fig. 8

Fig. 8. Western Province. Aid Post serving a few villages. It has a rain water collection system. This Aid Post was unoccupied at the time of the visit.

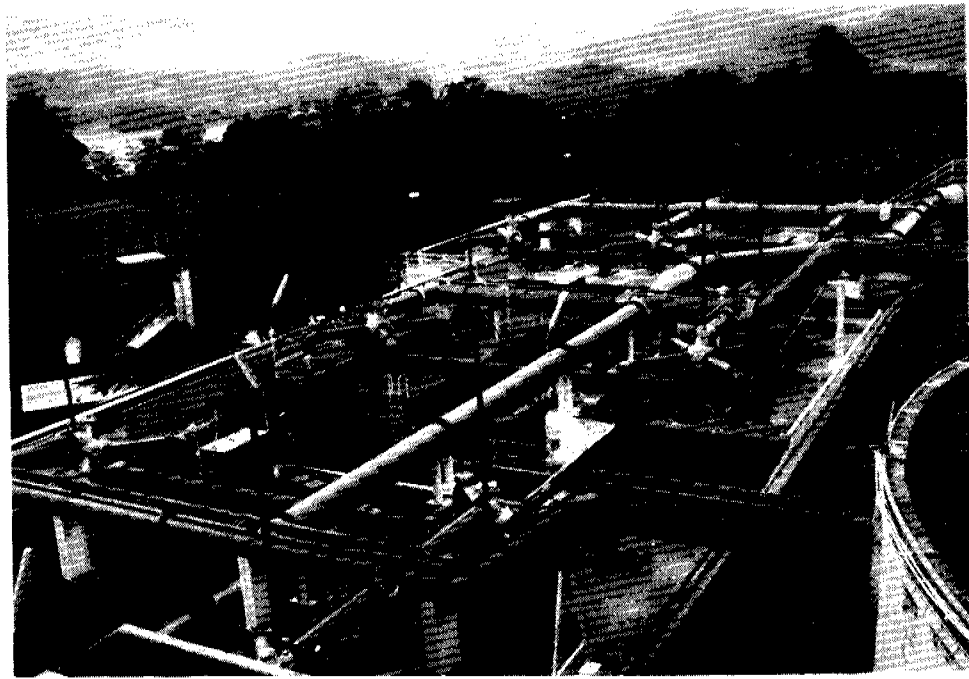
Fig. 12

Fig. 12. Port Moresby. Mt. Eriama water treatment plant operated by the National Capital District Interim Commission (NCDIC). This photograph shows concrete pressure filters.

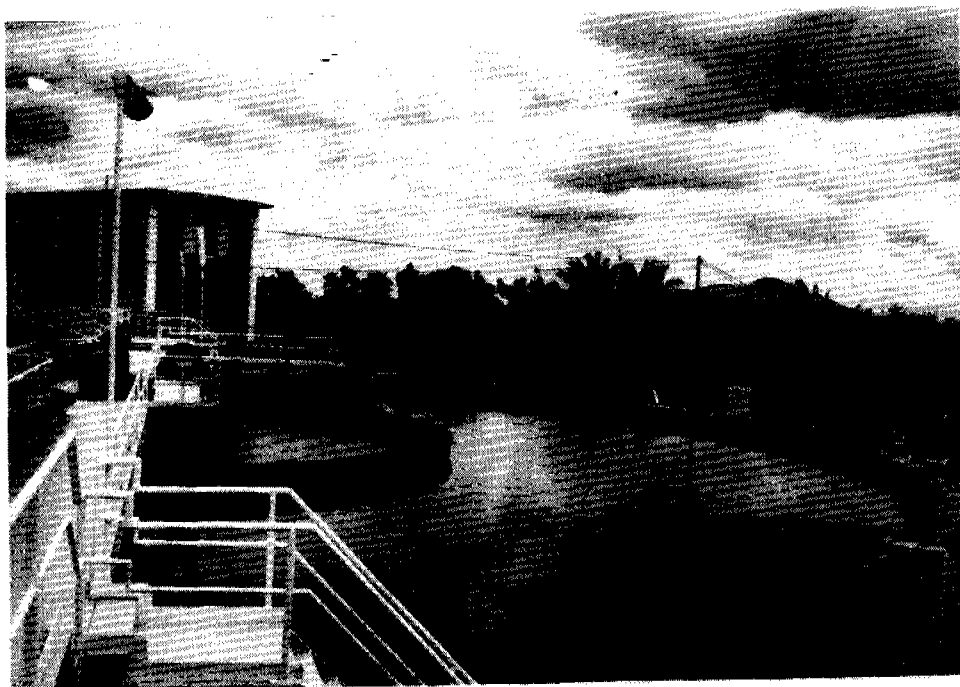
Fig. 13 and 14. Port Moresby. Mt. Eriama water treatment plant operated by the NCDIC. These photographs show one of the clarifiers. Figure 13 illustrates effectiveness of operation of this clarifier. Brown (dark if in B/W) water in the flocculator can be seen to the left of the photograph. The middle portion shows the settled water collecting channel. And finally, settled water collecting pipes can be seen through the clear water of the settling basin, at the right of the photograph.

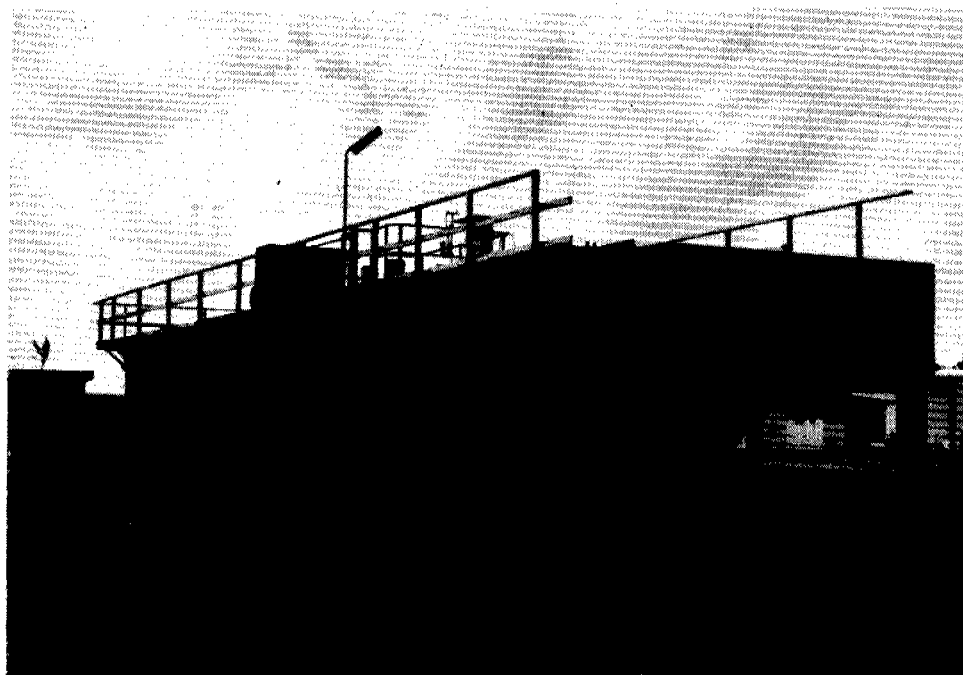
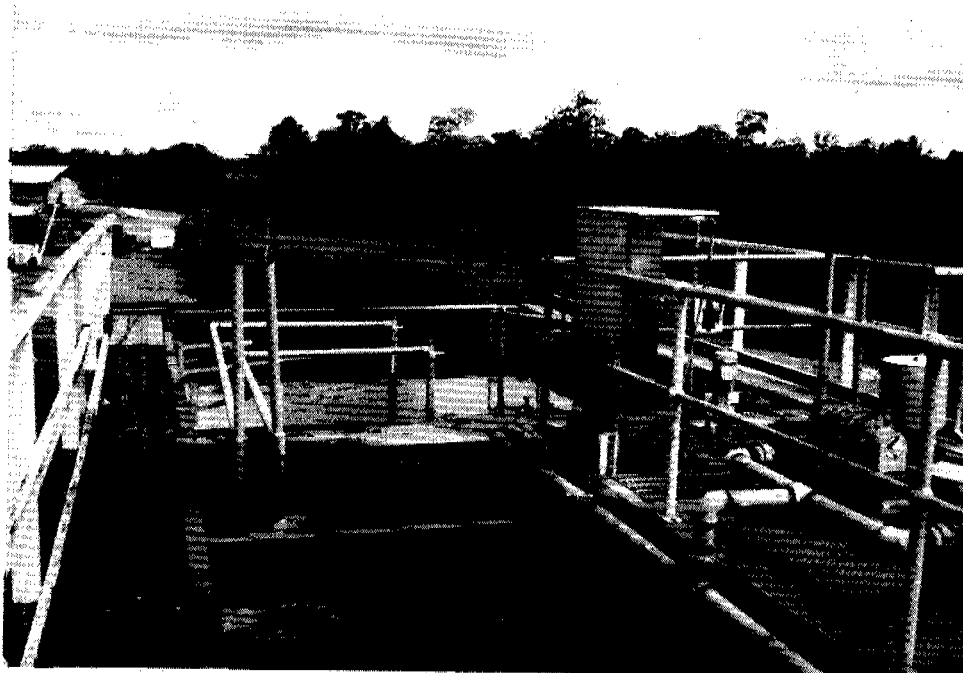
Fig. 17  
and 18. Western Province. Kiunga town sewage treatment plant  
operated by a mining company. This plant serves about 200  
households. Figure 18 shows effectiveness of the treatment.

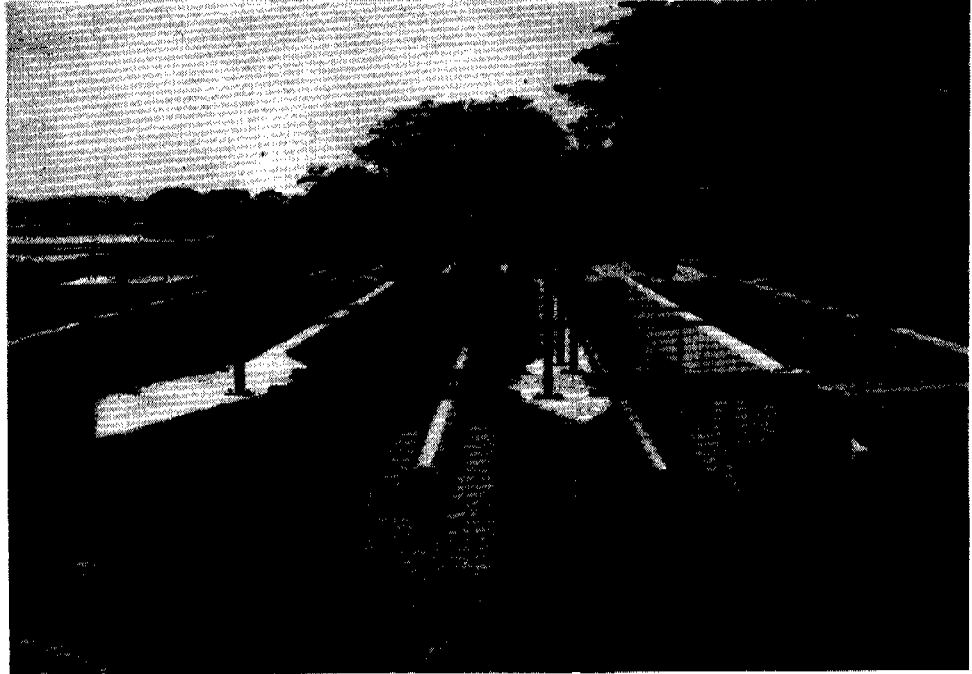
Fig. 19  
and 20. Port Moresby in National Capital District. Waigani lagoons  
treat sewage from a large part of the city. Figure 19 shows  
inlet works and Figure 20, the inlet to the first lagoon.

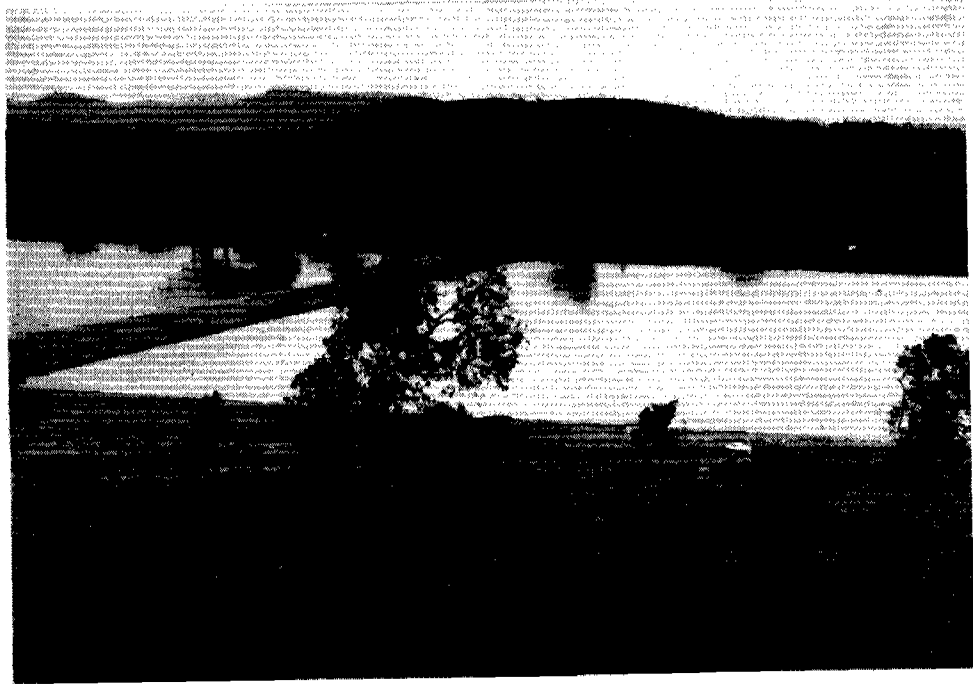
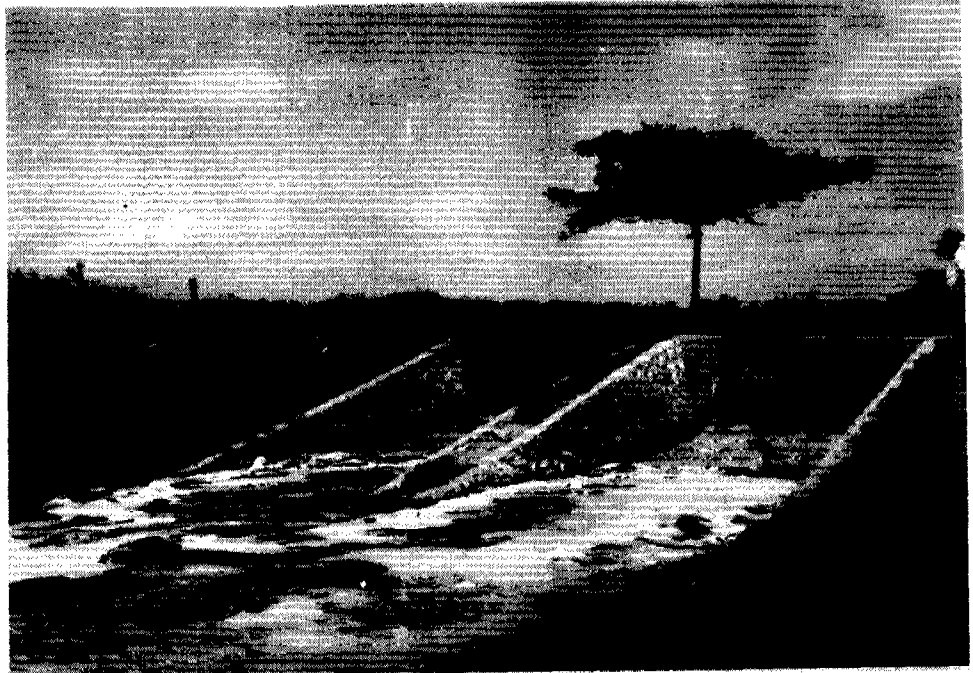
Port Moresby in National Capital District. Fish are present in the second lagoon. This indicates effective treatment. Figure 22 shows outlet from the second lagoon into Waigani swamp.

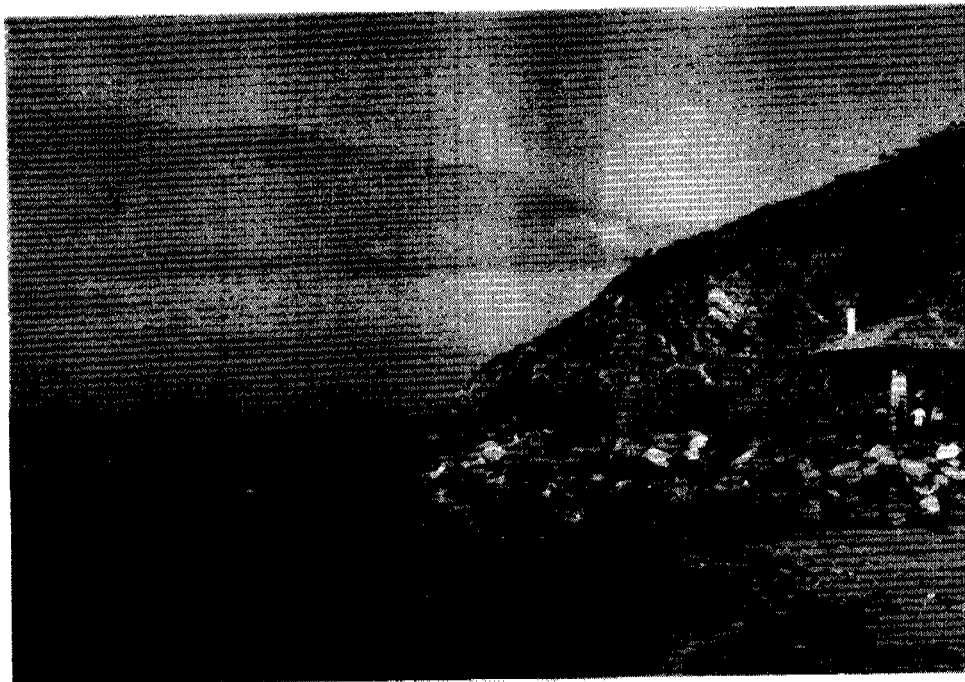
Fig. 23  
and 24. Port Moresby in National Capital District. Part of the city is served by a sea outfall at Paga Point. Figure 23 shows a screen and a mechanical disintegrator at the Paga Point pumphouse.
