# RURAL WATER SUPPLY IN DEVELOPING COUNTRIES

-Field and Laboratory Studies with  
Emphasis on Handpump Technology

Robert Hahn  
Lund 1985

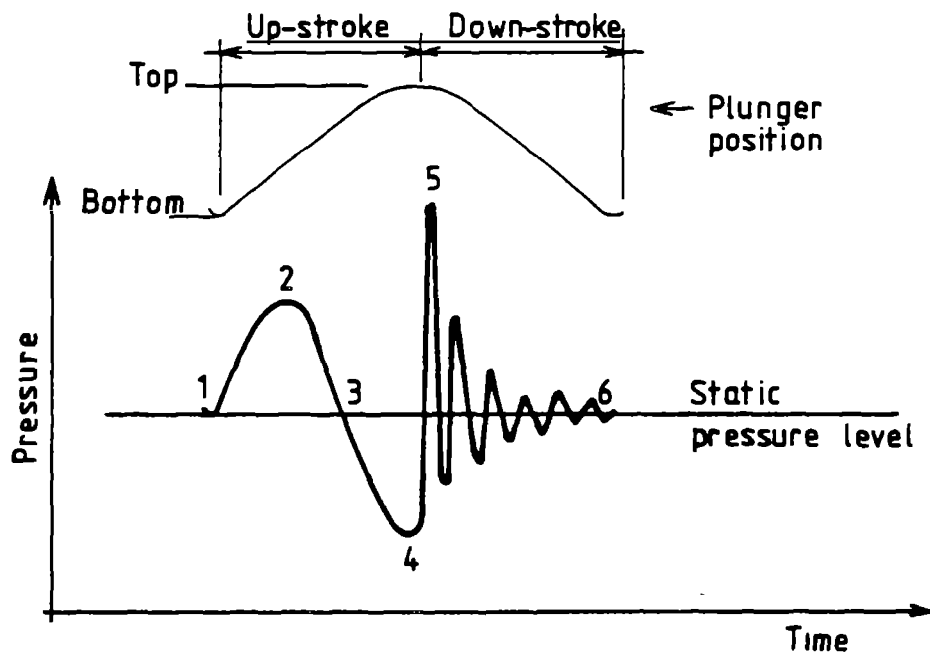
Figure 4.6 The pressure in the cylinder, above the piston, during a pump stroke.

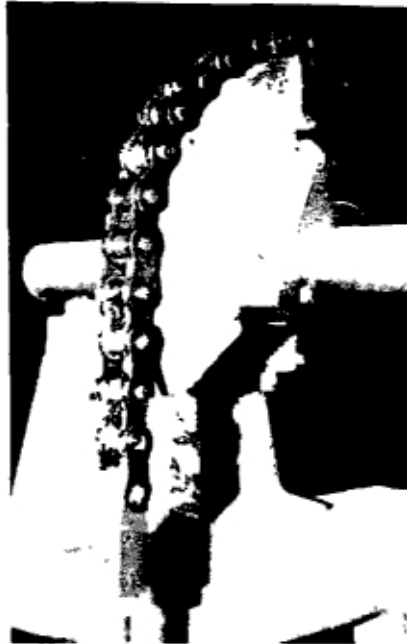
Figure 4.10 Standard SWS  
roller chain.

This chain fitted according to figure 4. 10 is standard in both SWS and IM II pumps. The chains installed in the test rig showed a tendency to get stiff after a few months. After cleaning and boiling in a mixture of grease and graphite, the chains operated smoothly. Chains installed in new handpumps are treated with grease and graphite boiling, which clearly proved to be necessary.

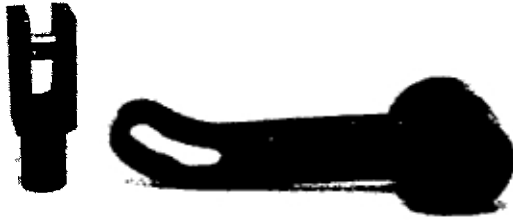
Figure 4.13 Roll and arm

design was that it could be locally manufactured and thus more easily available and at a lower cost.

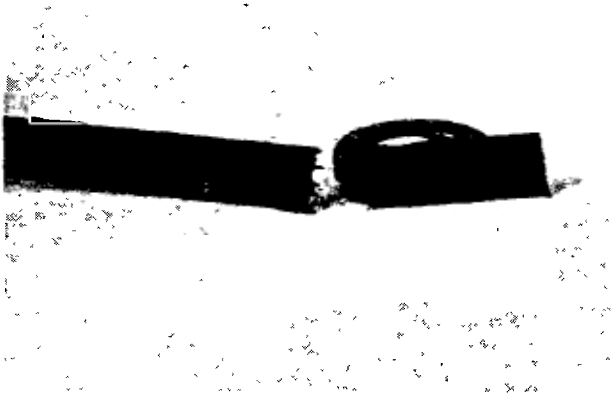
Figure 4.14 Reinforced rubber band broken.

This band is manufactured in Sweden, from EPDM rubber with a reinforcement of five thin steelwires. The design load is 800 kg. The band is flexible, but obviously not suited for continuous bending during operation. It broke after 0.8 million strokes. The wires were torn off and on the bottom side of the band the wires began to get visible although from the beginning they were embedded in the rubber. No further testing was done.

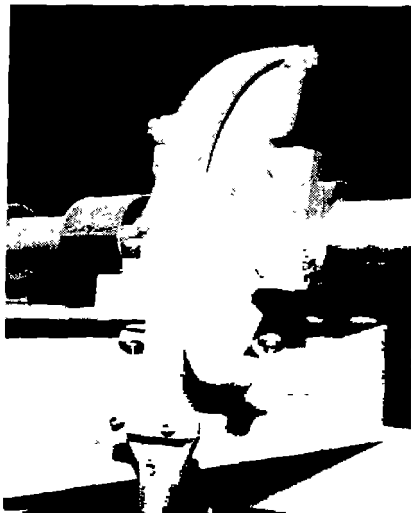
Figure 4.15 Double band

The change over to double bands was based on the assumption that if the upper band is carrying the load, the band underneath will protect it from wear. The movement from the stretching of the band will be between the upper and the lower band, so that wear from the metal surface of the circle segment will be on the lower band which does not carry any weight.

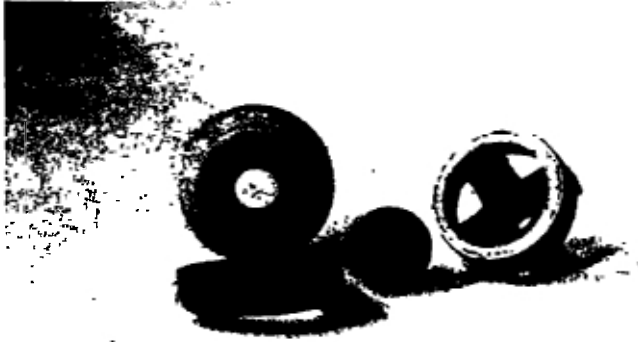
Figure 4.18 SWS plunger

from fabrication) and to the operation (the wear is accelerated by the constant vibration of the ball when pumping). On the plunger tested we also noticed that the gun metal guides for the ball had been worn, however, not to a degree affecting the operation of the valve.

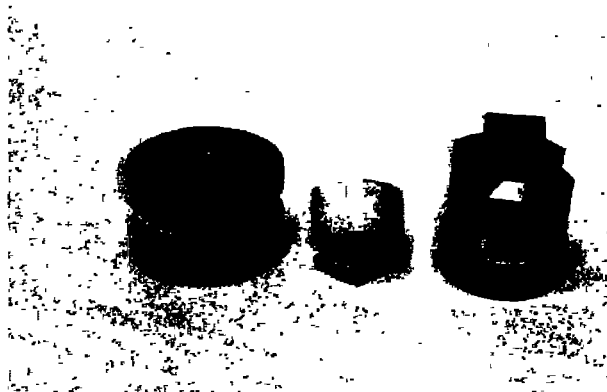
Figure 4.19 SWS new plunger

Out of six plungers tested, so far the cone has been worn in only one. In this case, the diameter of the cone was too small from the beginning, allowing it to move sideways during operation. The wear was especially noticeable at the upper and lower ends of the cone.

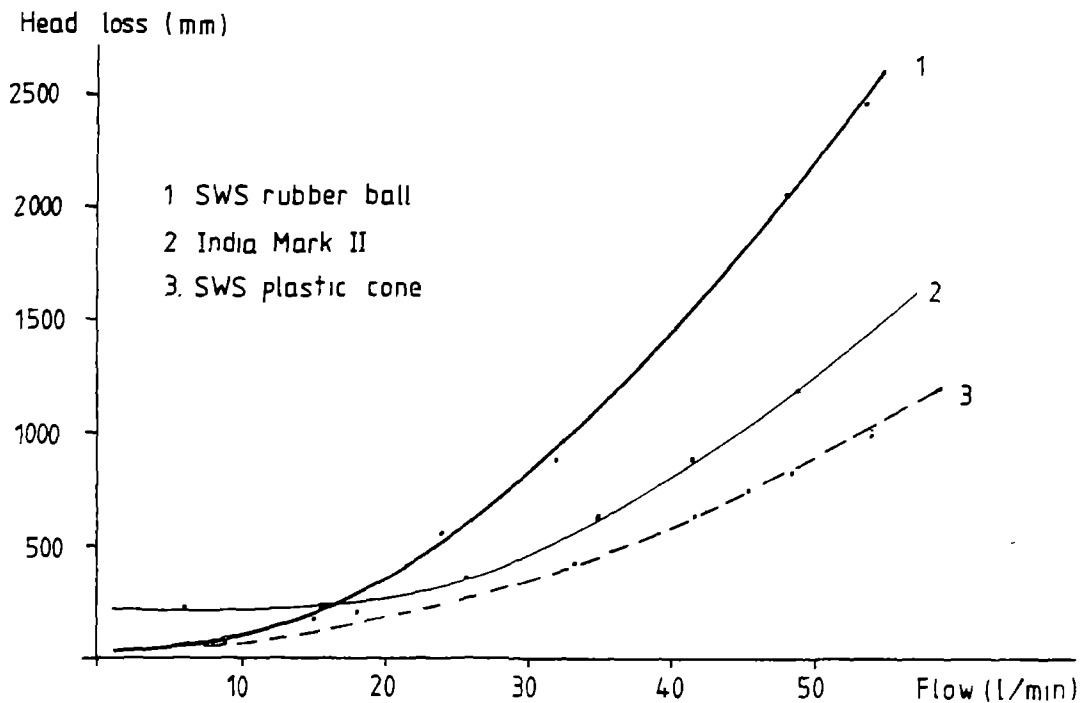
Figure 4.22 Difference in head-loss for the plungers tested.

As shown in figure 4. 22, there are only small differences between the plungers tested at high velocities (high flow rate). The rubber ball valve, however, is an exception. The flow induces vibrations in the ball, which may be the explanation for the comparatively poor result. Even if it does not have flow properties as good as other plungers, there is no cause for alarm. Field experience shows that this plunger type operates satisfactorily. It is also interesting to note that the India Mark II plunger valve is relatively heavy and requires a flow of about 20 liters per minute before it opens. The head-loss coefficient is twice as high for this valve compared to the others at low flow rate.

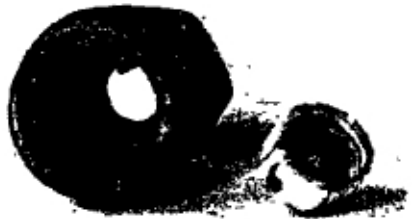
Figure 4.26 Painted iron valve

In the valve with corrosion protective paint, the guides were intact after the relatively short testing period, but the valve ceased to operate since the guides had cut almost right through the cone, see figure 4.26.

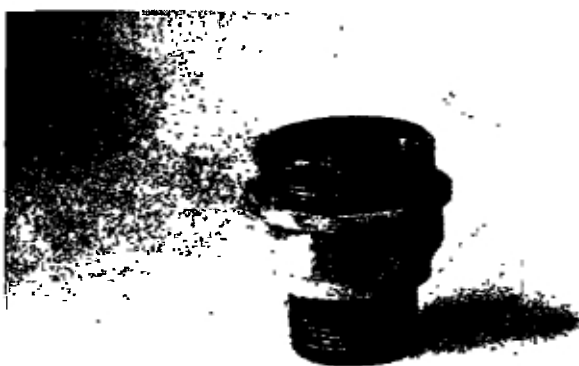
Figure 4.27 The POM valve

The POM valves all operated well. The PVC valves, however, were all broken down during the test. Cracks occurred at the valve seat or at the threads.
