HAND/FOOT OPERATED WATER PUMPS FOR  
USE IN DEVELOPING COUNTRIES

FINAL SUMMARY REPORT

DATE OF ISSUE: October 1980

1980  
International Development Centre  
for Community Water Supply

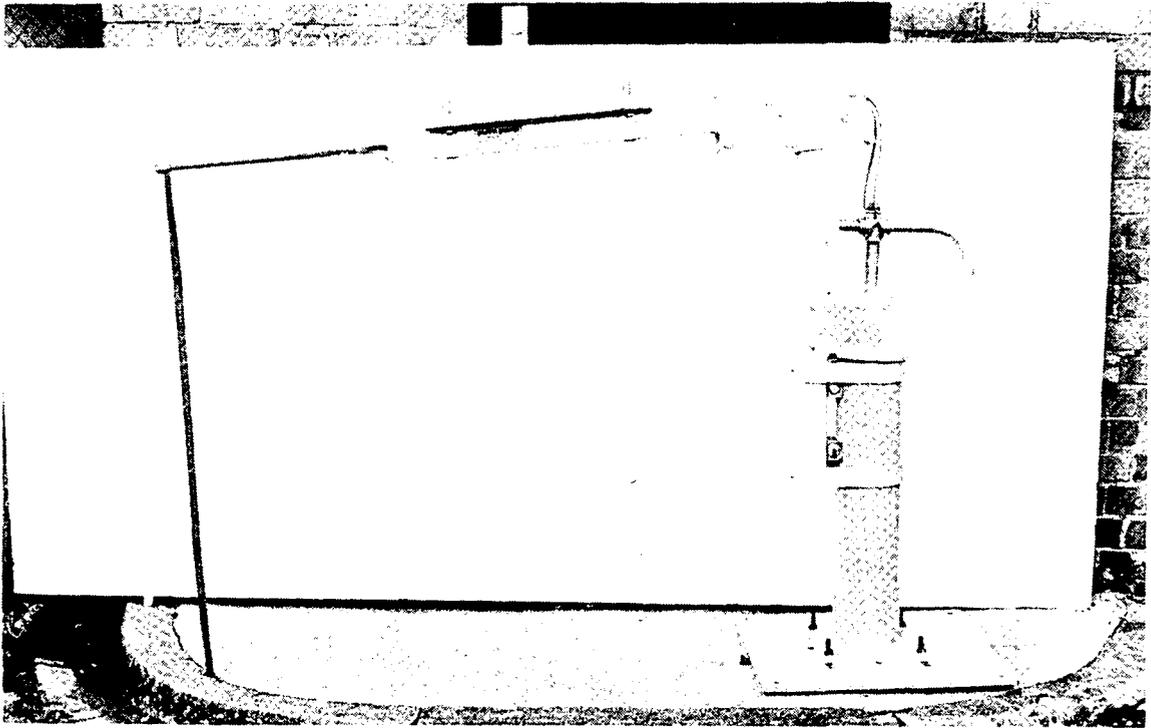
CODE A

Pumpstand (without counterbalance weight) showing method of clamping to the well casing.

2. The pump is designed for use in wells which are drilled in hard rock - this is required so that the pumping element anchors can grip. Although the pumping element can be made to grip in a well casing, the size required (4" ~ 100mm) is not compatible with that for the pumpstand (5" ~ 125mm). In the schematic drawing on p. 12, the pumping element is shown in a well casing. No problems of anchor slippage were found during tests when the pump was in the well casing but, after the pumping element had been removed for inspection, it proved very difficult to make it grip again. Small, hardened steel pins are inserted into the cast iron serrated anchors and these, it was found, tended to chip or break off because they were rather too hard. Redesigning the anchor so that it is made completely from steel hardened and tempered to the correct value (we suggest 550 - 600 HV) and with sharp teeth could be an answer.

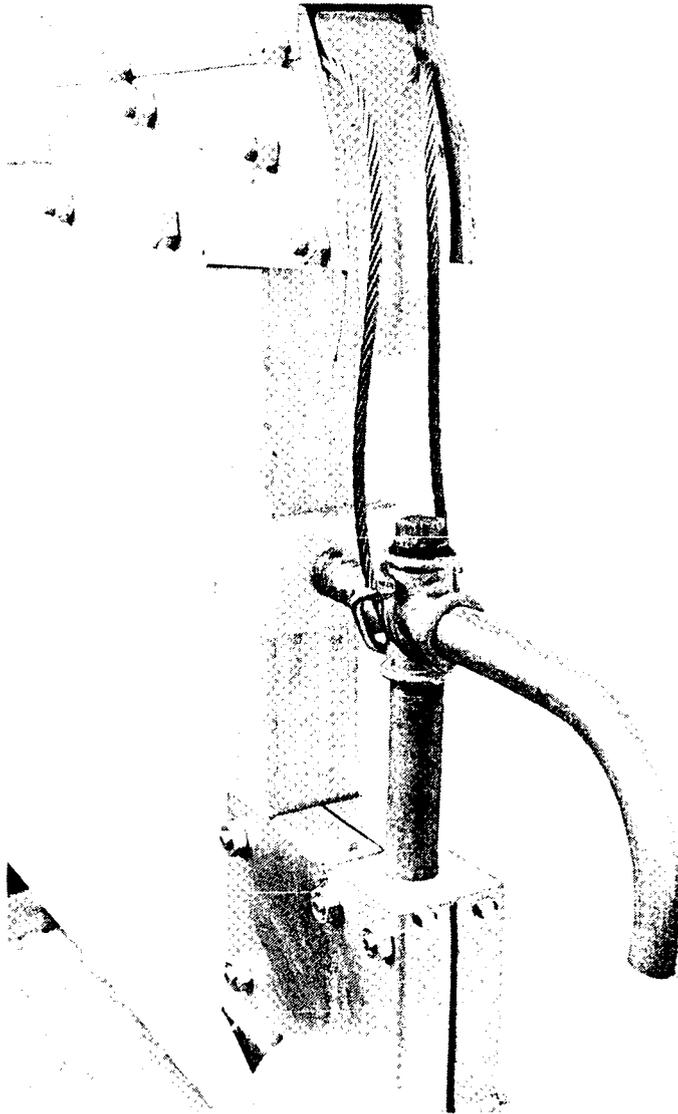
Pumping element.

1. A hardening thread sealant has been used on the pumping element; this has a tendency to break off when handling the pump, with subsequent jamming of the discharge valve. Either a non-hardening thread sealant should be used or, alternatively, a valve less prone to such jamming could be incorporated.
2. The threads on the anchor-locking wedge plate (arrowed by (X) on the drawing) were badly cut and resulted in a failure during endurance testing when the thread stripped. Good threading is vital on this component as the cyclic tensile stresses carried are high.

The reliability of the pump could prove somewhat variable. The major fault which occurred during tests was the failure of the pumping element. Its typical life was about 1500 hours. The cause of the failure was splitting of the rubber diaphragmatic hose at the ends where it was gripped by a plastic insert and a stainless steel clamping ring. Other problems encountered during testing include failure of the pumping element anchor, as mentioned previously, and nuts coming loose, particularly on the main handle bearing.

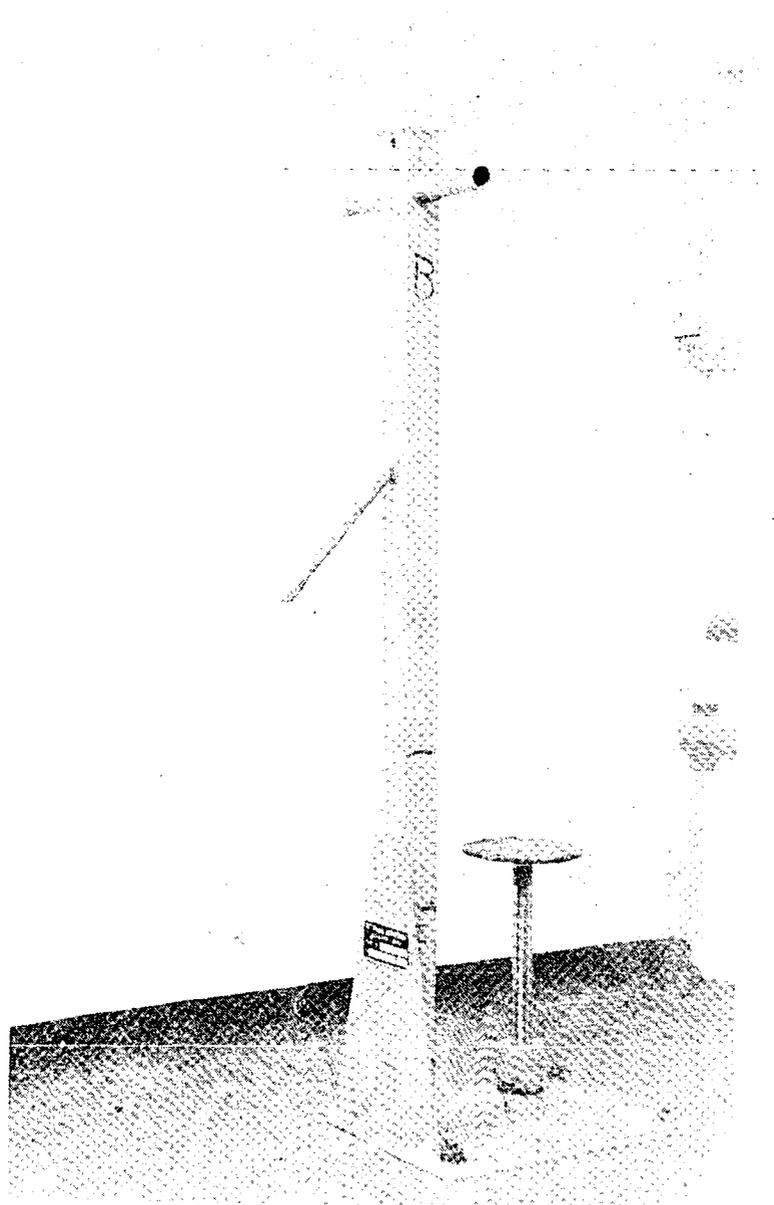
CODE B

Pumpstand and cylinder

The pumping element consists of a rubber diaphragmatic hose inside a stainless steel cylinder. The cylinder has discharge and suction valves and is connected to the pumpstand water outlet by a 26 x 32 mm high density polyethylene tube. The foot pedal is connected to a plunger in a cylinder on the pumpstand and pumps water through a second polyethylene tube (23 x 32 mm) to the diaphragmatic hose, which expands, reducing the free volume in the stainless steel cylinder and thus forcing water up the delivery pipe. When the foot pedal is released, the elasticity of the hose forces the water back up the hydraulic pipe, raises the foot pedal and simultaneously draws water in through the suction valve of the cylinder.

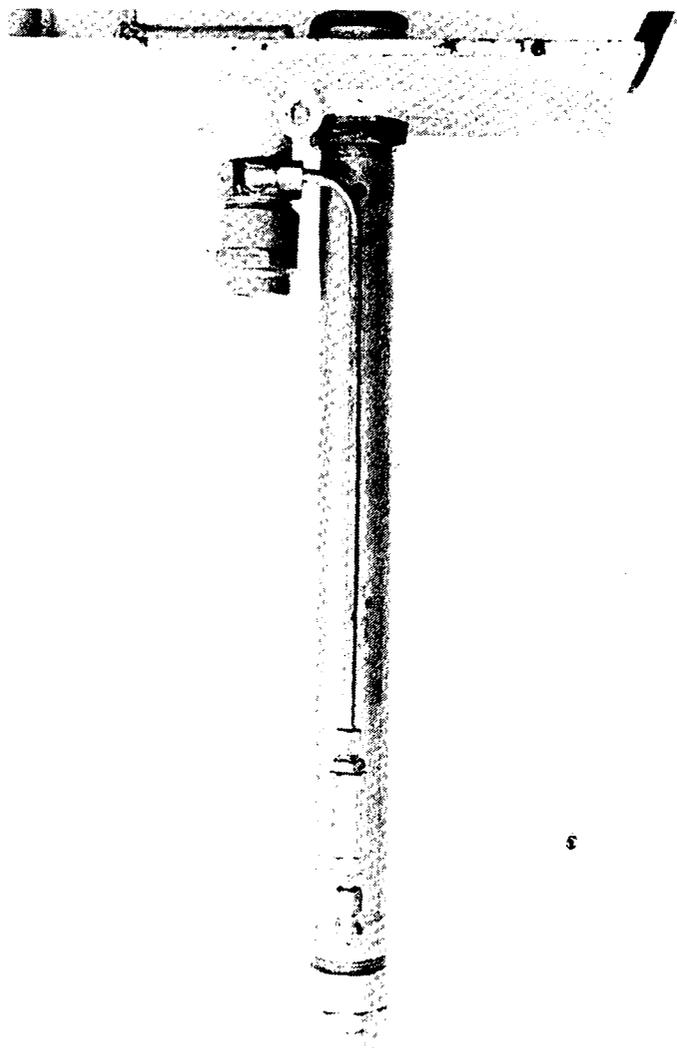
CODE B (Cont)

Underside of baseplate showing the hydraulic cylinder and the repriming circuit

Generally the pump is well designed. The main criticism is that water from the hydraulic circuit gradually leaks out during pumping and the pedal height drops. This must, from time to time, be rectified by lifting the foot pedal manually (once or twice a minute when new) to reprime the hydraulic circuit. The problem increases as the seals wear. This can be rather frustrating in use and we think it would be much better if the pump were made to reprime automatically.

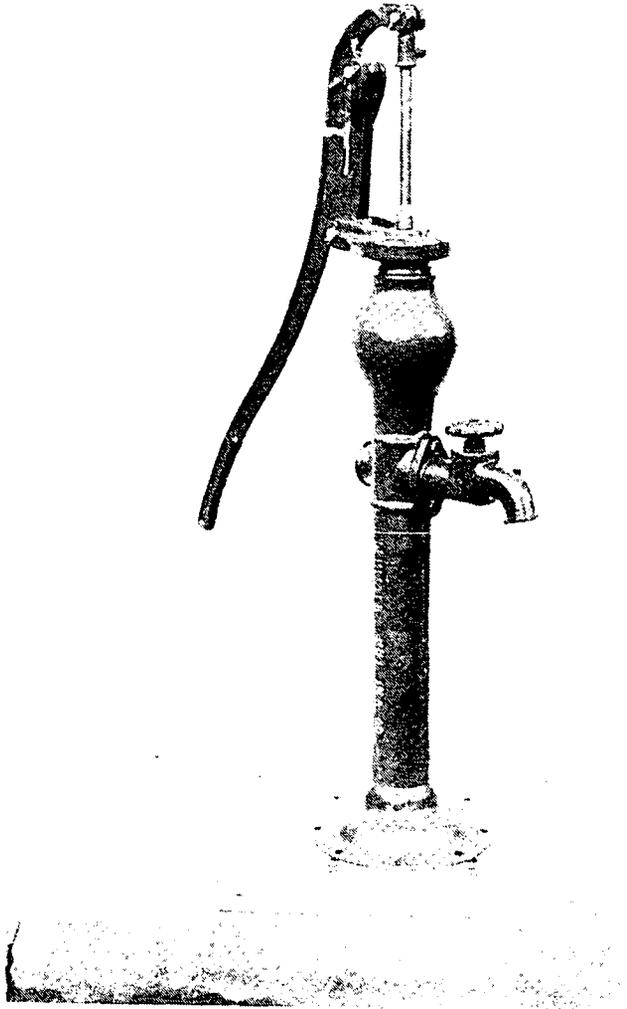
CODE C

Pumpstand

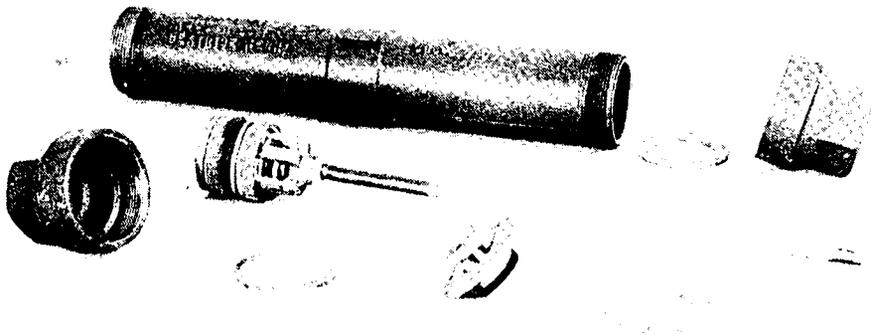
Dismantled pump cylinder

The cylinder design is fairly good, though corrosion of the cast iron casing could cause problems in acidic waters. The bimetallic corrosion couple by the use of a brass cylinder liner and valve cage, connected to a galvanised pipe and rod, can also cause problems. Severe pitting of the rod will occur if the dissolved oxygen content of the water is high.

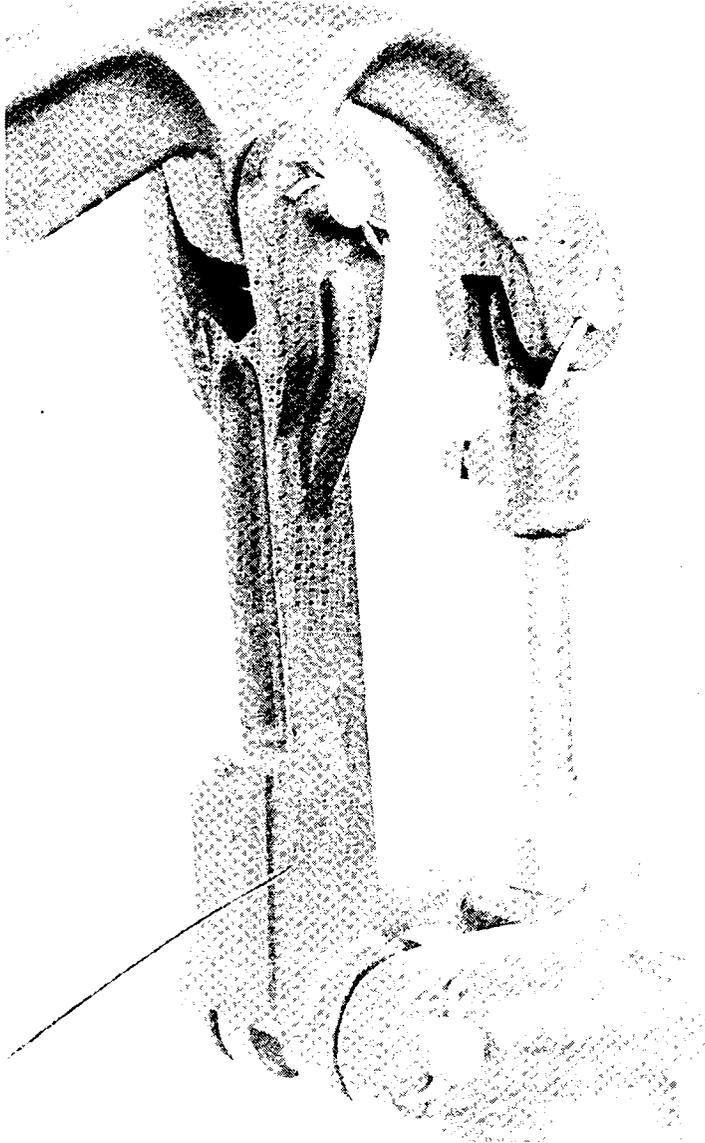
CODE C (Cont)

Pumpstand operating mechanism

The design uses mostly cast iron components, with plain pinned bearings. The bearing loads are excessively high for the type of bearing used, particularly the one to which the pump rod is attached, and considerable wear can be expected. Bearings are also open to the atmosphere and thus liable to be affected by dust.

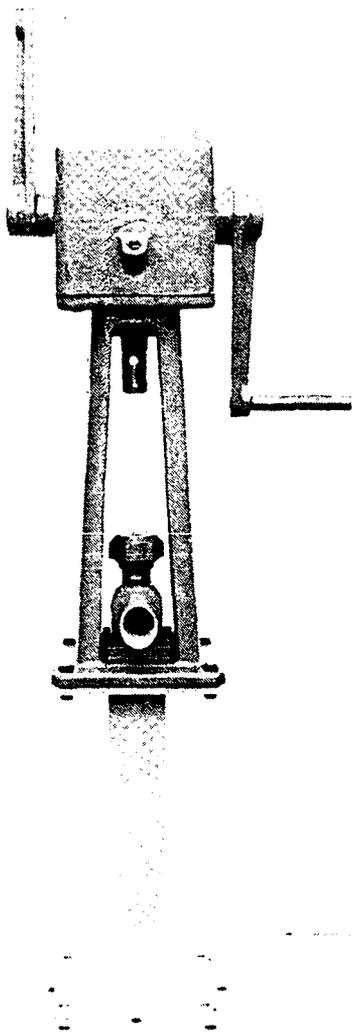
CODE D

Pumpstand (one handle not fitted)

The basic design of the pumpstand is very good and the only major problem associated with the pumpstand is the tendency for oil to leak from the gearbox. Most of the oil leaks from the handle bearings initially and, after some time, also from the vertical shaft seal. The leakage can contaminate the water as it runs down the shaft and into the gland packing. The leakage is never great, and very unlikely to run the gearbox dry for many years under normal operating conditions.

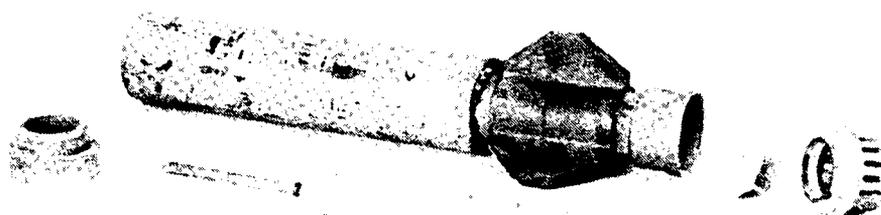
Dismantled pumping element.

The cylinder has only two basic parts, a rotor and a stator. The tolerances on the manufacture of these are critical as the fit between the two must be adequate to provide a good seal, and yet not so tight that the rotor is difficult to turn. In fact, this causes some problems as discussed later. Only one other minor criticism of the cylinder: the clearance between the valve and its surrounding cage is unnecessarily tight - a slight dent on the cage can jam the valve.

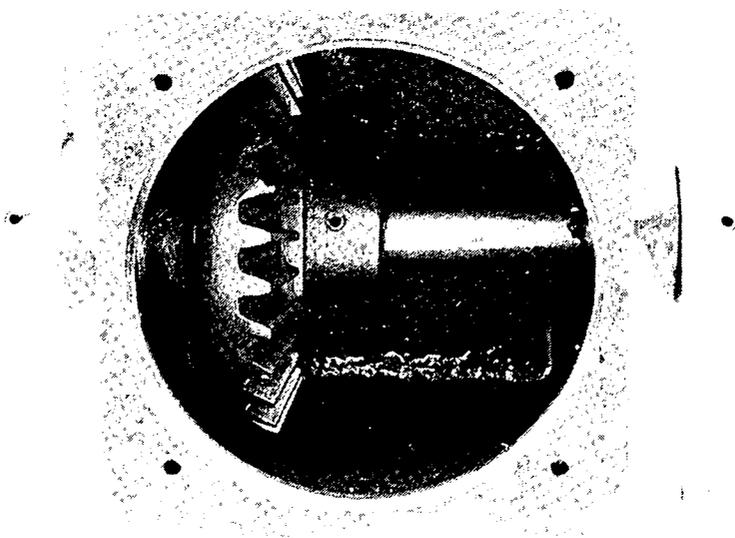
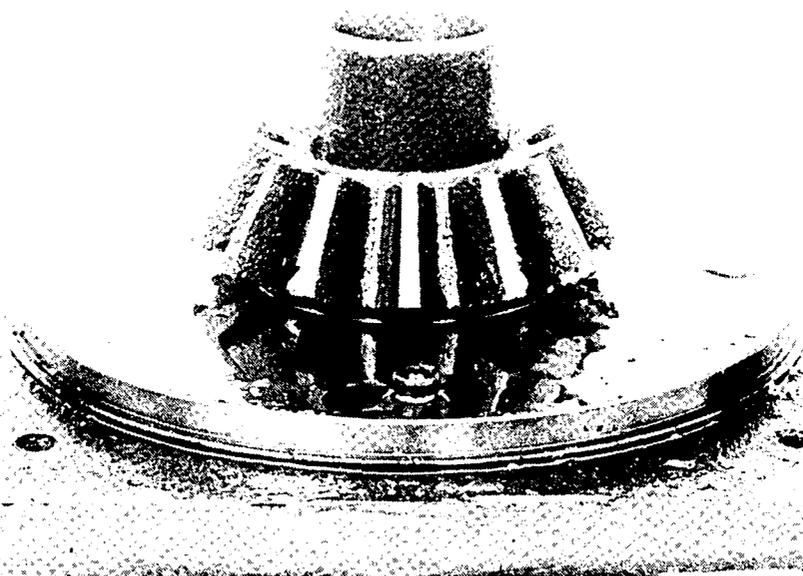
CODE D (Cont)

Dismantled gearbox

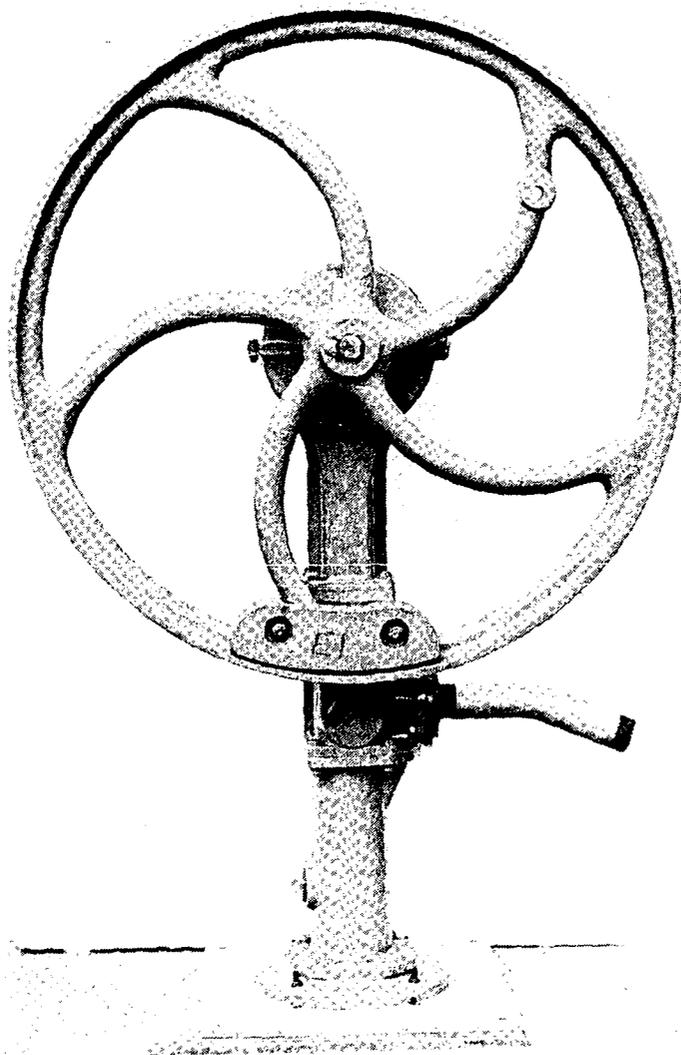
CODE E

Pumpstand (handle not fitted)

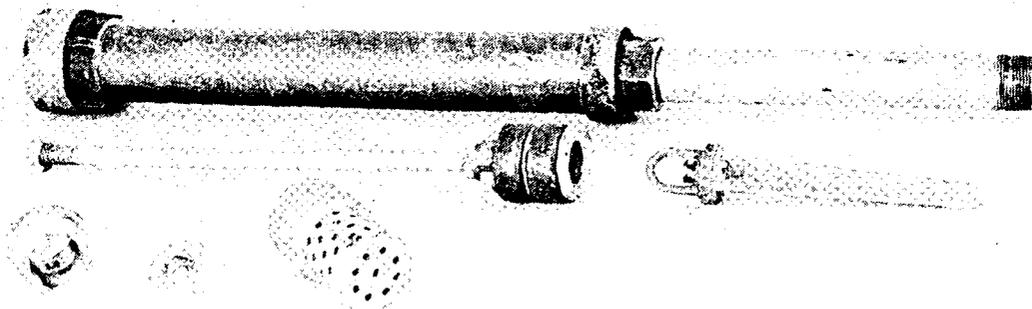
Dismantled pump cylinder

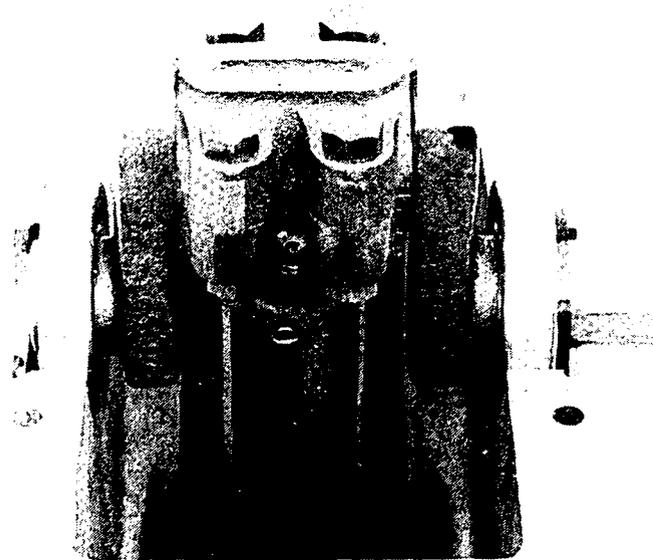
CODE E (Cont)

Pumpstand with flywheel and cover removed to show internal components

1. The use of a very heavy flywheel gives two opposing effects. It makes the pump smooth and easy to operate, even on deep wells - it was one of the most popular with users. However, it is also a possible safety hazard as the flywheel can rotate for several revolutions after the user has stopped pumping and any child who stepped in the way could be seriously injured.

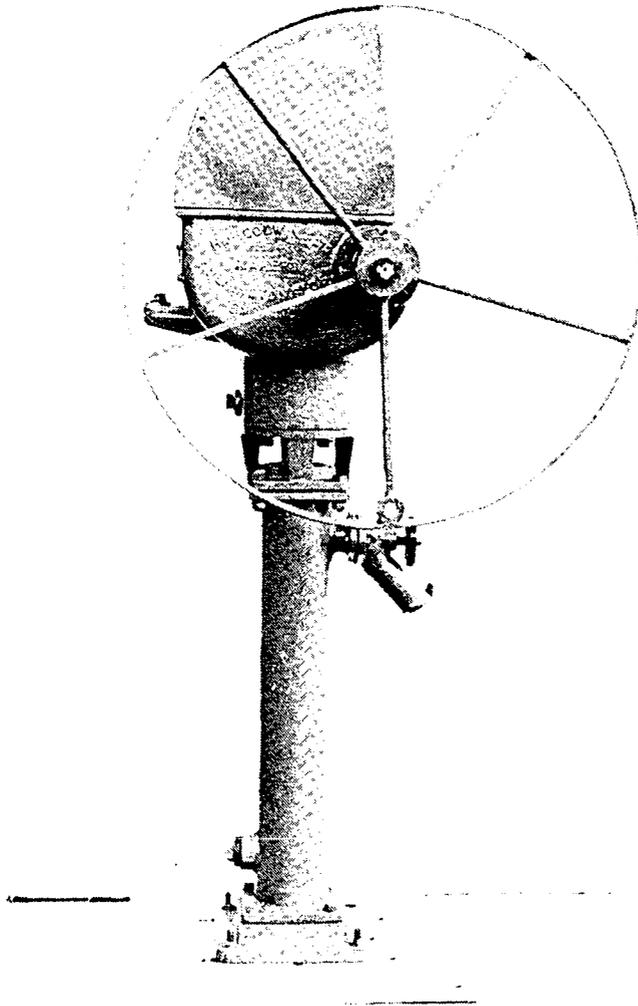
CODE F

Pumpstand (handle not fitted)

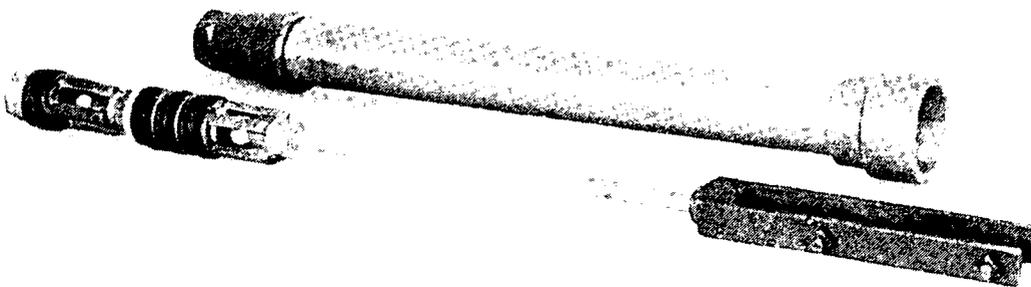
Dismantled pump cylinder

This pump uses a standard pumping cylinder made in extruded brass and gunmetal, and has stainless steel ball valves for the suction and discharge valves and the foot valve. (The pumping cylinder we tested was of the 2¼" extractable type, both suction valve and plunger capable of being removed from the well leaving the cylinder intact). A wooden pump rod is used which is joined together by plates secured to both wide faces of the rectangular section rod, by bolts passing through the rod.

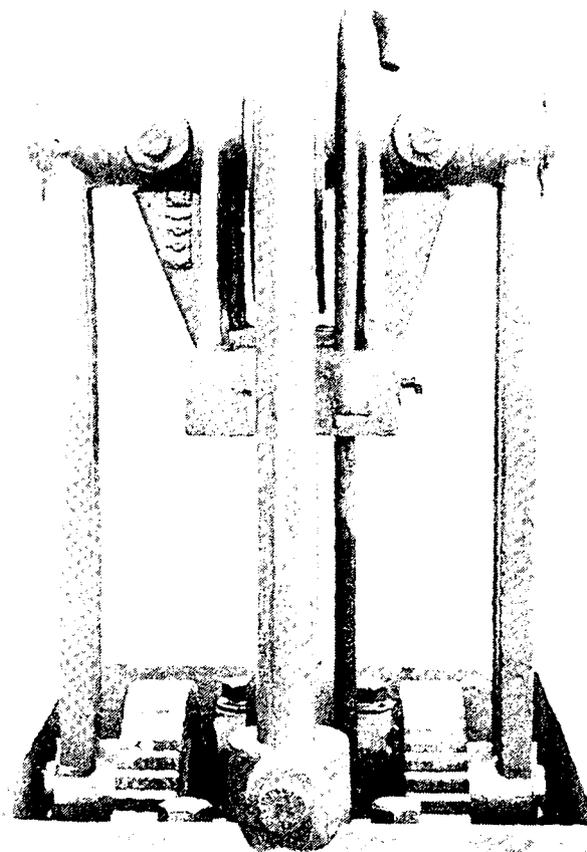
CODE F (Cont)

Pumpstand with cover removed to show internal components

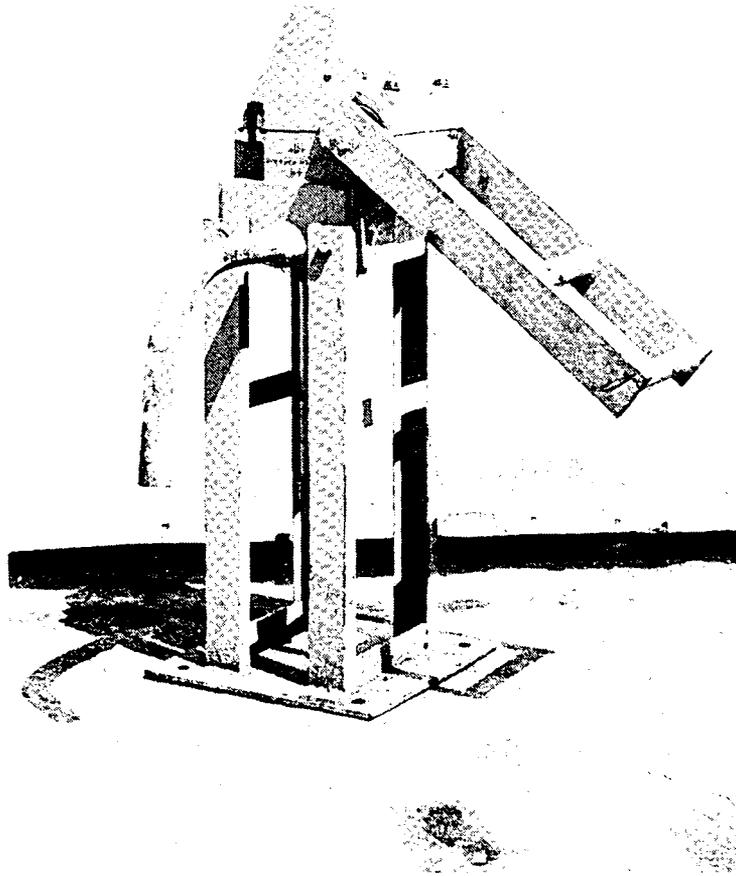
CODE G

Pumpstand

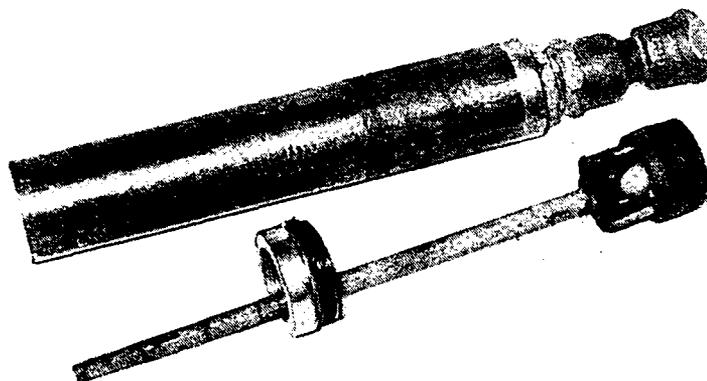
Dismantled pump cylinder

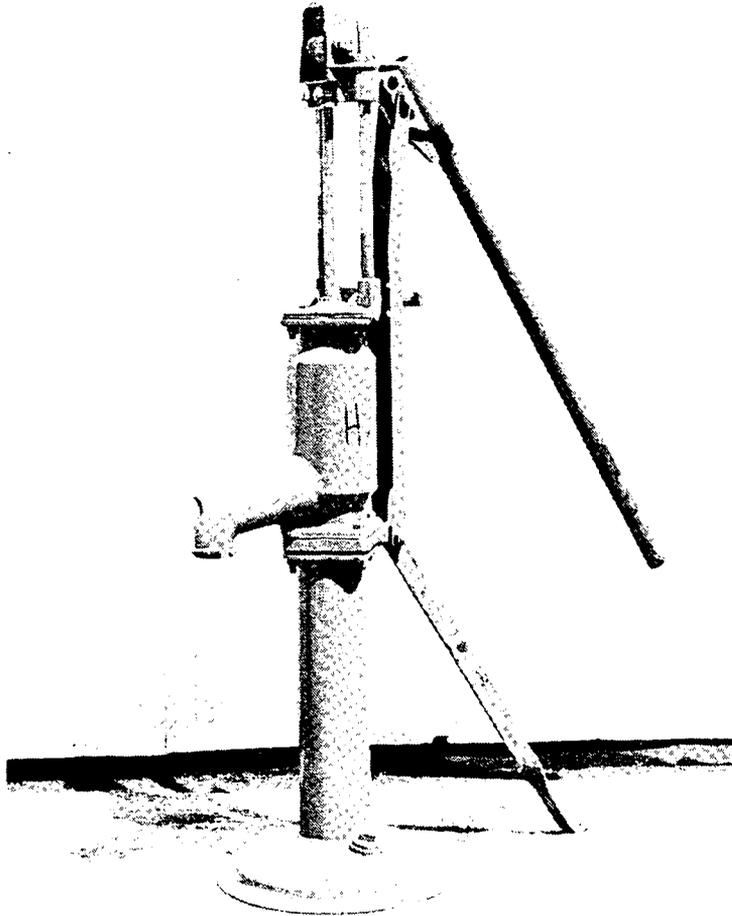
CODE H

Pumpstand

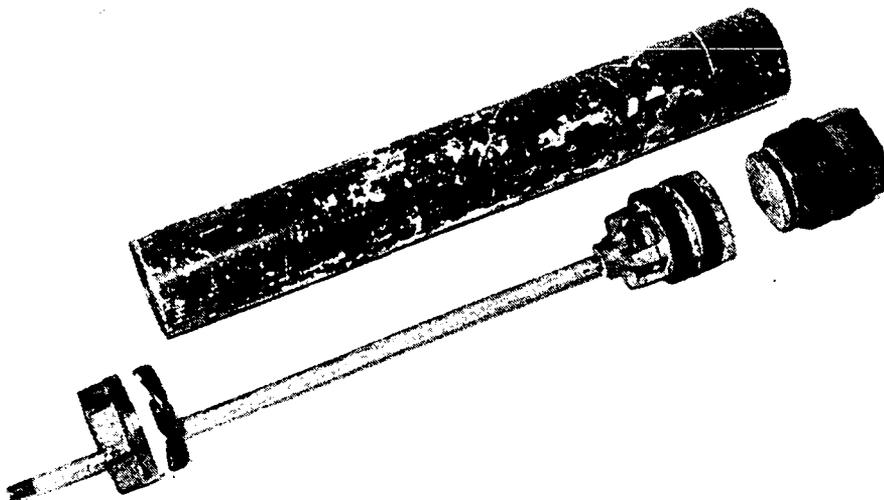
Dismantled pump cylinder

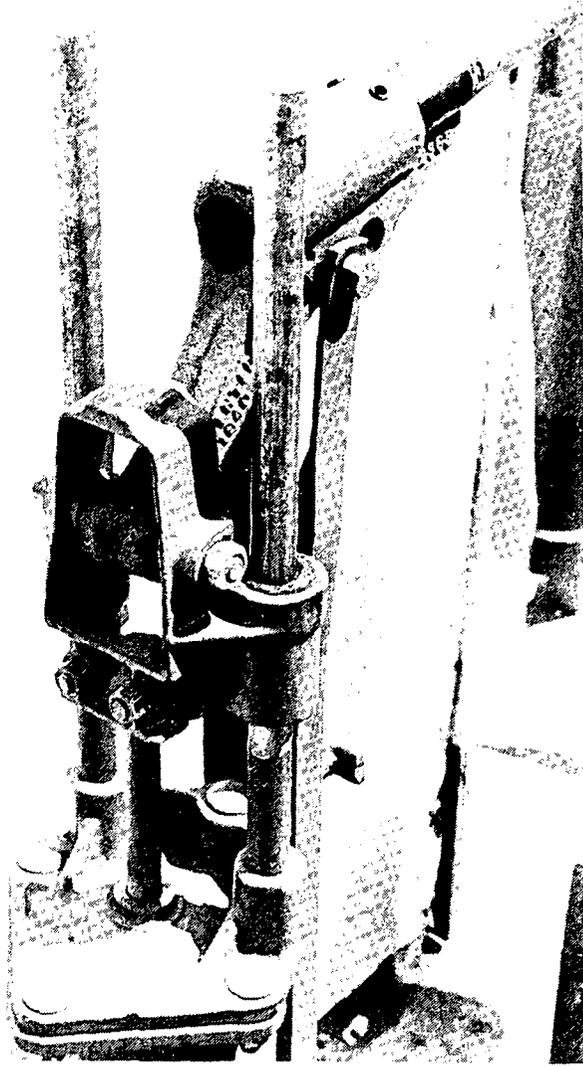
CODE H (Cont)

Pumpstand operating mechanism

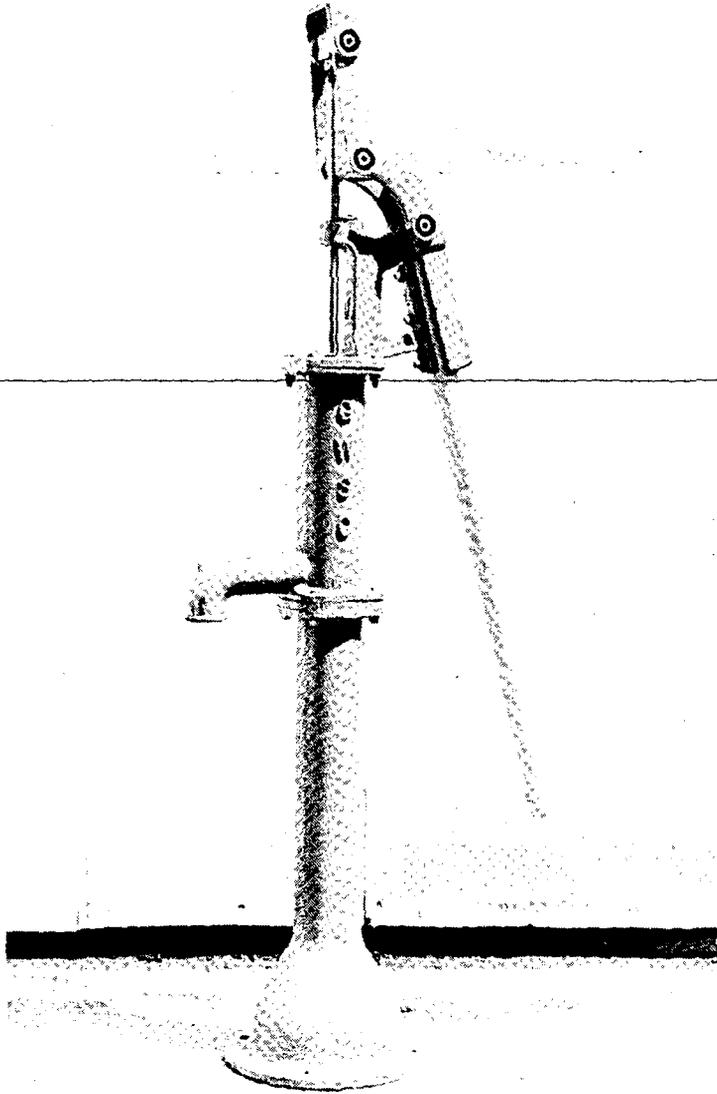
CODE J

Pumpstand

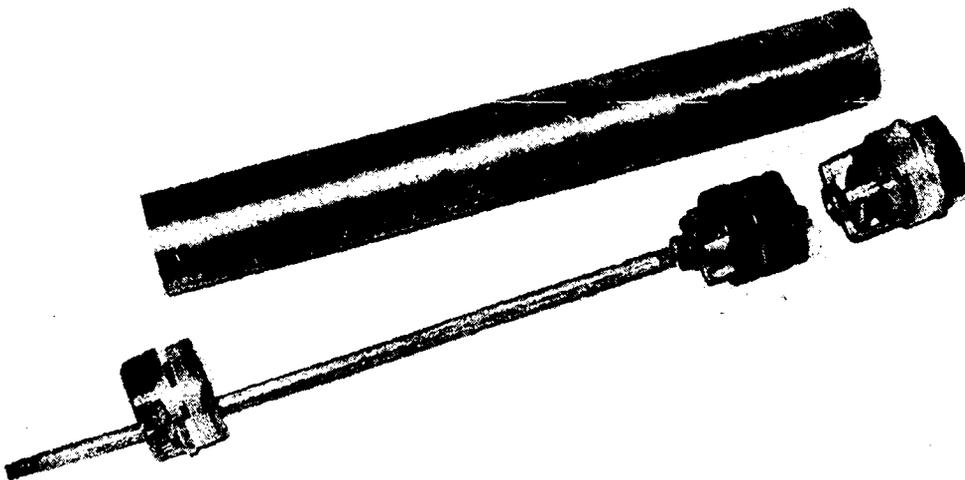
Dismantled pump cylinder

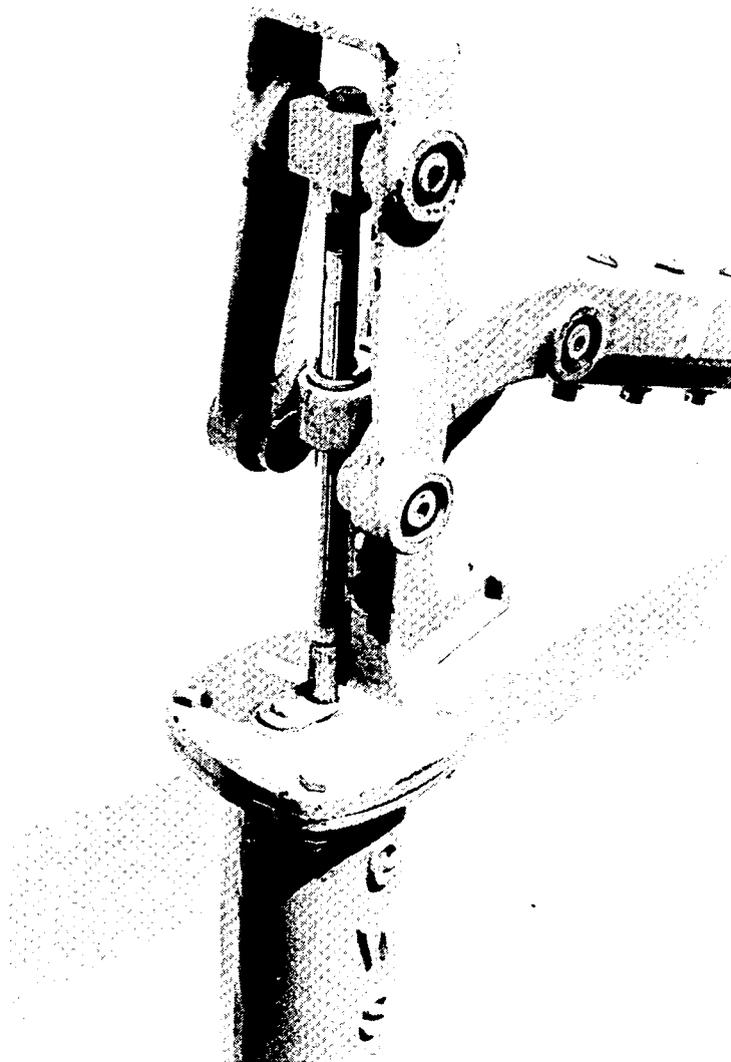
CODE J (Cont)

Pumpstand operating mechanism

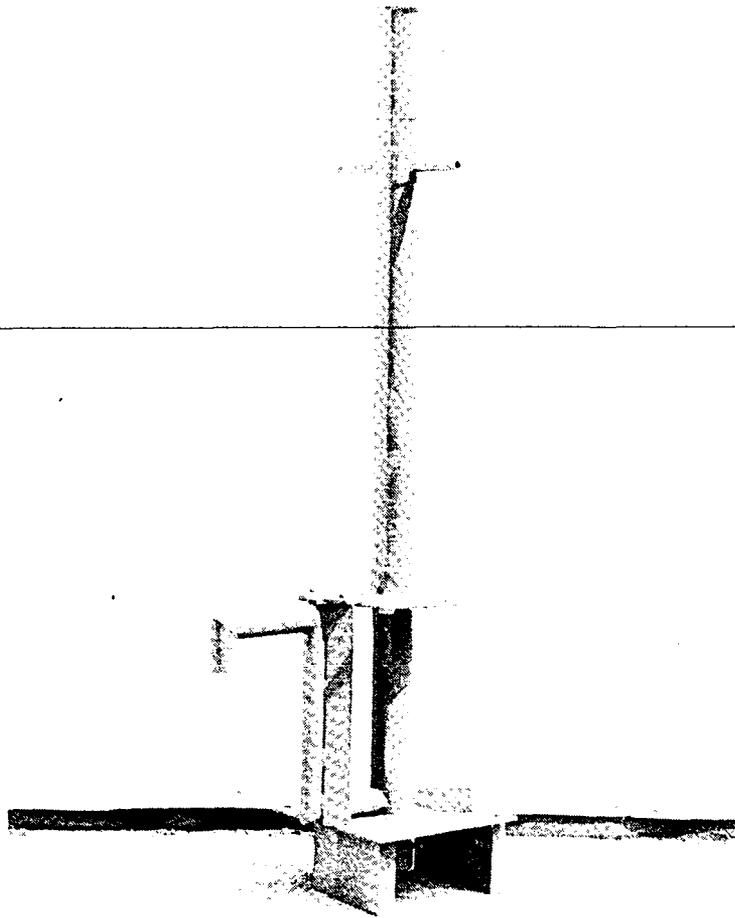
CODE K

Pumpstand

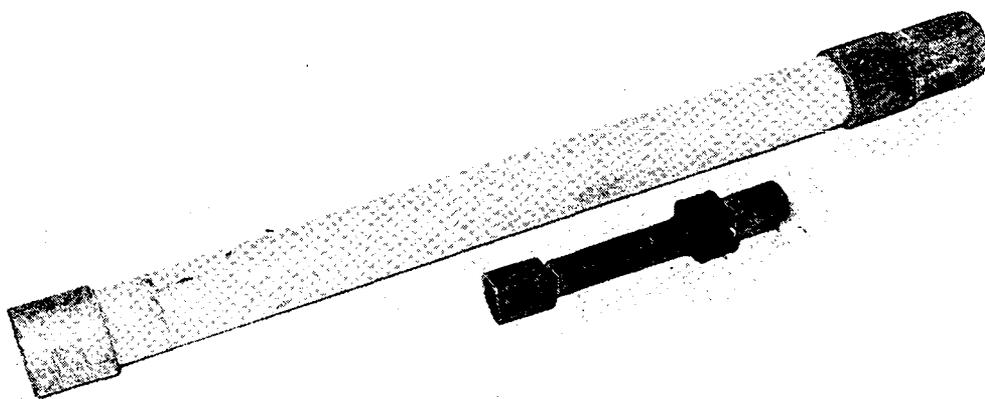
Dismantled pump cylinder

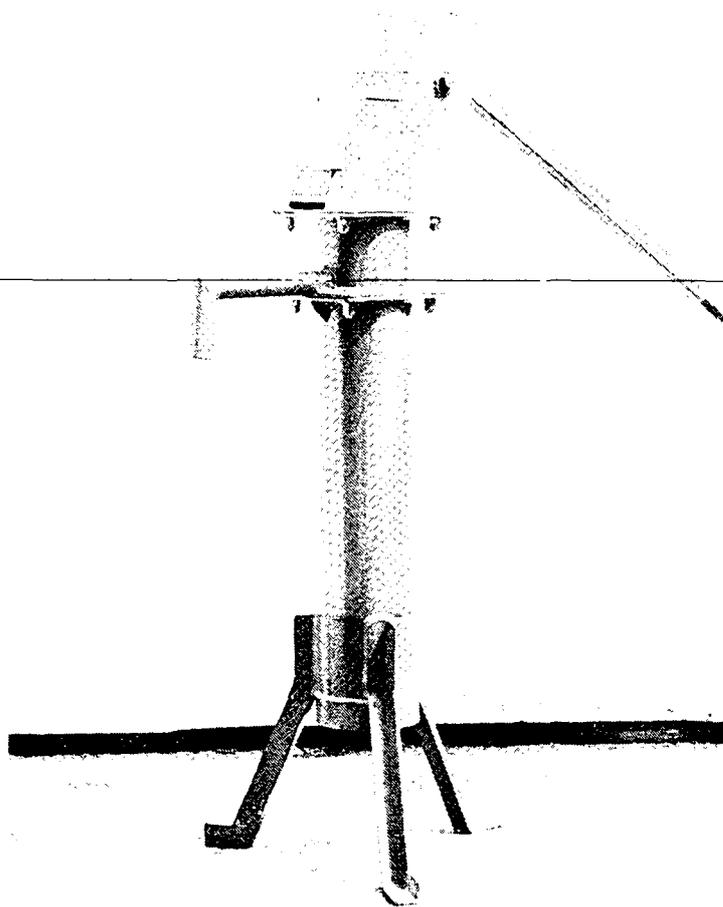
CODE L

Pumpstand

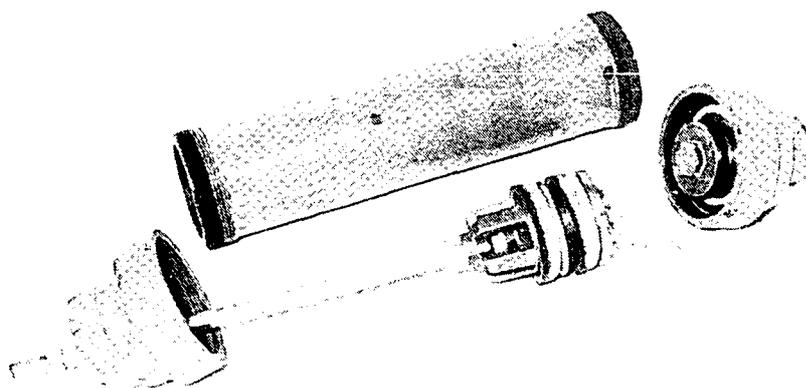
Dismantled pump cylinder

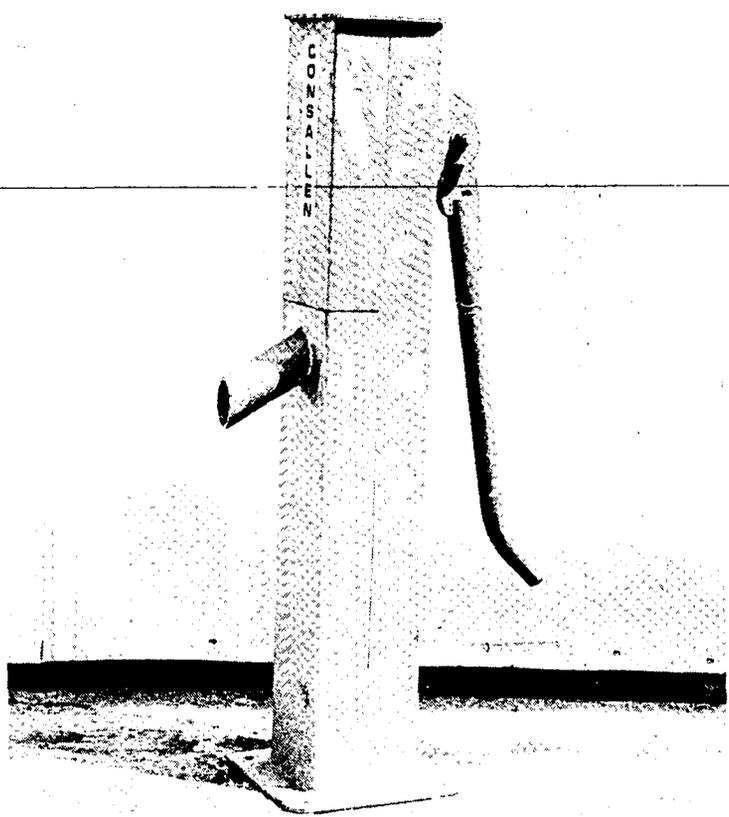
CODE M

Pumpstand

A new and very simple design made from steel plate and sections welded together. Some parts of the handle have been flame-cut with a profile cutter. The pump body has been galvanized after fabrication. A simple, two pivot handle has been used, so no correction of the pump rod alignment is provided. Heavy sealed ball bearings are used in each case.

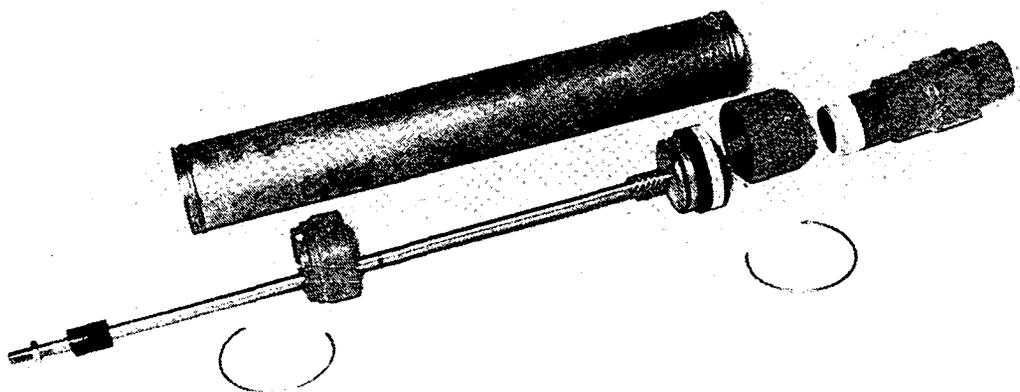
Dismantled pump cylinder
