Fieldwork and recommendations for drainage and solid waste management within the Bamenda Urban Council Area

Co-operation between Bamenda Urban Council (Cameroon) and
the City of Dordrecht (Netherlands)

Drainage and solid waste management within the Bamenda Urban Council Area.

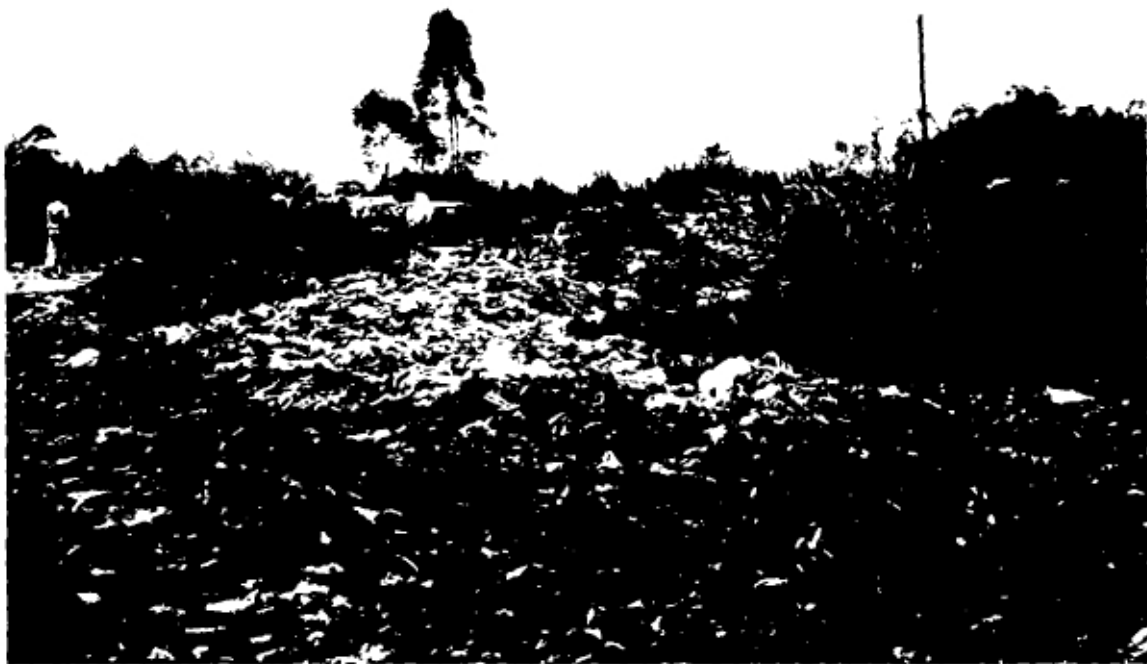
At Mezam Bridge (span 15m, height 6-7m) the authorized dump site was visited.

Although some of the waste is polluting the river, the situation seemed to be under control. It was noticed that a large quantity of the solid waste is degradable. It was stated that most of the solid waste comes from the Bamenda Central Market.

Mezam bridge, dump-site

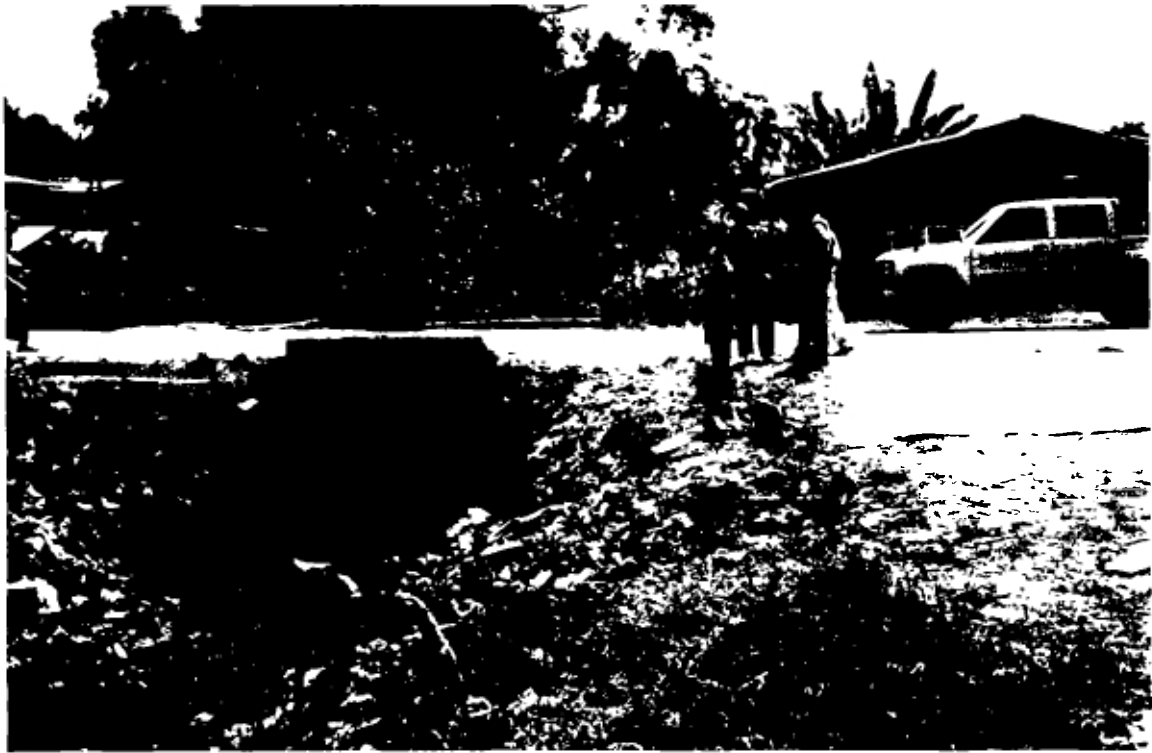
Further downstream the bridges near the Post Office and near the Government Delegates House act as barriers, forcing the water up to a higher level. Therefore it can be said that the three small and narrow bridges play a dominant role in the flooding which occurs in that area. But there are also other important factors that influence the stream. Again it was noted that many houses have been built in the flood plain, often very close to the stream and thus narrowing the profile of the stream during the rainy season. This narrowing of the stream profile was also evident in the section between La Chance Bridge and Church Centre where the flood plain is 50-70m wide.

Church Centre junction bridge

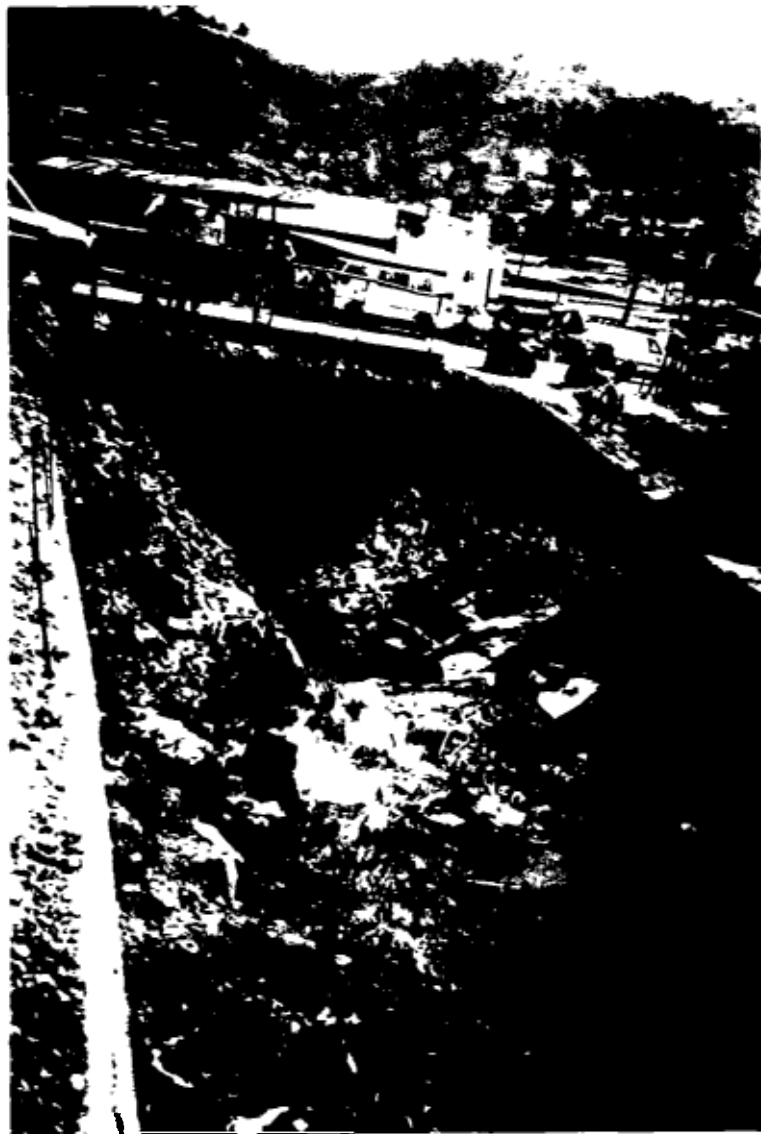
On the east side of the T-junction the drain is too narrow and because of the garbage which has been thrown into it, the drain is unable to disperse the storm water.

On the south-eastern side of the junction the drain ends abruptly against the pavement. The culvert under the road is completely inadequate. The road near "Rota Cinema" is flooded regularly during the rainy season.

Rota Cinema bridge

h. The drainage situation near Rota Cinema is in urgent need of improvement.

It is recommended that designs be made for new drains and culverts which will have a much greater capacity, and that priority should be given to reconstruction at that particular location.

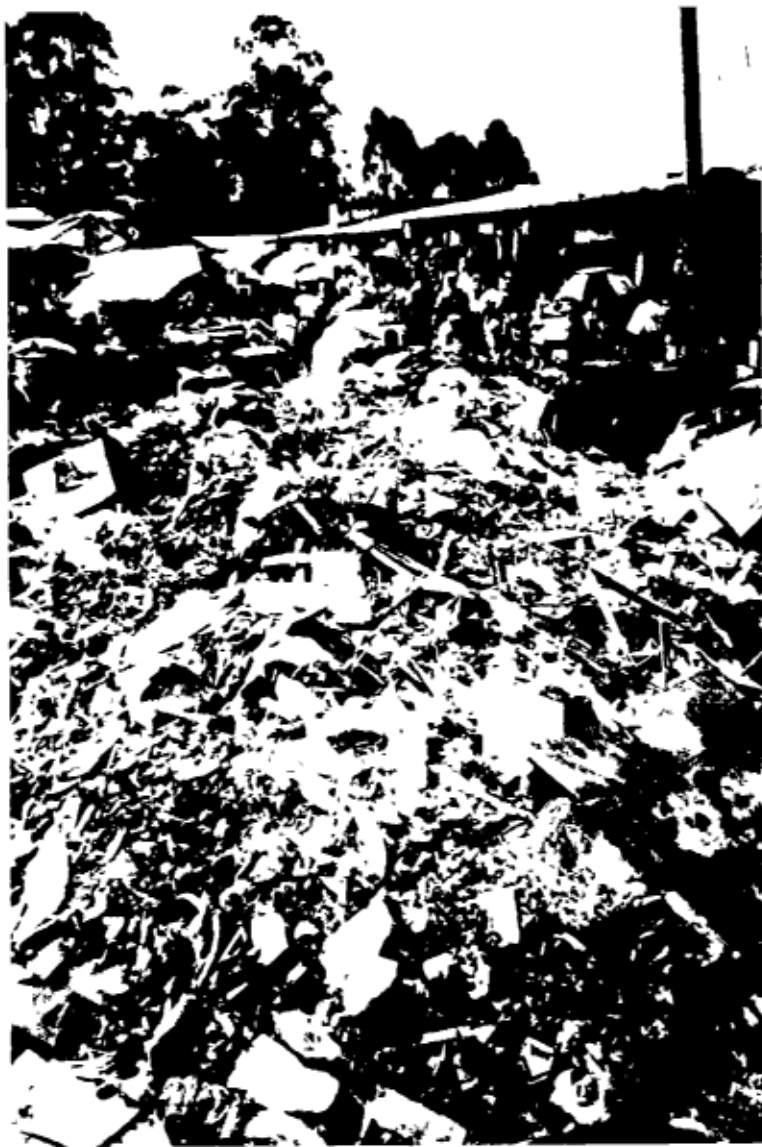
- d. In the area of the Central Market of Bamenda the solid waste problem is probably the most urgent of all. Large quantities of solid waste are left behind by the numerous hawkers of food, vegetables, fruits and other

We were informed that the waste is discharged from the dumping sites by Bamenda Urban Council twice a week. As the market starts rather early, around 7 a.m., the Council does not always succeed in removing all the waste; consequently the garbage is regularly left for more than three days, causing an unhealthy environment for the surrounding stall holders. Due to the lack of waste disposal facilities, many drains are filled with garbage, rendering them incapable of coping with the storm water. The situation becomes even more complicated, due to the fact that several drains are covered with heavy concrete blocks, which cannot be displaced by hand, so cleaning them out becomes a real problem.

Central Market, dump-site

- k. Improve the waste collection system in and around the market, including Commercial Avenue.
- l. Shift the vegetable market to the newly proposed site.
- m. Provide a refuse collection truck with compression facility, plus a number of refuse containers (1.500 litres).
- n. Place these containers in various sites around the present market place and the new vegetable market, to facilitate collection.
- o. We will see whether we can make high pressure pumps available to clean the inaccessible drains.
- p. Information, education and communication are vital to maintain people's awareness of waste management. From Dordrecht we can assist you in developing this communication exercise.
