**Water loss investigations in the distribution  
system of Dar es Salaam, Tanzania**

Thesis submitted to the Department  
of Civil Engineering, Tampere  
University of Technology,  
in partial fulfilment of the  
requirements for the degree of  
Master of Science in Engineering.

October 1990

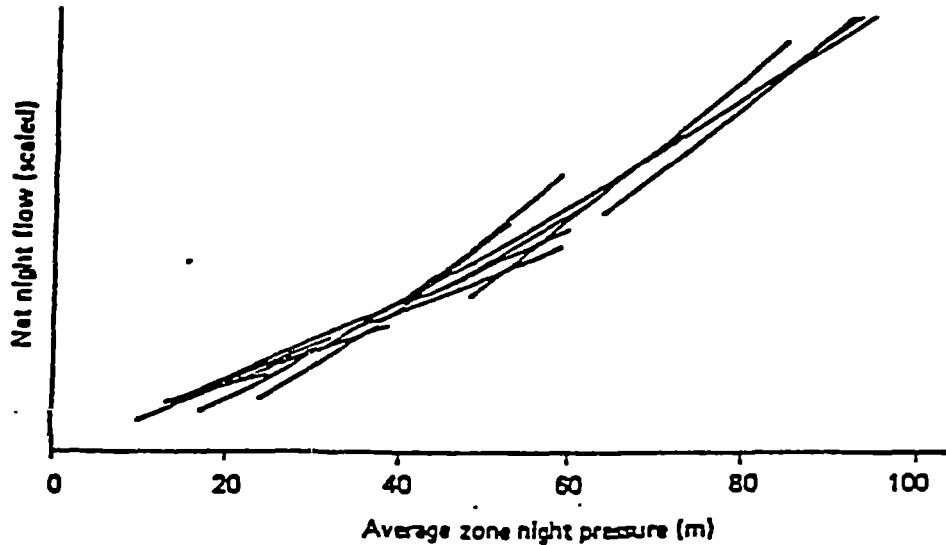
Figure 1. Graph of scaled net night flow and pressure relationship (Goodwin 1980).

The rate of leakage reduction with pressure was investigated by Water Research Centre in England. Research was carried out by operating the distribution network at different pressures every night. The MNF measurements were taken using waste metering. When MNF figures were plotted against average zone night pressure for each night, a relationship was discovered revealing that for zones with maximum pressure of 500 kPa or below, MNF was directly proportional to the pressure. In zones with pressure between 500 - 1 500 kPa the relationship was plotted as an upward curve (Figure 1).
