### WASH Reprint: Field Report No. 354

Surface and Groundwater Contamination  
in Selected Watersheds  
in Southwestern El Salvador

December 1991

Prepared for the USAID Mission to El Salvador  
under WASH Task No 265

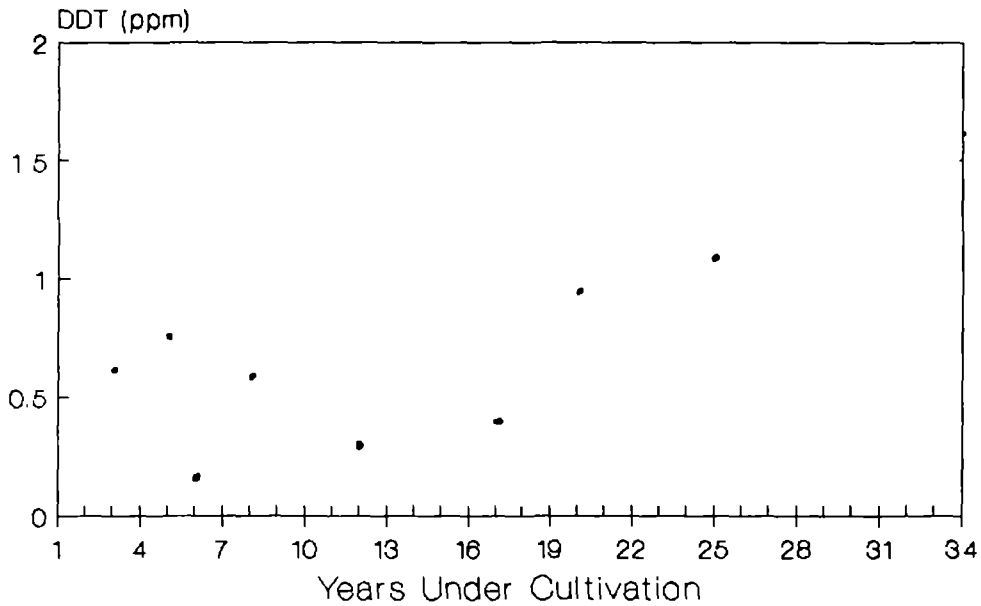
**Figure 1**

**Relationship between Years under Cultivation and Concentration of DDT in Cotton Growing Areas**
