A Loud Cry for Access to Quality, Safe Water in Rwangara Parish in Kanara Sub County, Ntoroko District, Uganda

by Stephen Birungi, HEWASA Programme

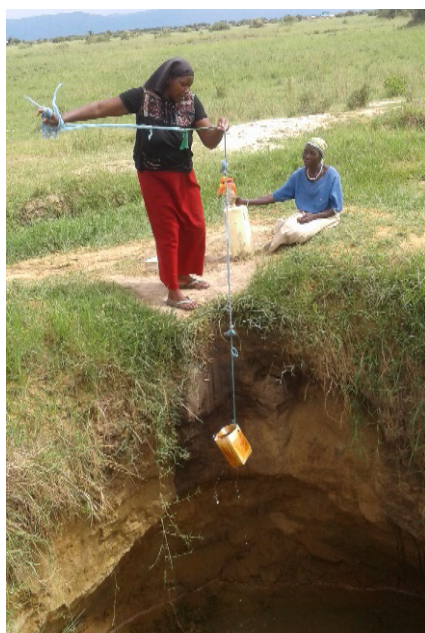
FIGURE 2: A woman in Rwangara draws water from an unprotected open hand dug well after paying \$0.14

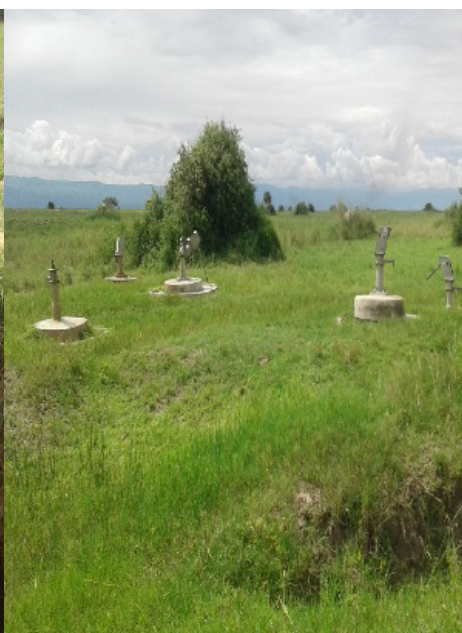
FIGURE 3: Some of the nonfunctional boreholes where pipes have eroded due to the saline water in Rwangara, Kanara Sub County.

- An assessment of the geology and hydrology needs to be commissioned involving capacity building of all stakeholders that will result in suggestions and recommendations for long-term sustainable solutions, including sustainable technology, balancing both ecosystems and socio-economic development.
- Government with development partners should extend the gravity flow scheme from neighbouring Karugutu Sub County to this area to provide a sustainable water supply.
- Promotion of other water treatment methods such as filtration by using ceramic filters through a social marketing approach should enhance access to household drinking water.
- Civil Society Organizations should undertake community empowerment initiatives so that people can demand for quality and sustainable WASH/IWRM services.

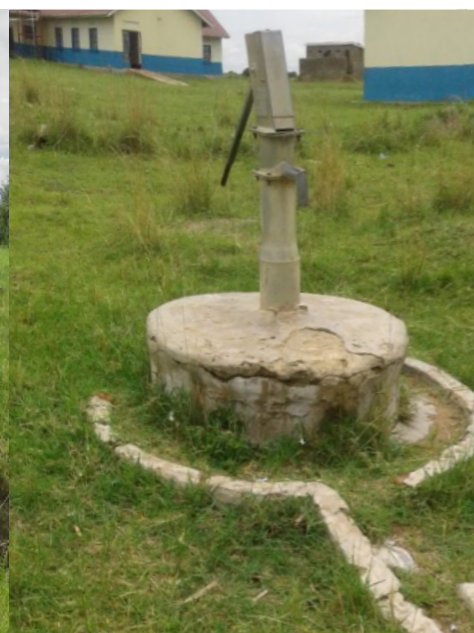
FIGURE 4: The high salinity levels in the water have also rendered the borehole at the Rwangara Health Centre II dysfunctional.

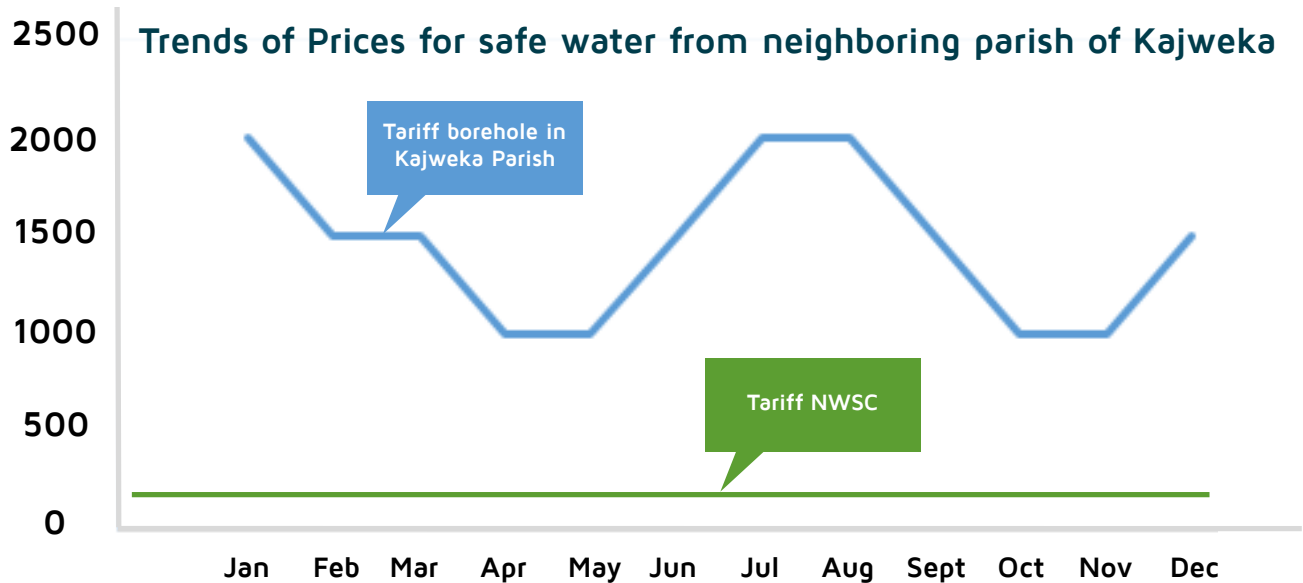
FIGURE 5: Graph showing the trends of prices for safe water from the neighbouring Parish of Kajweka.
 Source: Survey conducted by HEWASA, March 2018
