EVALUATION ON THE SARVODAYA
SI-5 HANDPUMP
MATARA AND GALLE DISTRICT

by
Annemarieke Mooijman
Mariet de Savornin Lohman
N. Franklyn

Sarvodaya RTS
Moratuwa, august 1988

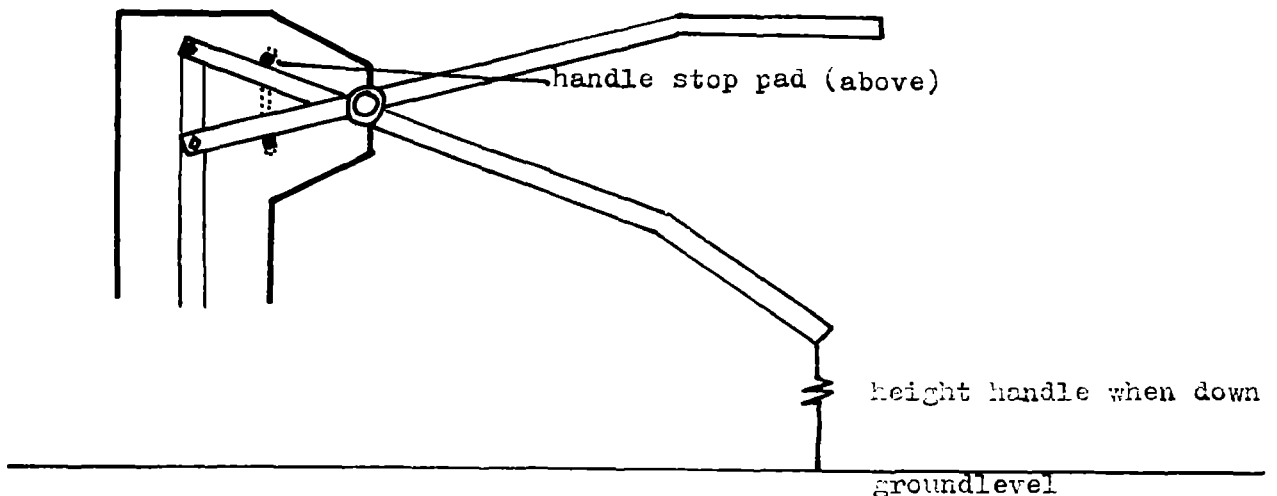
This table shows the relation between the height of the handle when the handle is pushed down and whether the handle stop pad is broken. We found that when the height of the handle when down was lower than 57 cm. the handle stop pad was never broken.

So the conclusion can be that it's better to instal the pump at a height lower than 57 cm. (when the handle is down).
The handle stop pad (under) was broken inside none of the evaluated pumps.
