FINAL REPORT ON THE UTILIZATION/ EVALUATION OF AN AID HAND-OPERATED WATER PUMP

The U.S. Agency for International Development under Contract No. AID/ta-C-1354

Office of International Programs
Engineering Experiment Station
GEORGIA INSTITUTE OF TECHNOLOGY
Atlanta, Georgia
January 1979

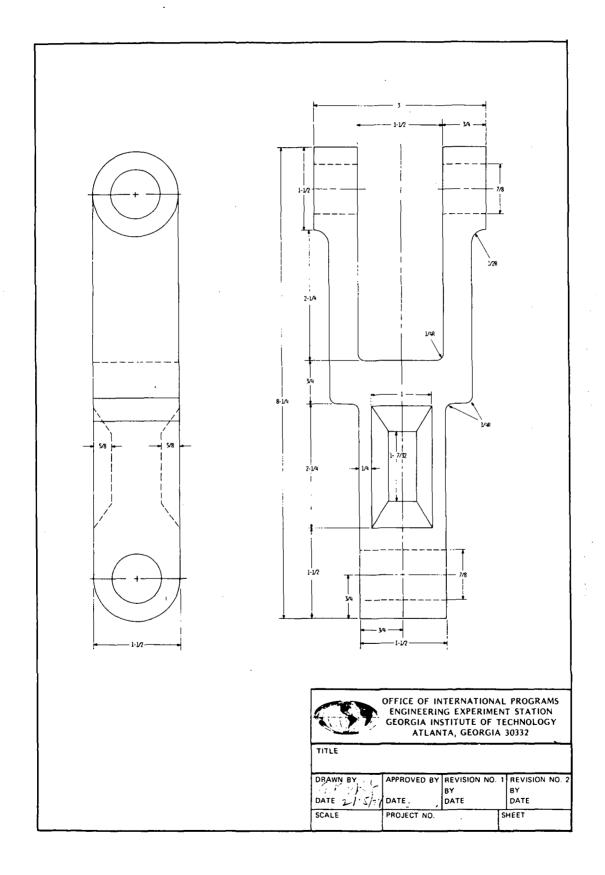
FULCRUM HANDLE FOR MODIFIED DEEP-WELL

Excessive wearing of leather cups has also presented problems for the AID pump in Nicaragua principally because of insufficiently smooth cylinders and oversized cups. Battelle drawings specify a 3-inch diameter leather cup for a 3-inch cylinder, which would be satisfactory if leather did not expand when wet. To allow for expansion, the dry cups should have been made approximately 1/16-inch undersized. A replacement order for the original oversized cups was filled by the pump manufacturer, and the wearing of these new cups has been considerably less due to the use of a blanking tool that improves the quality controls of the manufacturer. The blanking tool has proven to be very beneficial and is being modified to resemble a method suggested by Dr. Eugene McJunkin in a recent publication:

was redesigned by lifting the pivot arm up and away from the pump body and positioning it so that it does not absorb so much of the stress caused by the downward force of the pump handle. The redesigned cap was put into production at the manufacturer's foundry, installed on the pumps in the field, and has presented <u>no</u> additional problems.
