ANNUAL REPORT
ON
HANDPUMP TESTING IN UPPER LIVULEZI PROJECT
IN MALAWI

K.G. Liyanage

March 1986

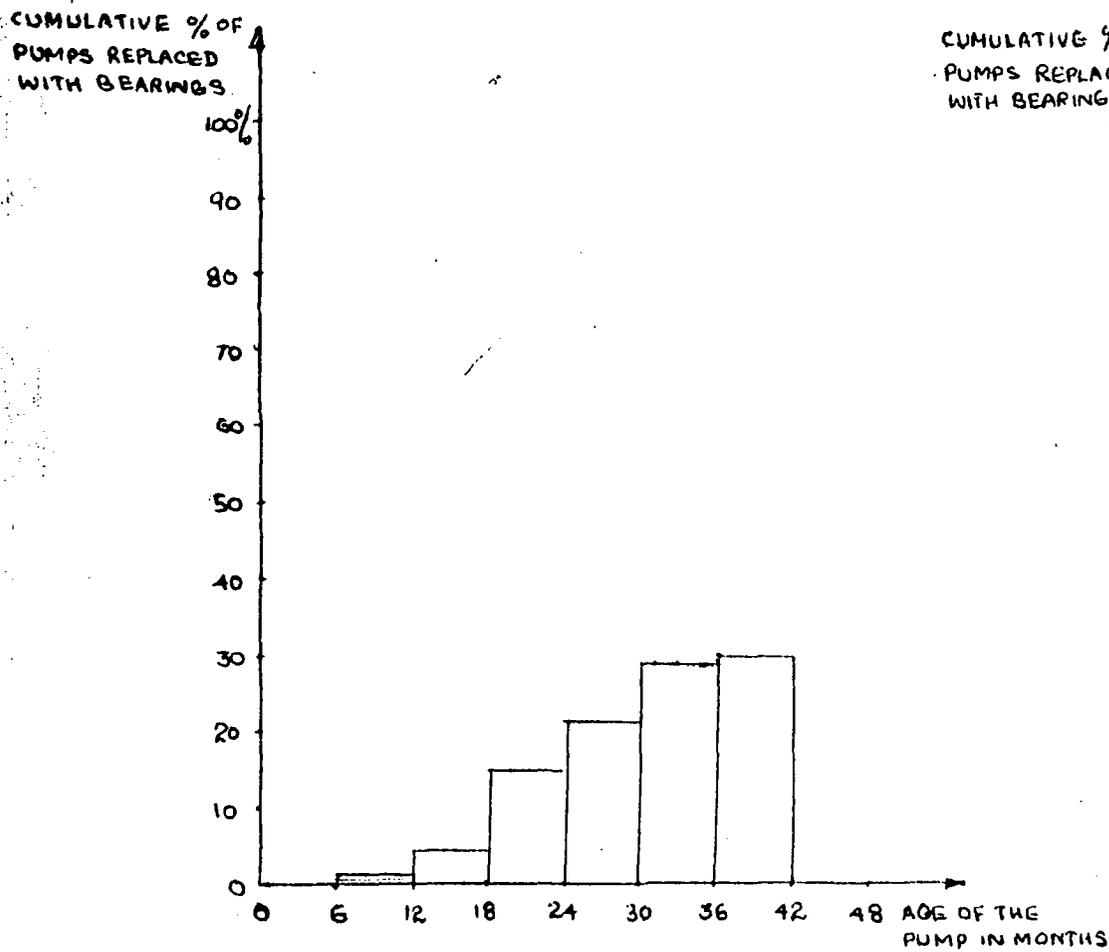
FIG 2. FIRST HANGER BEARING REPLACEMENT OF MALDEV HANDPUMPS.

According to figures 1 and 2, the fulcrum bearings had to be replaced in about 10% of the pumps and in another 10% of the pumps the hanger bearings had to be replaced during their 18th-24th month operation. Fig 5 shows that 20% of the total number of pumps have had either hanger bearings or fulcrum bearings replaced in their 18th-24th month of operation. As shown in Fig.6, by the end of the 36 months of operation, 52% of the total number of pumps had either hanger or fulcrum bearings replaced for the first time. When analysing the breakdown records there were only two occasions where all three bearings (one hanger and two fulcrum) had to be replaced at the same time or within the same period of six months taken for plotting the histograms. Therefore Fig. 5 is the addition of Fig. 1 & 2 and Fig. 6 is the addition of Fig. 3 & 4.

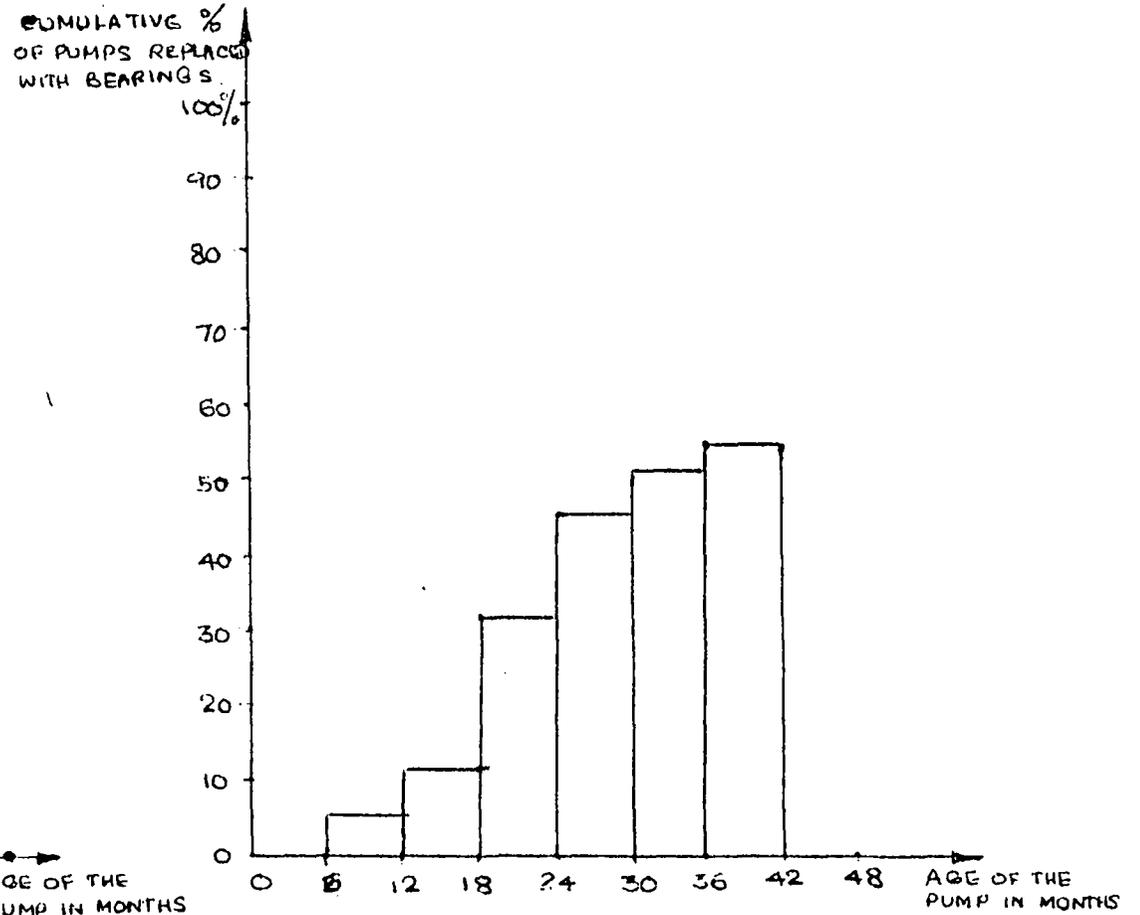
FIG. 5. FIRST BEARING(S) REPLACEMENT
IN MALDEV HANDPUMPS (HANGER & FULCRUM)

As indicated in Fig. 5, there is a peak between the age of 18th-24th month of the pumps showing 20% of the pumps needed bearing replacements. At the age of 36 months only 52% of the total population of the pumps have had bearing replacements. It would be interesting to draw the histogram for the first bearing replacement of the other 48% of the pumps with the information collected in future. These data could be used for maintaining stocks of bearings in projects.

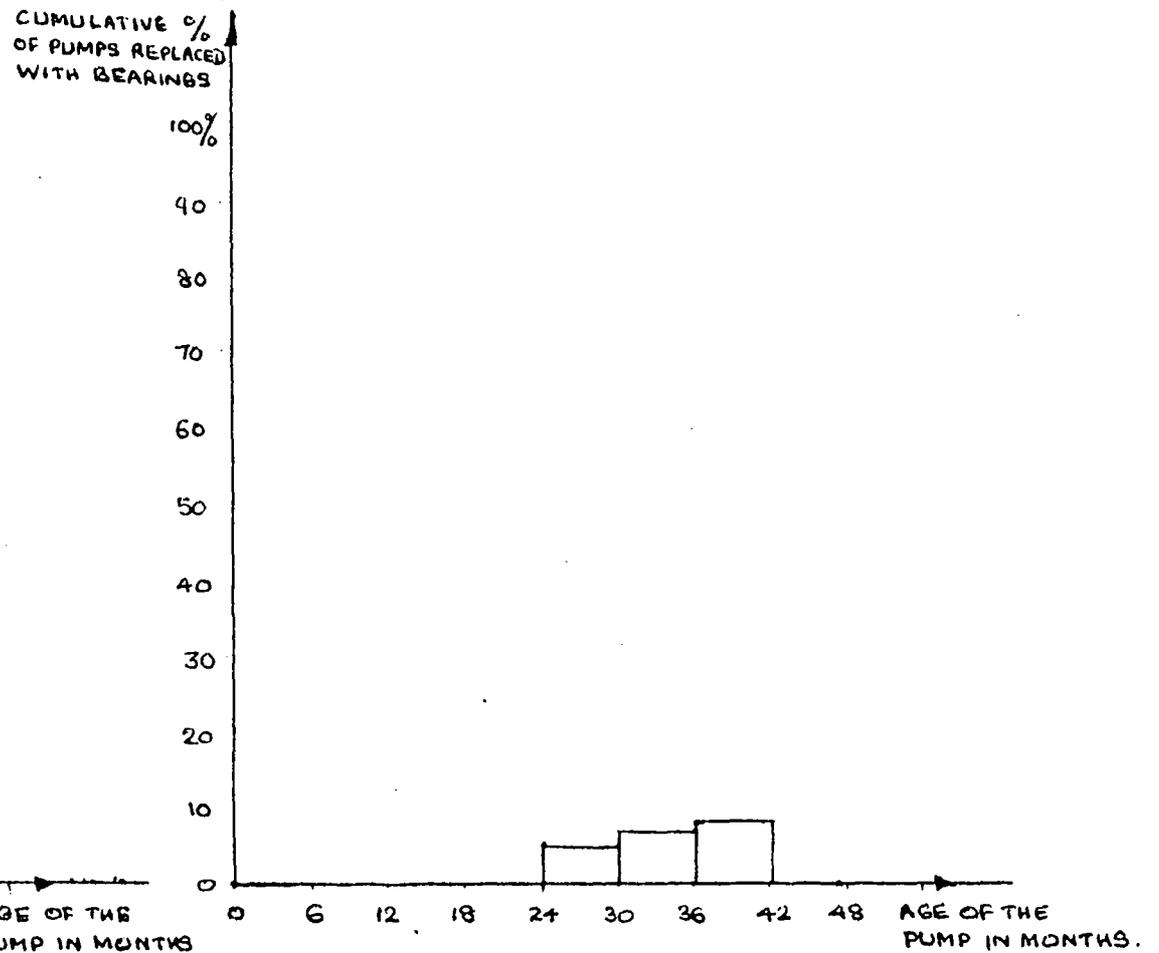
FIG. 7. SECOND BEARING(S) REPLACEMENT IN MALDEV HANDPUMPS

Fig.7 shows that five pumps had to have either hanger or fulcrum bearings replaced (3 with fulcrum and 2 with hanger) for the second time during their 24th-30th month in operation. According to Fig.8 only 7% of the total number of pumps had to be replaced by either hanger or fulcrum bearings (2nd time) before completing an operational period of 36 months (3 years). All of these eight bearings which had to be replaced for the second time were fitted on site.

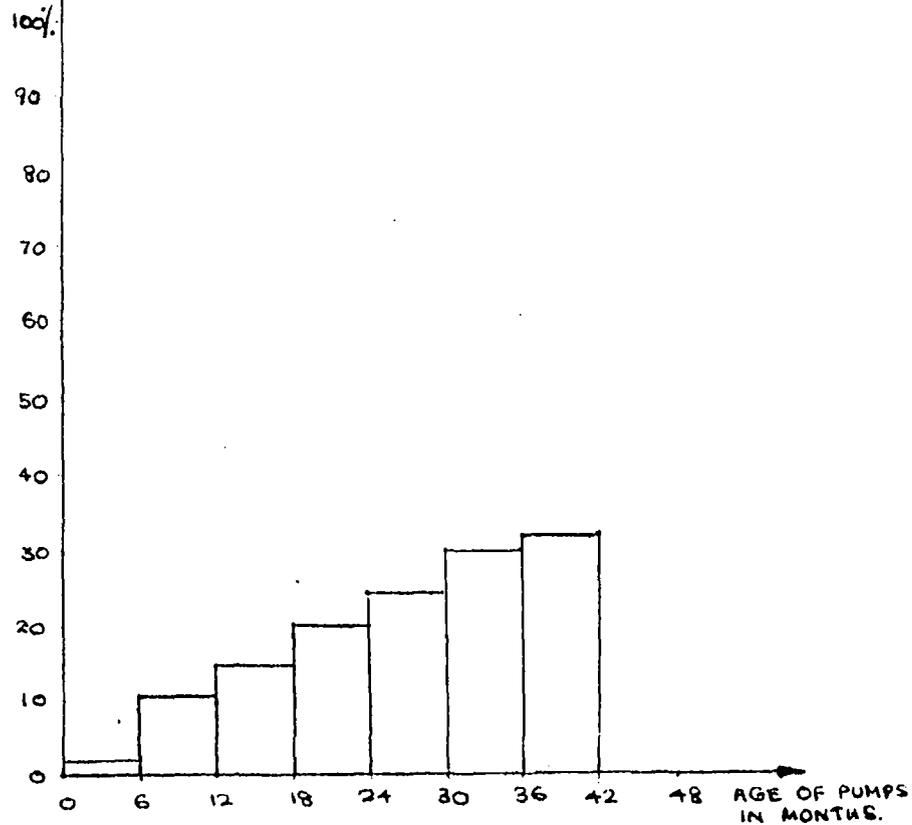
FIG. 9 FIRST PISTON SEAL REPLACEMENT
IN MALDEV HANDPUMPS.

Fig. 9 shows the first piston seal replacement in the Maldev pump. It shows a fairly equal distribution over the different ages of the pumps and according to Fig.10. 30% of the pumps had to have the seals replaced within the first 36 months of use. Second piston seal replacement in the pumps, shown in Fig. 11, has a similar distribution as for the first (Fig.9).
