Ministry of Lands, Minerals Resources and Energy
Mineral Resources Department

**Water Resource Investigations
on
CICIA**

Prepared by
B. J. Lewis and L. J. M. Mourits
Centre for Community Water Supply and
Sanitation Studies

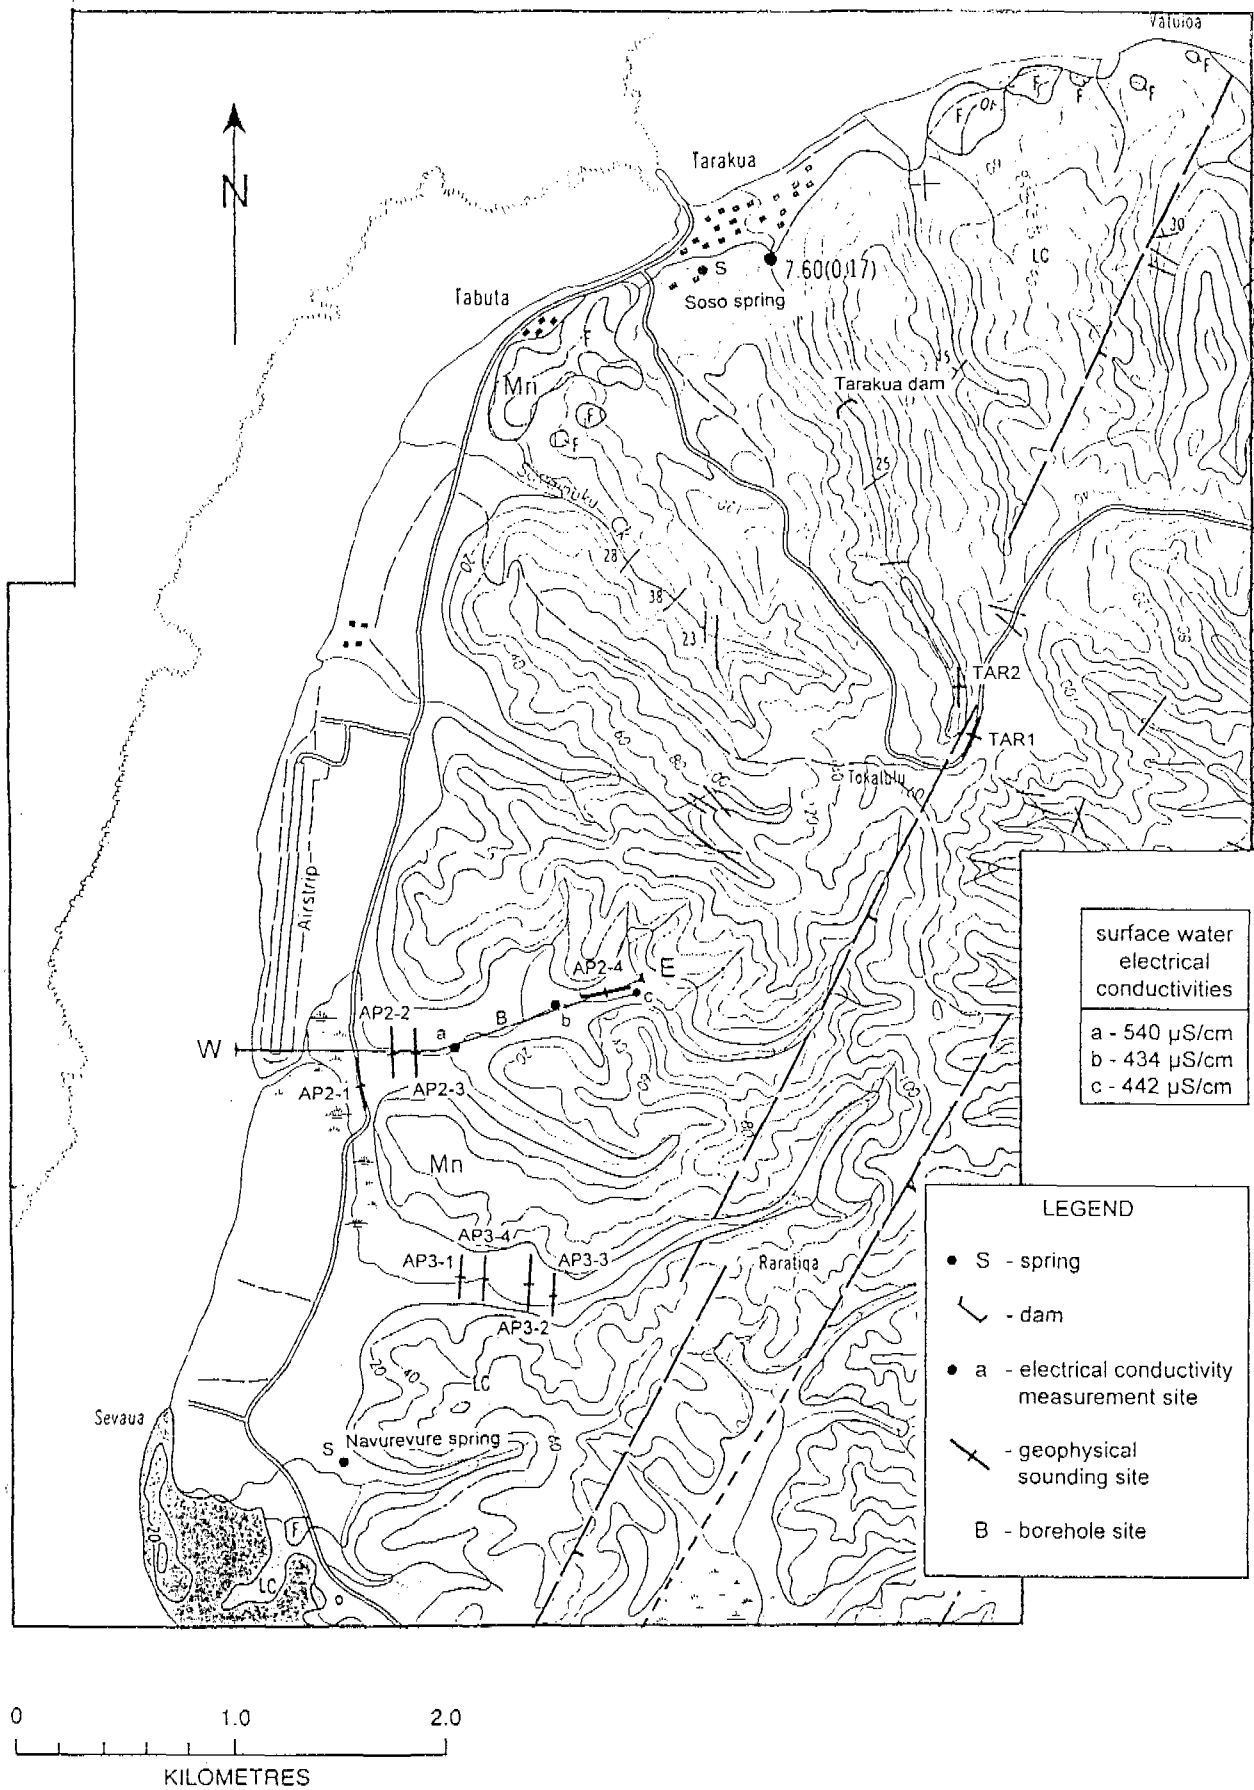
Figure 3 : Tarakua location map, Cicia

A borehole site has been chosen in valley AP2 and is indicated in Figure 3. It is located within the northern splay of the valley about 800 metres inland from the coast. Based on the electrical resistivity and seismic soundings the weathered bedrock should begin at about ten metres below ground level. The borehole should be drilled to bedrock or no more than about 15 metres below ground level and finished to an 8-inch diameter (6-inch minimum). The catchment above this site has an area of about 0.85 km². The sustainable yield for a borehole at this site has been calculated to be about 0.63 l/s, which is 268 l/p/d for the Tarakua population in 1986 (Census). There is easy access to this site for a drill rig.

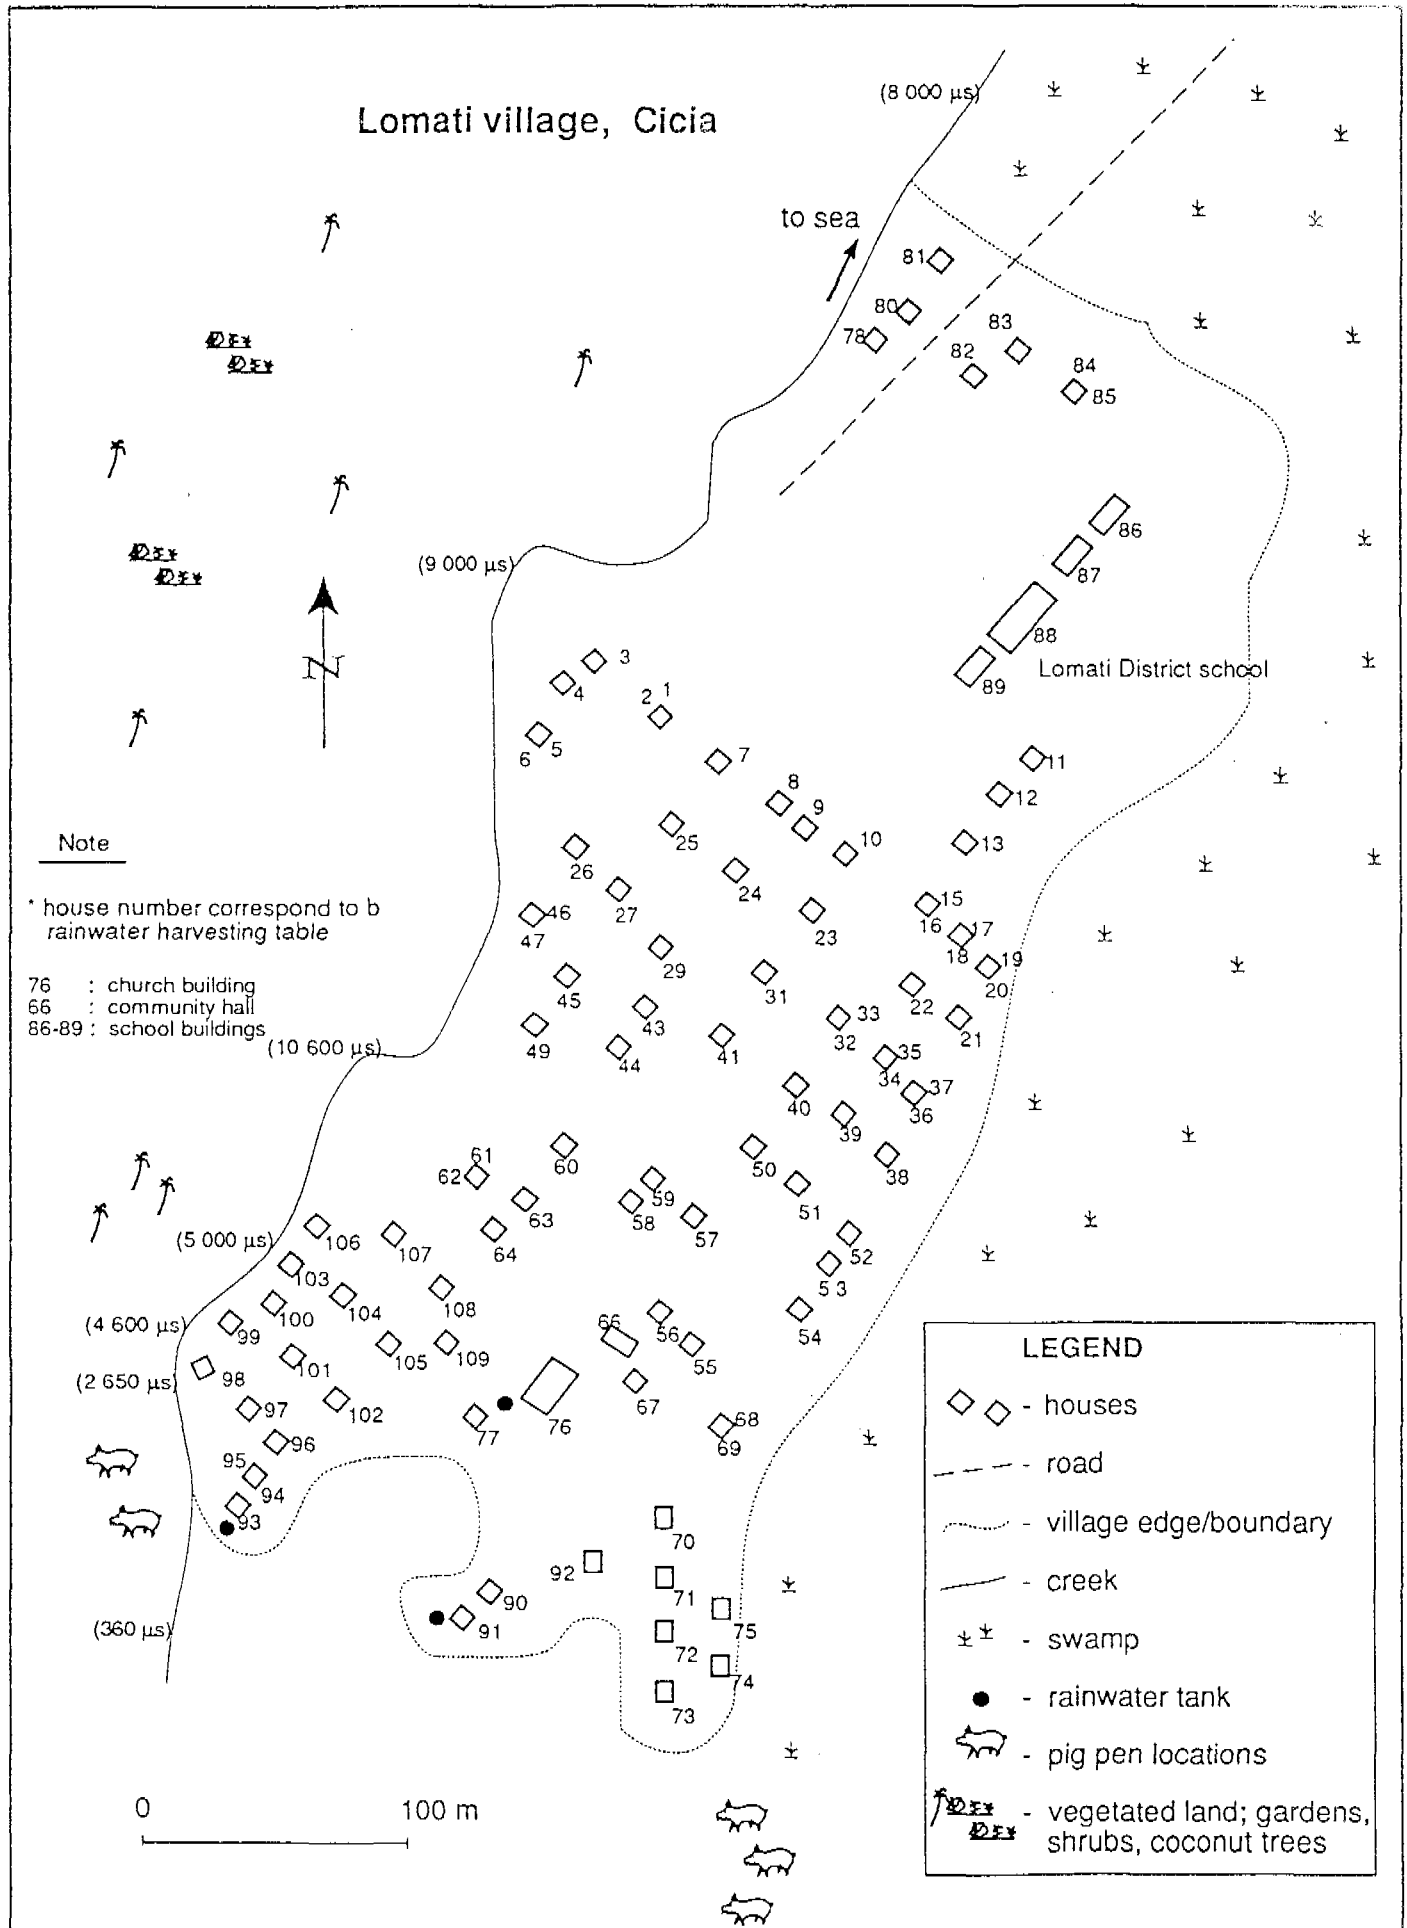
Figure 8: Lomati village map, Cicia

Taps The village has a piped water supply with taps in the village. There is about one tap per six households, which is not enough according to the women in the village. It means they have to wait at the standpipes. There are five standpipes at the school compound.

1. The existing pipes need to be inspected and repaired as needed.
2. When water demand increases, water storage can be introduced into the existing reticulation system.
3. The village can better use their rainwater harvesting potential for water quality reasons. Currently only 10.5% of the available roof area is being used and current rainwater storage capacity is 6.6 m³.
4. Treatment of the reticulated water is recommended.
5. Additional protection of the spring sources is recommended. A proper design has to be sought.
6. The groundwater potential for this village is the best of the island. The proposed borehole is expected to have a maximum potential yield of 4.3 l/s (more than sufficient for the villager's present needs). However, actual yields can be less.

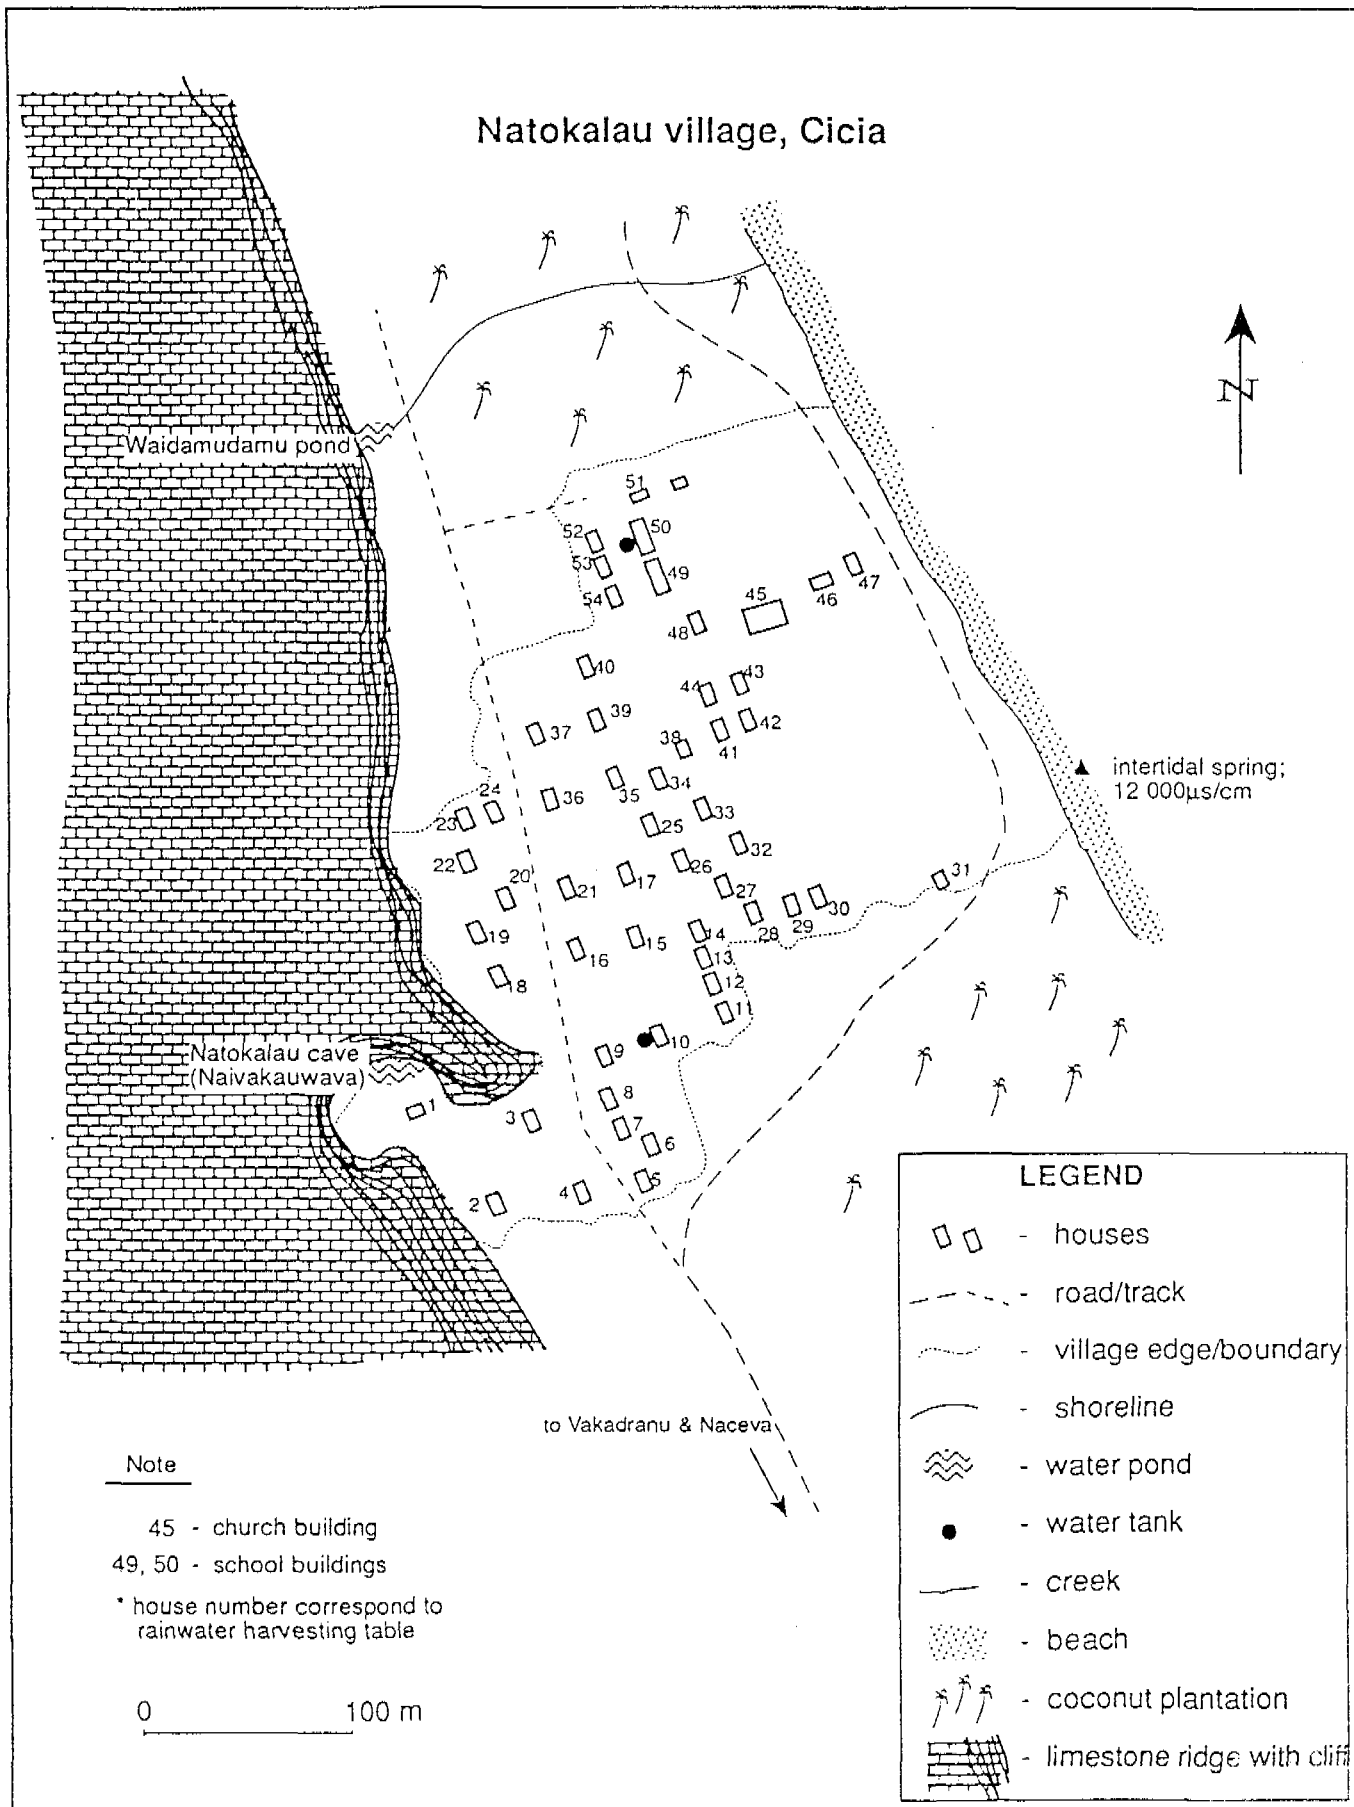
Figure 11: Natokalau village map, Cicia

Waidamudamu pond Waidamudamu¹ pond is located 100 m north of the school at the foot of the limestone cliff where Mataniwai Creek emerges from Naivakauru cave. During rains, fresh water flows out of the cave, and the pond is then used for washing and bathing. During this visit the pond water was dirty brown and fairly

salty (3500 $\mu\text{S}/\text{cm}$).

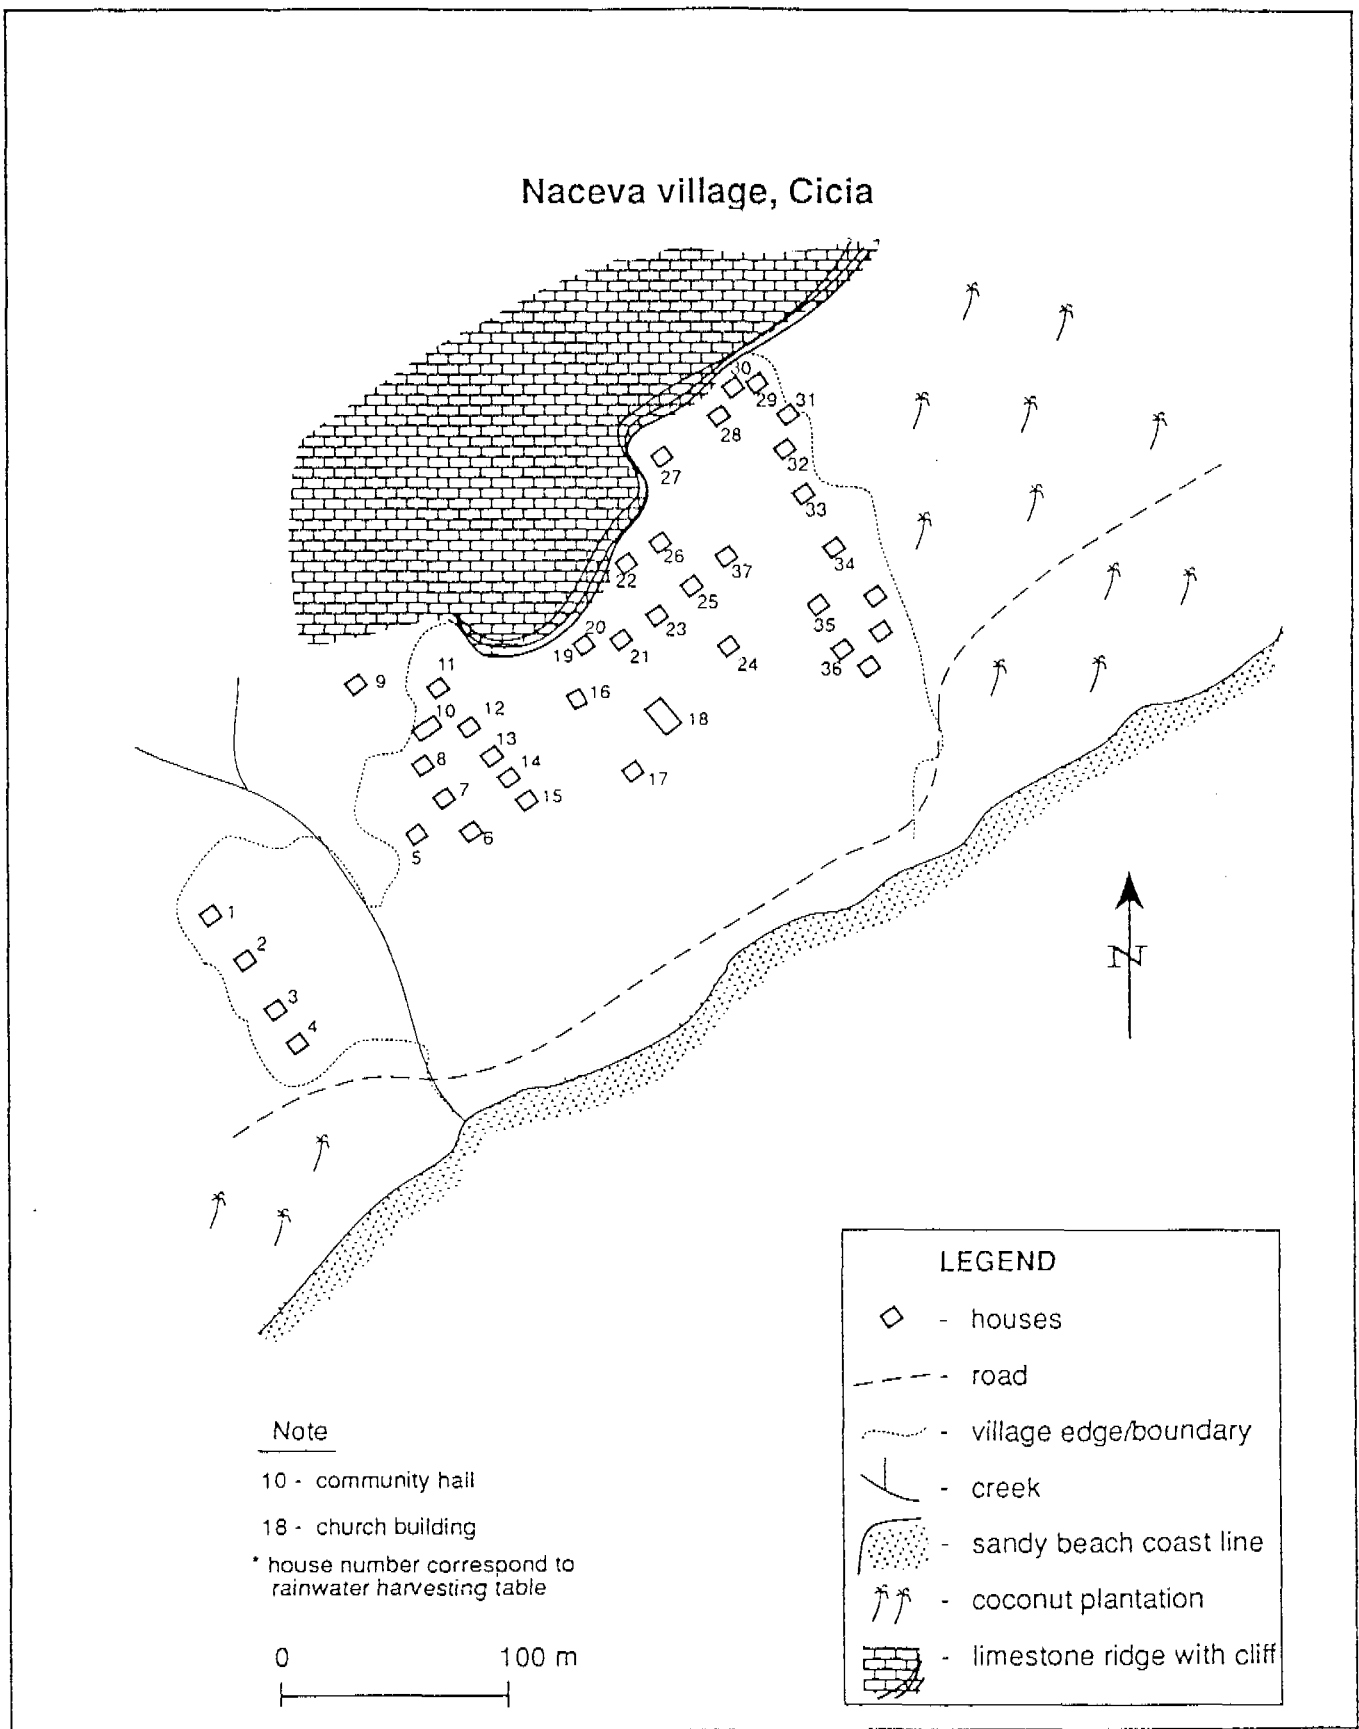
Figure 14: Naceva village map, Cicia

Taps Taps in the village are all communal standpipes except for one house with inside taps, shower and water-flush toilet. Most of the outside standpipes have some kind of construction built around them. For one toilet an old rusty galvanised iron tank was used as protection. Toilets are mainly water-sealed.

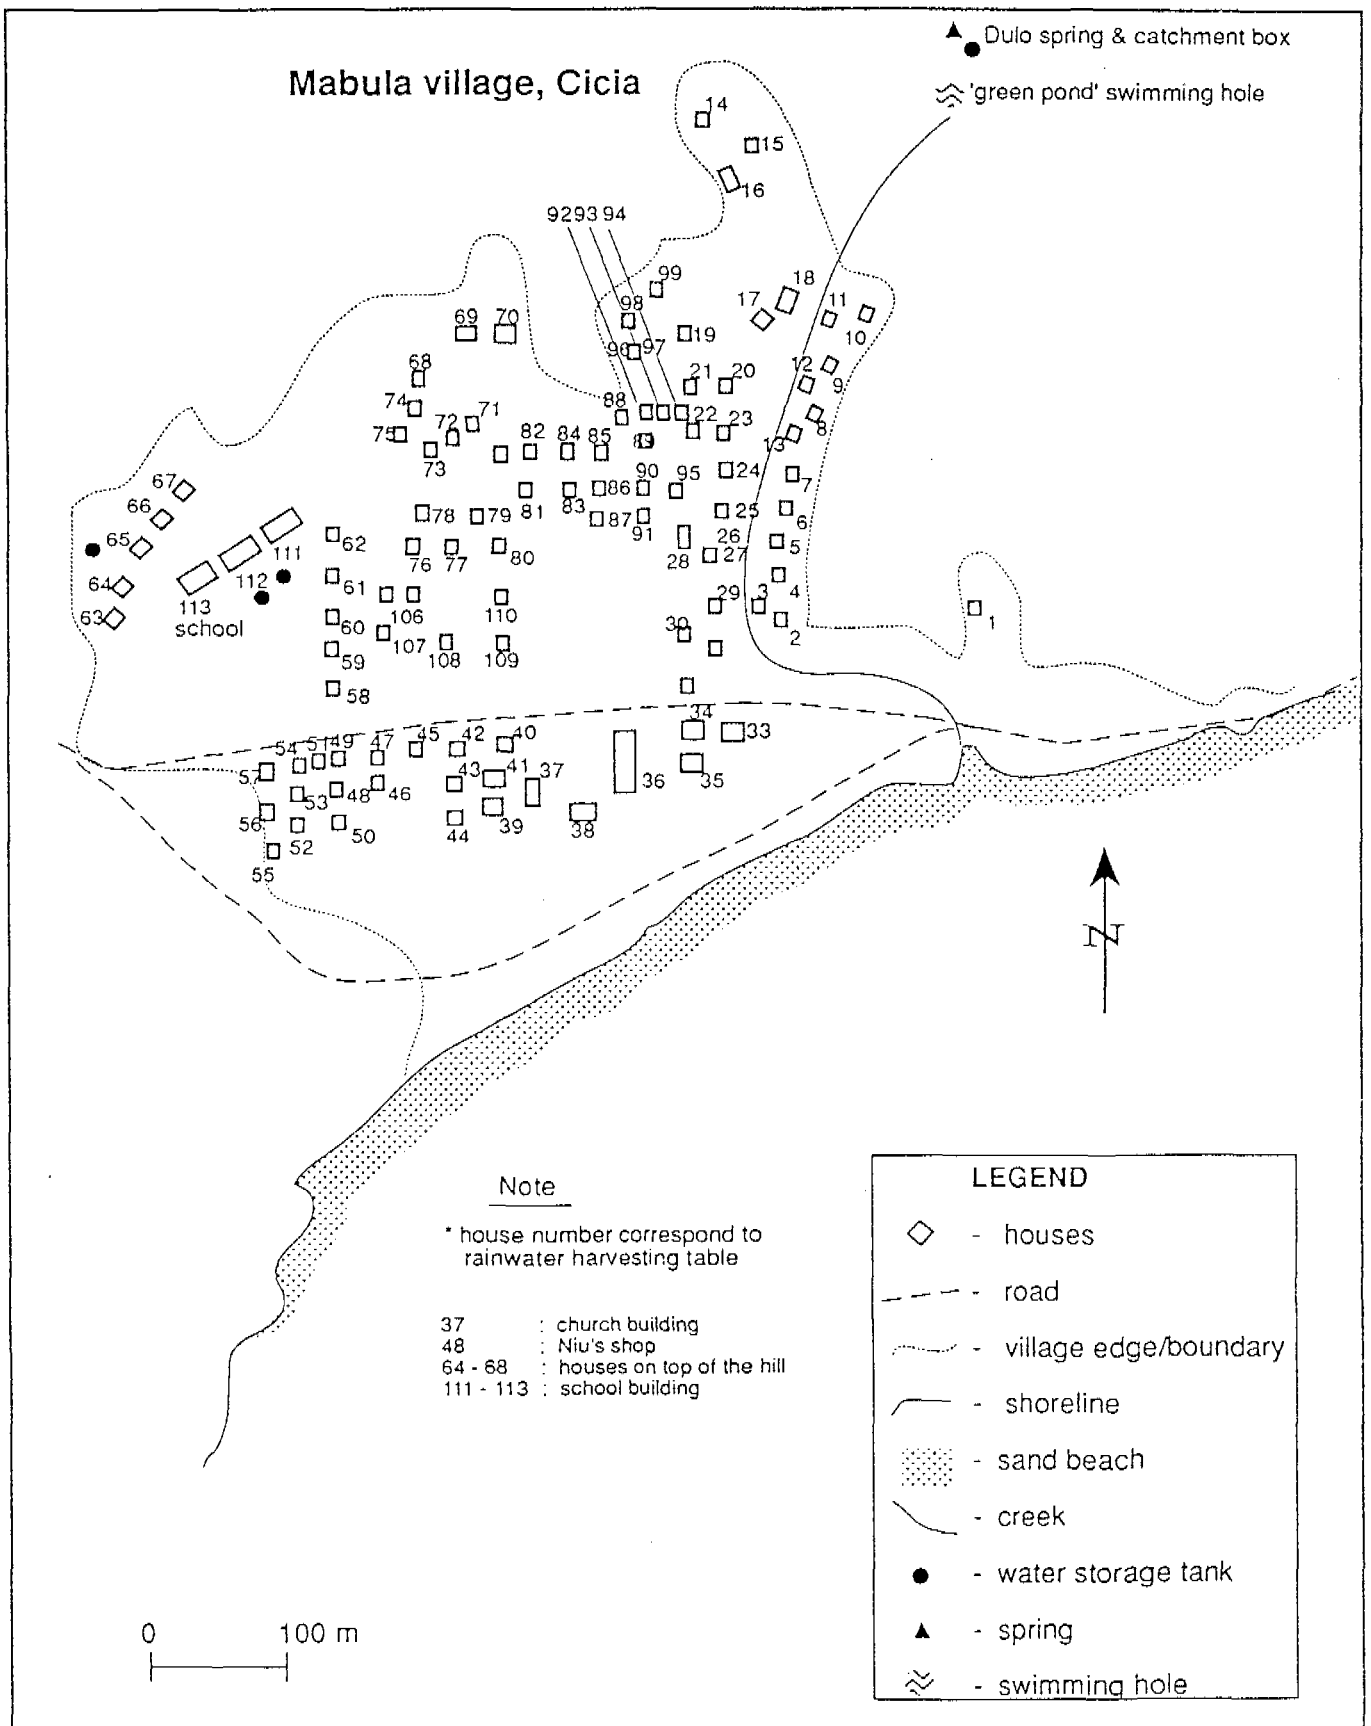
Figure 17: Mabula village map, Cicia

The rainwater system serving five houses on the hill was empty on 27/7/94. The last rains had fallen in May and the tanks were empty by June. One full tank is used up in one or two months. When the tank is empty the people carry buckets up hill from the village (a distance of 200 to 400 metres). The water from the rainwater tank is preferred to the village tap water.

The pool near Dulo spring is used for bathing.
