INTEGRAL FILTER SYSTEMS FOR RESERVOIRS
OF SMALL EARTH DAMS

Volkhard W. Werner

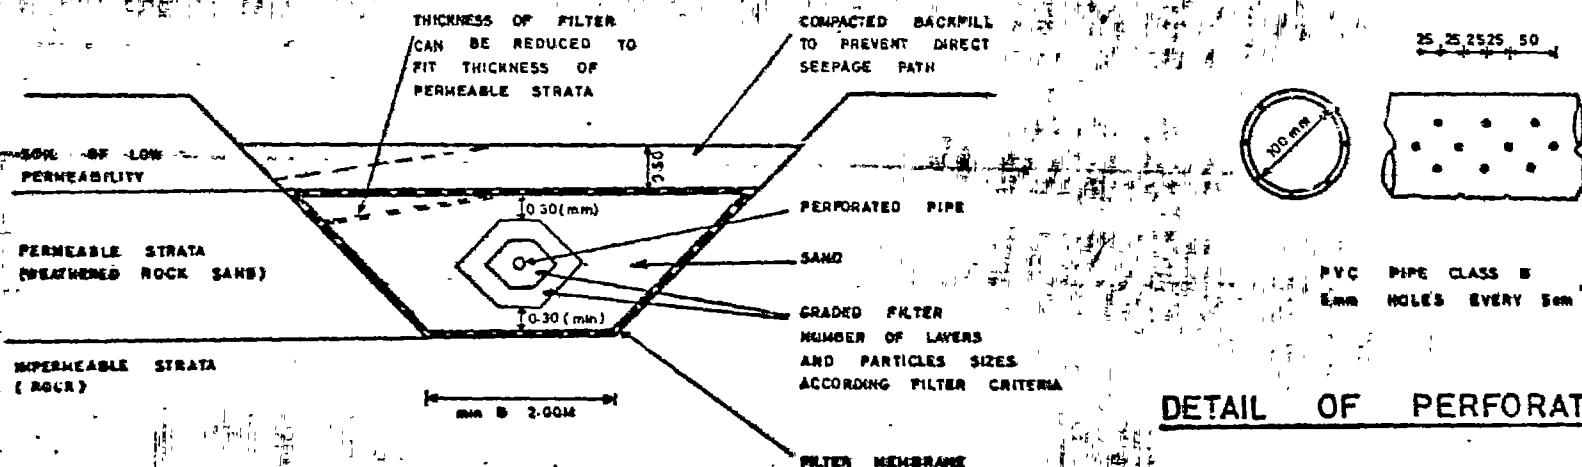
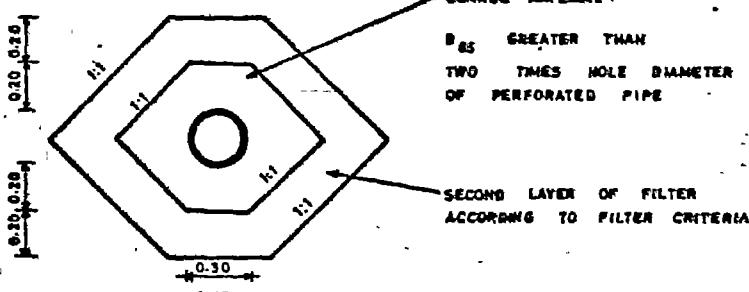
FIG 1 DETAILS OF FILTERSYSTEM

The Integral Filter System consists of a perforated PVC pipe of 100 mm diameter which is embedded in graded filter medium and placed at the bottom of the reservoir, see. Figure 1.

This filter package is placed into run-off the bank sand with a minimum thickness of 0.3 m at the bottom and 0.3 m at the top. The whole filter system including of the surrounding sand layer is wrapped by a

DETAIL OF PERFORATED PIPE

DETAIL OF FILTER

spunbonded filter membrane to prevent eventual clogging of the filter layers.

The top of the filter is covered by about 0.5 m slightly compacted backfill to prevent development of a direct seepage path into the filter. The filter is preferably placed such that the permeable strata of the reservoir are adjacent to the filter. These permeable strata are frequently found in the old river bed, it's banks and in branches of the river, if any.
