**Results of Yield Testing  
of Wells in  
Marakkanam Block  
South Arcot District  
Tamil Nadu**

**Raj Kumar Daw  
PHE Adviser  
IRS & WS Project, Cuddalore  
Tamil Nadu**

**July 1995**

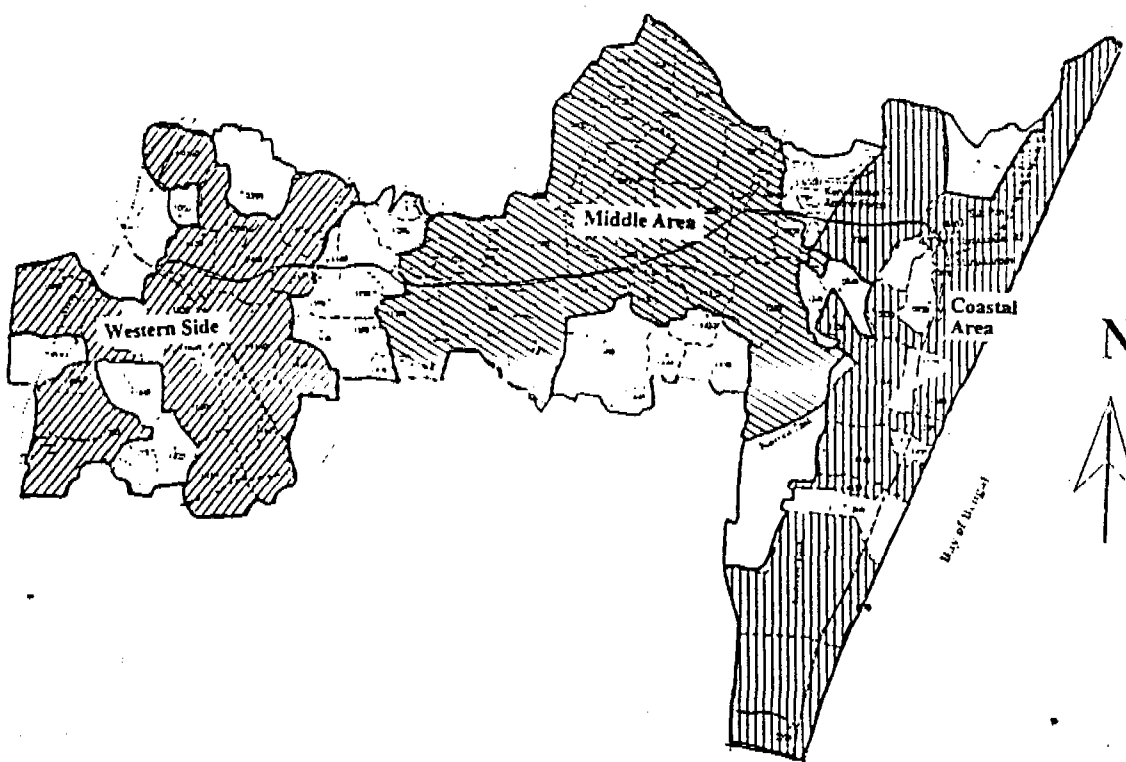
Fig. 2 : Map of Marakkanam Block, showing Villages (shaded areas) where Yield Tests were conducted

In order to arrive at a territorial basis for analysis of the yield results, the list of test sites was classified into 3 broad geographical regions of the Block - Western Side, Middle Area and Coastal Area, as shown in Fig. 2.

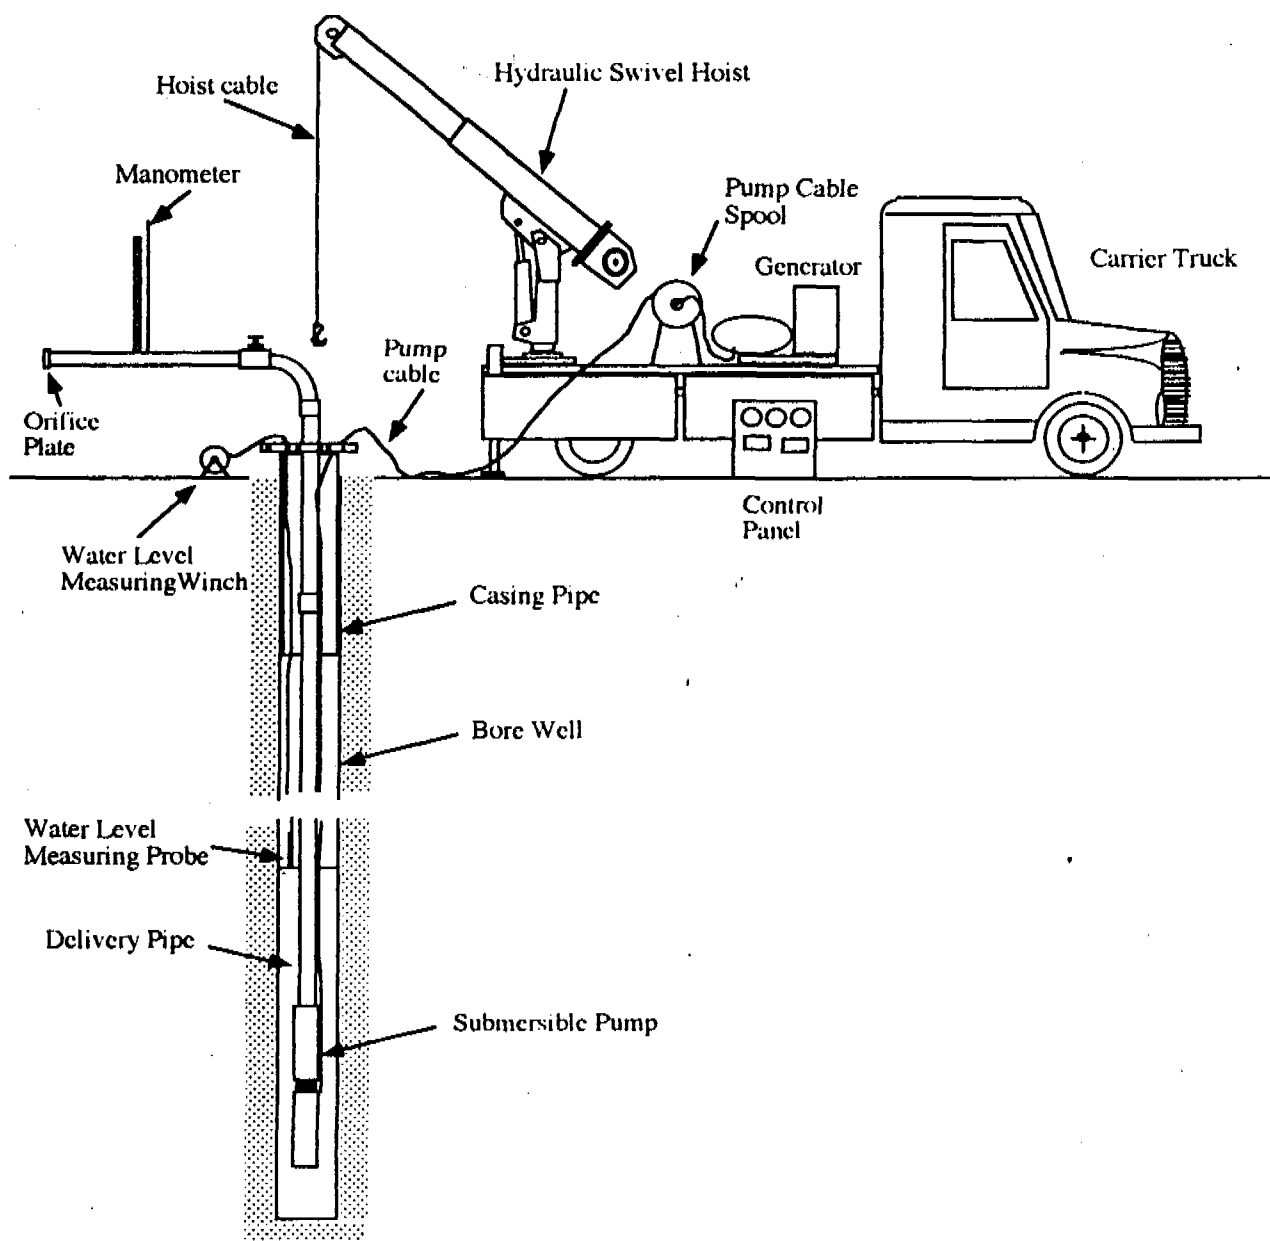
Fig. 3 : Layout of a typical Pumping Test

The equipment used for conducting yield tests was a truck-mounted hydraulic swivel crane to lower submersible pumps in tube wells. The pump was powered by an electric generator mounted on the same truck. Fig. 3 shows a schematic layout of a typical pumping test or yield test.

Most tests were step draw-down tests. A manometer, an orifice plate and a control valve were used to set the yield steps in each test. Draw-down was measured with an electrical water level recorder. Recovery rates in each well were also measured with the water level recorder. Annexure 1 shows the equipment that was actually used for this programme.
