FINAL REPORT

THE CONTINUED DEVELOPMENT AND  
FIELD EVALUATION OF THE  
AID HAND-OPERATED WATER PUMP

August 28, 1970

BATTELLE MEMORIAL INSTITUTE  
Columbus Laboratories  
505 King Avenue  
Columbus, Ohio 43201

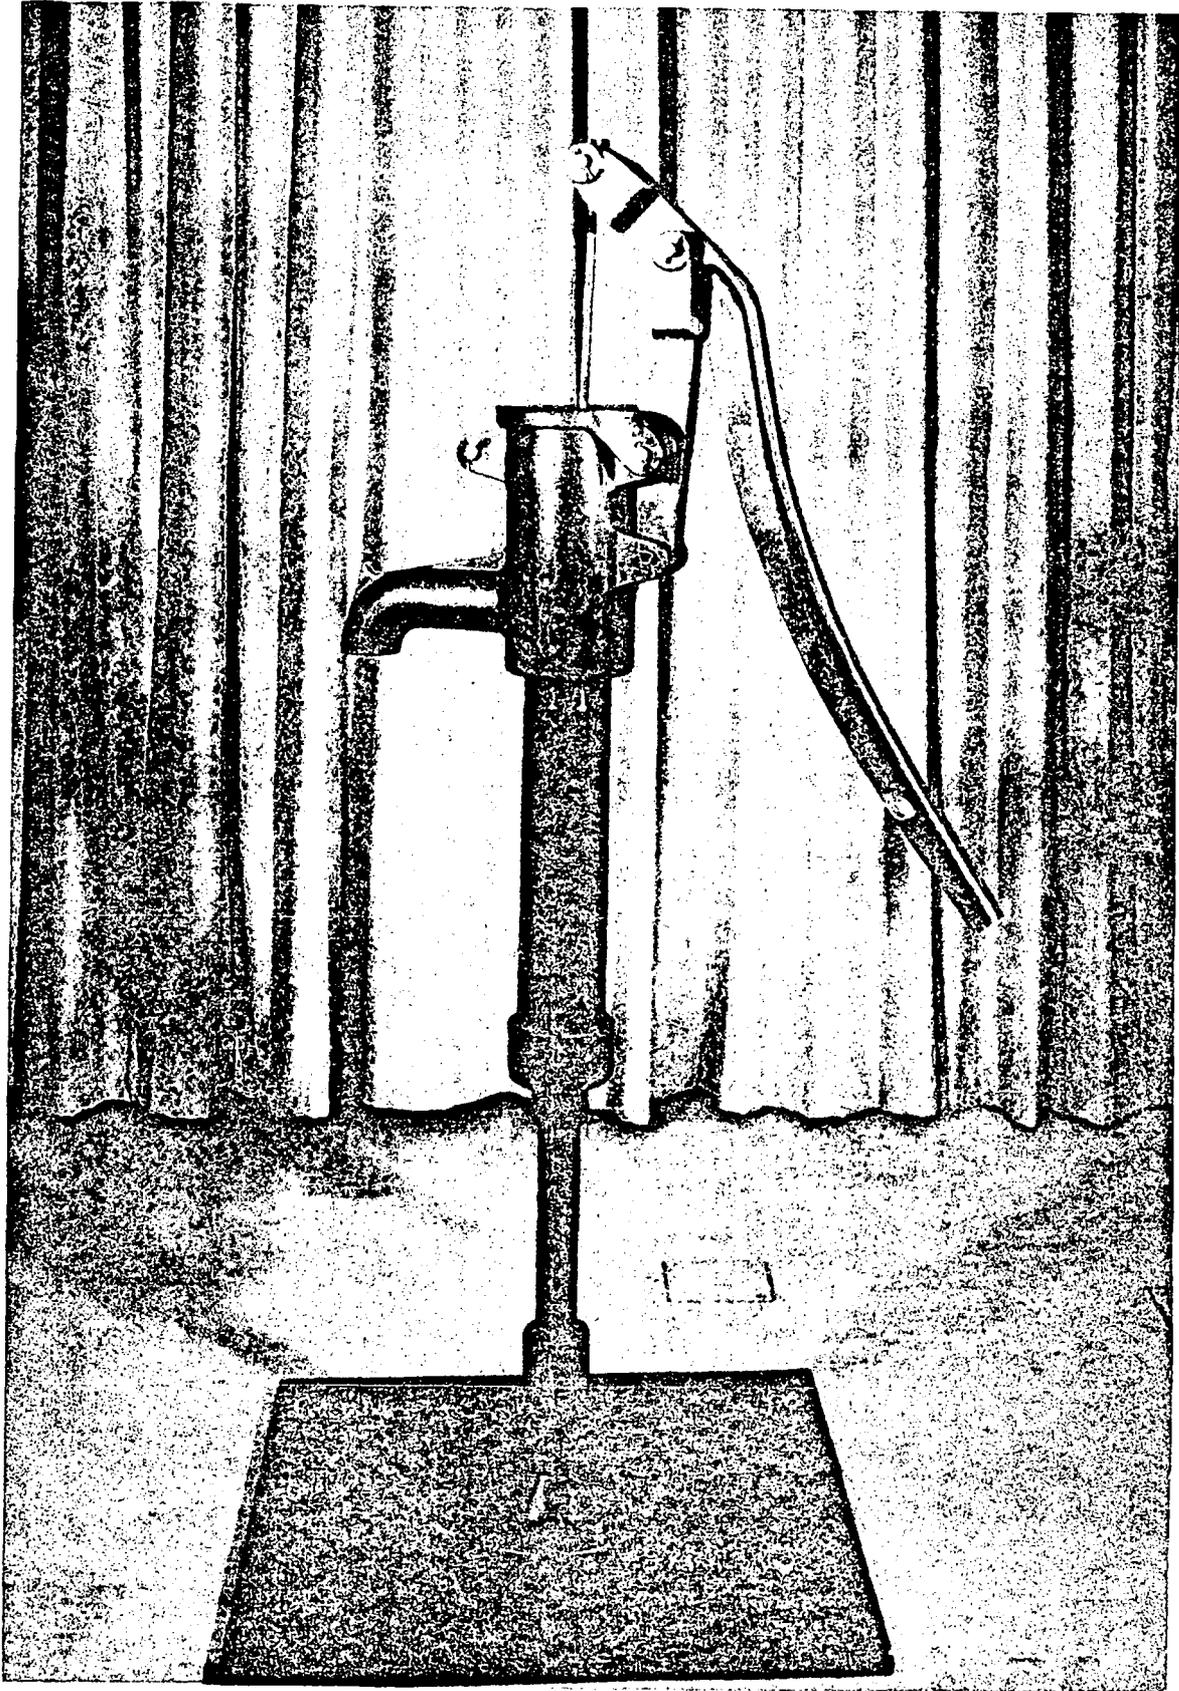
FIGURE 1. SHALLOW-WELL VERSION OF AID PUMP  
BATTELLE MEMORIAL INSTITUTE - COLUMBUS LABORATORIES

During the previous program, a simple pump design was evolved to meet the needs of developing nations. The basic pump consisted of a body, a fulcrum, a handle, a single cylinder, a plunger, and two check valves--one in the plunger and one in the cylinder. Figure 1 shows the design incorporated in a shallow-well pump. In this type of pump the suction cylinder is attached above ground to the pump body since the water can be lifted from the ground by suction. Figure 2 shows the selected pump design incorporated in a deep-well pump. In this type of pump the suction cylinder is placed below ground in or near the water source. A rod extends from the pump handle down through the connecting pipe (shown foreshortened in Figure 2) to the suction cylinder. The primary action of the plunger in a deep-well pump, therefore, is to lift the column of water to the pump body. Appendix A contains assembly drawings and parts lists for both types of pumps.

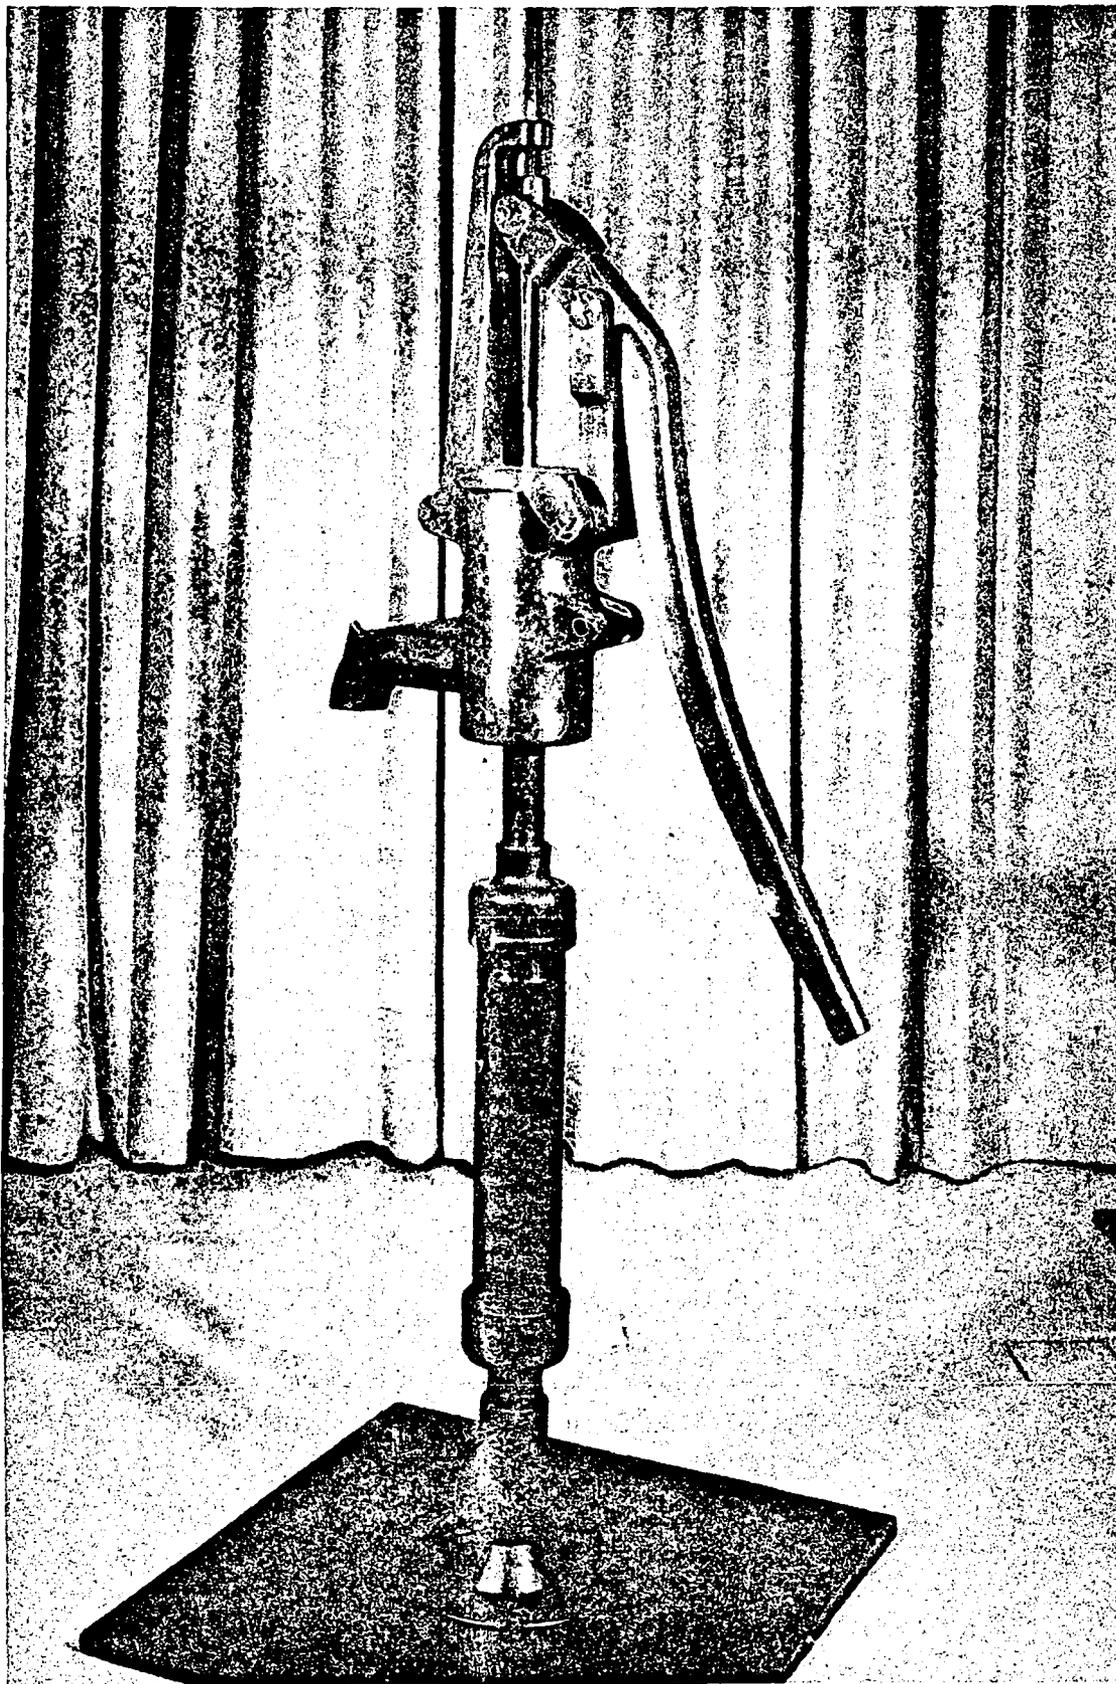
FIGURE 2. DEEP-WELL VERSION OF AID PUMP  
BATTELLE MEMORIAL INSTITUTE - COLUMBUS LABORATORIES

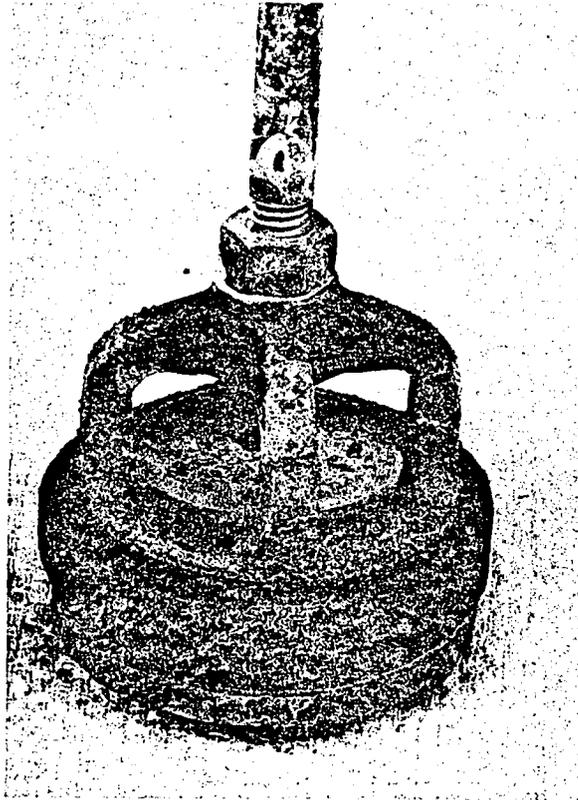
FIGURE 3. TYPICAL PUMP PLUNGER WITH METAL POPPET VALVE

Figure 3 shows a typical pump plunger with a metal poppet valve located in the middle of the plunger. Figure 4 shows the typical wear sustained by a metal poppet.

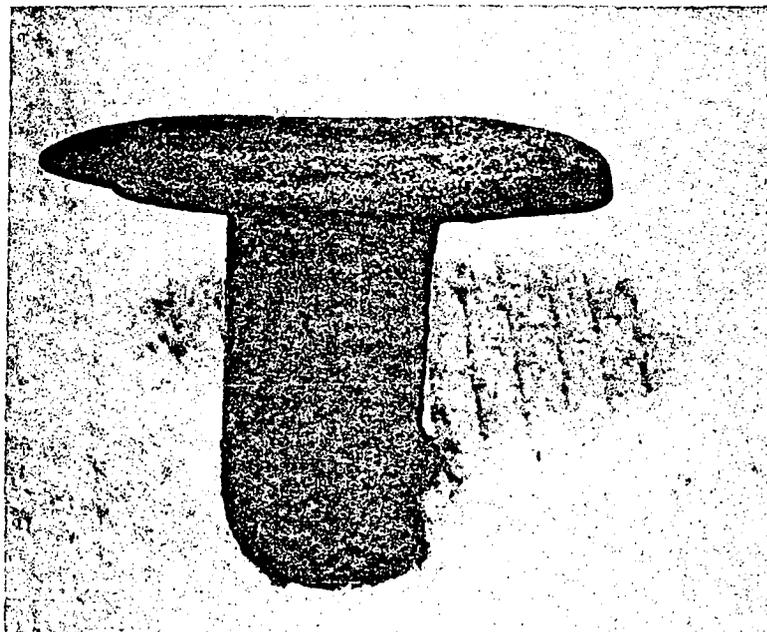
FIGURE 4. WORN CAST-IRON POPPET FROM PLUNGER VALVE AFTER SEVERAL TEST PERIODS

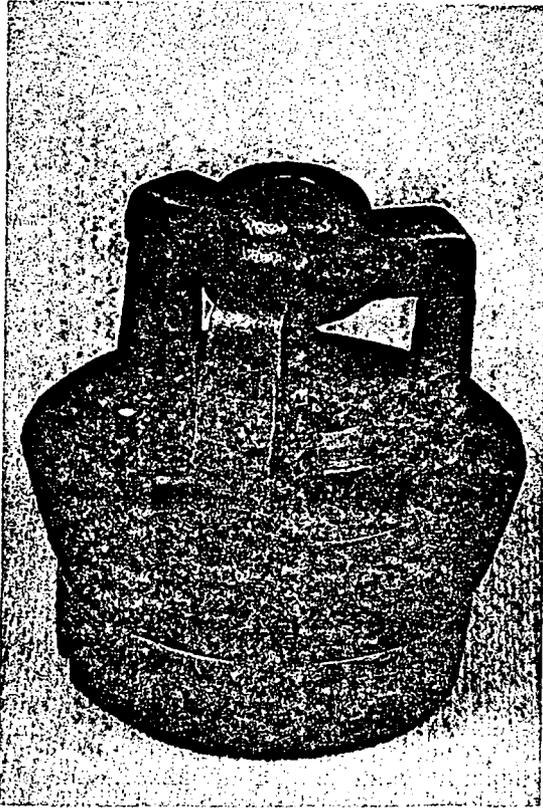
FIGURE 5. WEIGHTED FLAPPER VALVE  
INSTALLED IN PUMP PLUNGER

Figure 5 shows a weighted flapper valve installed in a pump plunger in place of the metal poppet. The neoprene-impregnated nylon flapper is attached to the plunger with two screws. To facilitate this attachment, three supports are used for the pump rod attachment rather than the four shown in Figure 3. A metal weight is attached to the back of the flapper to keep the flapper from floating and to insure that the flapper makes a satisfactory seal with the seat.

The plunger shown in Figure 5 was cast from bronze. The assembly was operated in a typical shallow-well pump for more than 5000 hours. A visual examination of the parts after the test showed no sign of wear or fatigue.

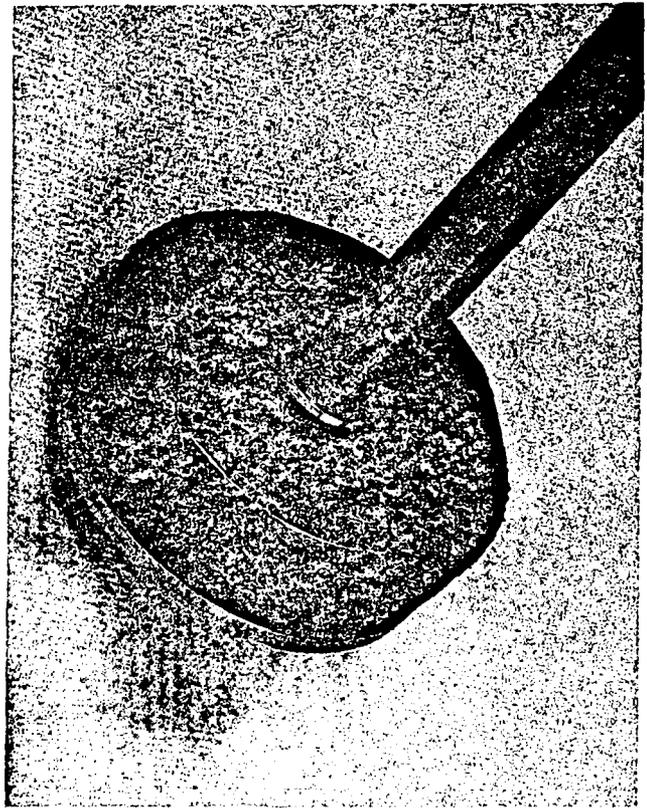
FIGURE 6. ASSEMBLED SERRATED FLAPPER  
VALVE AND PLUNGER

The second flapper-type plunger valve that was developed and evaluated is shown in Figures 6 and 7. It is similar to a valve described by drawings

The serrated flapper valve is composed of parts which are simple to make. The cup seal is a standard shape. The flapper can be stamped or cut from sheet material, and the metal supports can be made from castings or from bar stock. As with the weighted flapper valve, the serrated flapper valve was operated for over 5000 hours with no detectable signs of wear or fatigue.

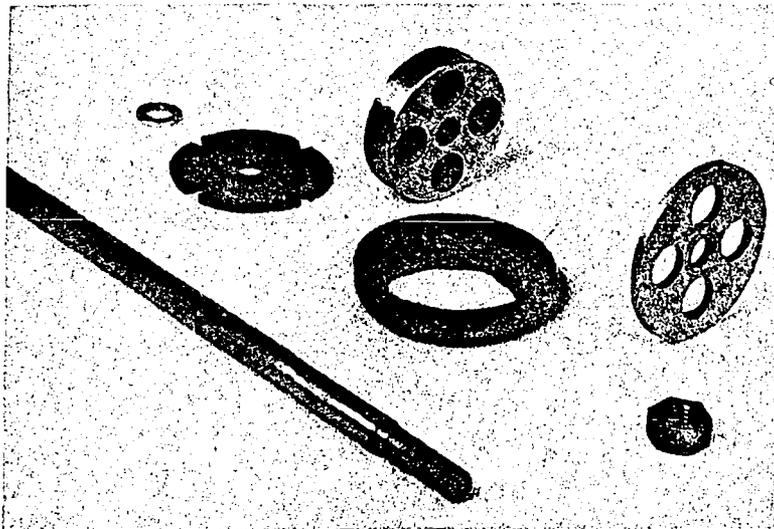
FIGURE 7. DISASSEMBLED SERRATED FLAPPER VALVE  
AND PLUNGER

The work during the previous program showed that high-quality leather is a good material for plunger cup seals. (A typical cup seal is shown in Figure 7.) Wide tolerances are acceptable and long life can be expected with fairly smooth cylinders. However, very poor leather is produced in some geographical areas, and even good leather is deteriorated (cracked) by alternately wetting and drying. In addition, poor storage conditions can cause excessive deterioration of cups held in stock. Thus, a part of the follow-on program was directed toward finding a leather substitute that would have uniform properties and be less affected by wetting and drying and by poor storage conditions.

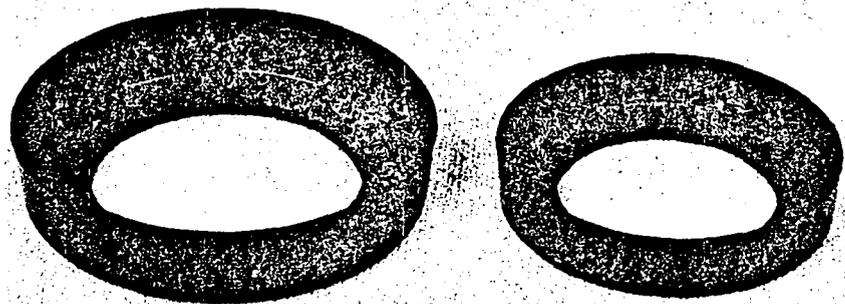
FIGURE 8. REK-SYN CUPS AFTER 964 HOURS OF OPERATION

Figure 8 shows Rek-Syn cup seals after 964 hours of operation. The test showed that the material has low friction and is wear resistant. However, as the cups wore, the material did not stretch to maintain good contact with the pump-cylinder walls. Pumping effectiveness was reduced and it was apparent that the cups had a shorter useful life than leather cups.

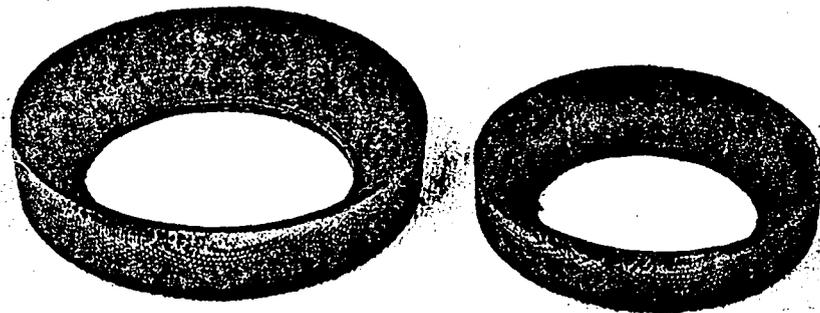
FIGURE 9. VIX-SYN CUPS AFTER 1020 HOURS OF OPERATION

Figure 9 shows Vix-Syn cup seals after 1020 hours of operation. Although the cups were still functioning at the end of the test, they showed more wear than any other test material. In addition, as with the Rek-Syn cups, the Vix-Syn cups did not stretch as much as the leather cups.

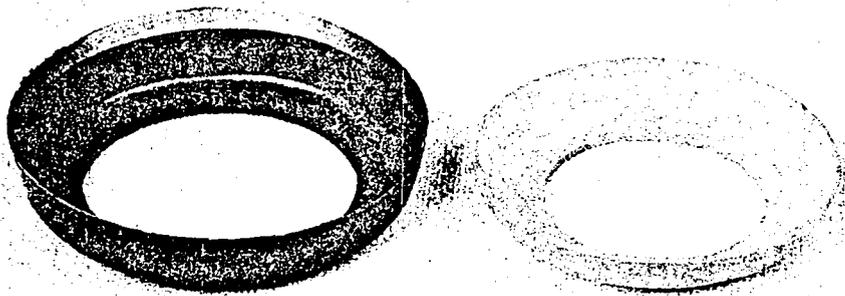
FIGURE 10. VERY FLEXIBLE 3-INCH CORFAM CUP AFTER 1121 HOURS OF OPERATION AND 2-1/2-INCH RULON J CUP AFTER 949 HOURS OF OPERATION

Cups made of the three Corfam materials were operated for over 1000 hours. Figure 10 shows a very flexible 3-inch cup, while Figure 11 shows a 2-inch medium flexible cup, and a 2-1/2-inch stiff cup. Good wear resistance was exhibited by all of the Corfam cups. However, the very flexible cup and the stiff cup had the same difficulty maintaining contact with the cylinder walls that was exhibited by the Rek-Syn and Vix-Syn cups. In contrast, the medium flexible Corfam cup exhibited good stretch and maintained good contact with the cylinder wall. In lots of 100 to 1000 pieces, the 3-inch cup was estimated to cost from \$90 to \$100 per hundred.

Rulon J is a fluorocarbon made to run dry against soft materials such as aluminum and brass. Figure 10 shows a 2-1/2-inch Rulon J cup seal after 949 hours of operation. Although the cup was still functioning at the end of the test, the plunger had begun to chatter during the last week of testing. This seemed to be caused by the narrow, stiff wall of the cup which did not conform well with the cylinder wall.

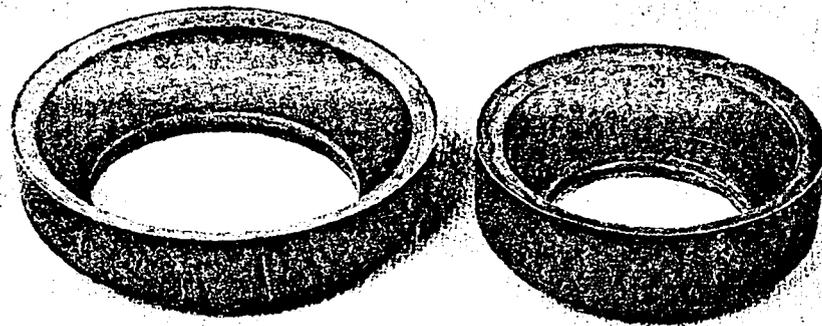
FIGURE 11. MEDIUM FLEXIBLE 3-INCH CORFAM CUP AFTER 1040 HOURS OF OPERATION AND STIFF 2-1/2-INCH CORFAM CUP AFTER 1150 HOURS OF OPERATION

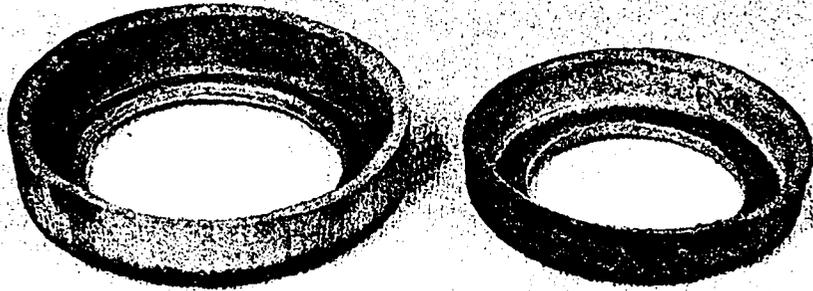
FIGURE 12. CHROME-TANNED, WAX-IMPREGNATED LEATHER CUPS AFTER 948 HOURS (3-INCH) AND 1106 HOURS (2-1/2-INCH) OF OPERATION

The leather cup seals were tested primarily as a control against which the other materials could be compared. Figures 12 and 13 show chrome-tanned and oak-tanned leather cup seals after approximately 1000 hours of operation. The more expensive, chrome-tanned, wax-impregnated leather cups showed very little wear and remained soft even after drying. The oak-tanned, nonwaxed leather cups showed a definite wear and became stiff when dry. The price of 3-inch chrome-tanned leather cups is approximately \$128 per hundred in lots of 500 cups.

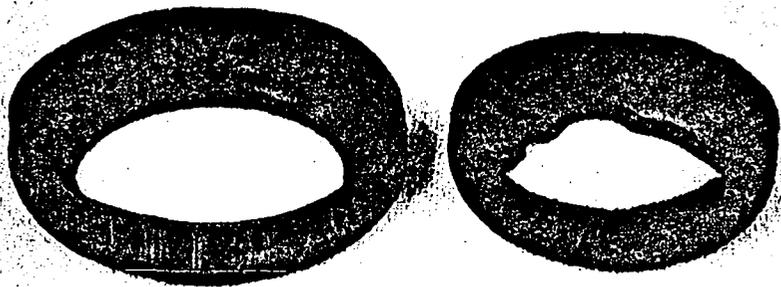
FIGURE 13. OAK-TANNED, NONWAXED LEATHER CUPS AFTER 1147 HOURS (3-INCH) AND 1039 HOURS (2-1/2-INCH) OF OPERATION

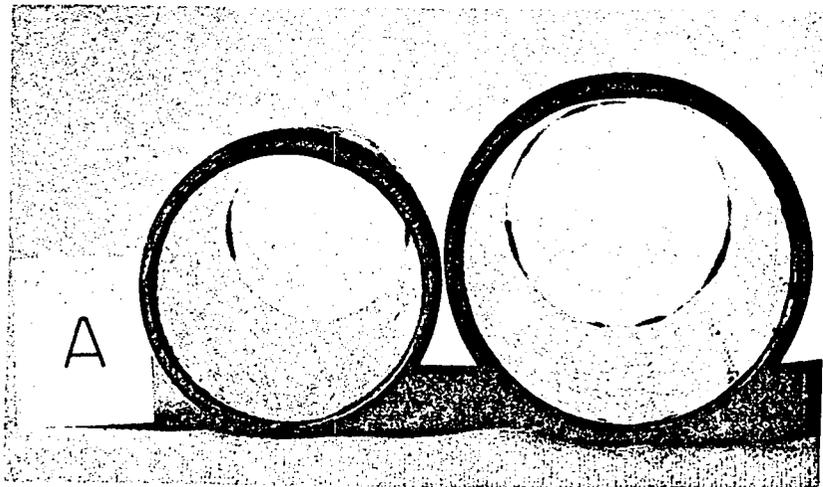
FIGURE 14. VINYL-COATED PIPE SPECIMENS AFTER 1000 HOURS OF OPERATION

The coating materials were evaluated by using each to coat a 2-1/2-inch-diameter pipe specimen and a 3-inch-diameter pipe specimen. Each of the six pipe specimens, as shown in Figures 14, 15, and 16, was then operated for over 1000 hours with leather plunger cup seals at 55 strokes a minute with a 5-1/2-inch stroke.

The marine epoxy coatings were approximately 0.008 inch thick and had a smoothness of about 40 to 60 CLA (centerline average). The high-build vinyl coatings were about 0.006 inch thick and had a smoothness of about 26 CLA, while the pigmented uralkyd had a thickness of about 0.004 inch and a smoothness of about 10 CLA. The CLA values included the roughness due to running. For comparison, good cast-iron cylinders made in the United States have a smoothness of from 40 to 200 CLA. The baked epoxy phenolic that was tested during the previous program had a smoothness of from 12 to 18 CLA.

The cylinders were inspected following the 1000 hours of testing. No appreciable wear could be detected visually, and there were no breaks in any of the coatings. Likewise, very little wear was noticed on the leather cups. Thus the performance of the coatings was estimated to be equal and satisfactory.

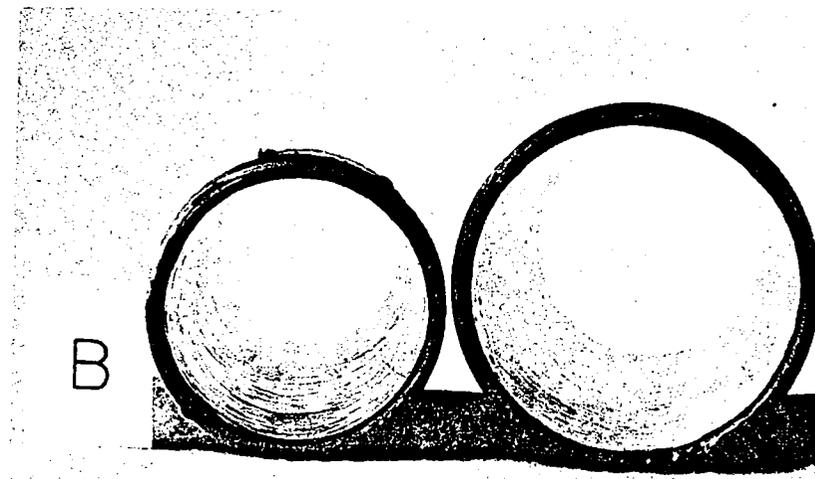
FIGURE 15. EPOXY-COATED PIPE SPECIMENS AFTER 1000 HOURS OF OPERATION

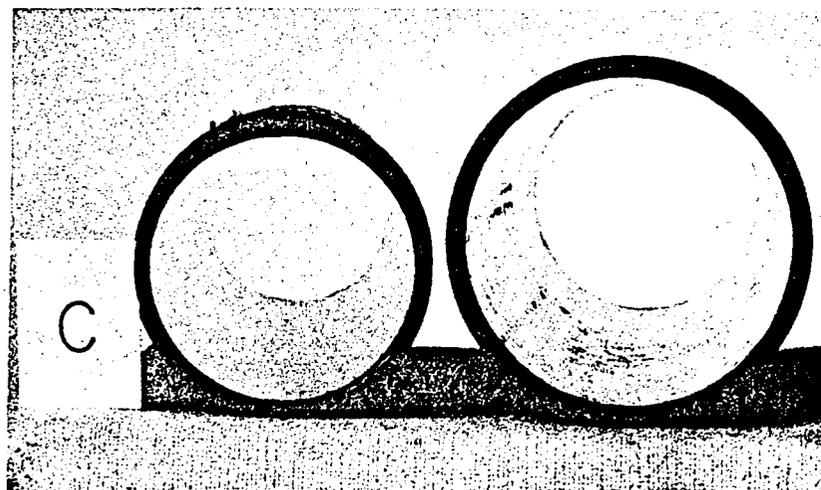
FIGURE 16. URALKYD-COATED PIPE SPECIMENS AFTER 1000 HOURS OF OPERATION

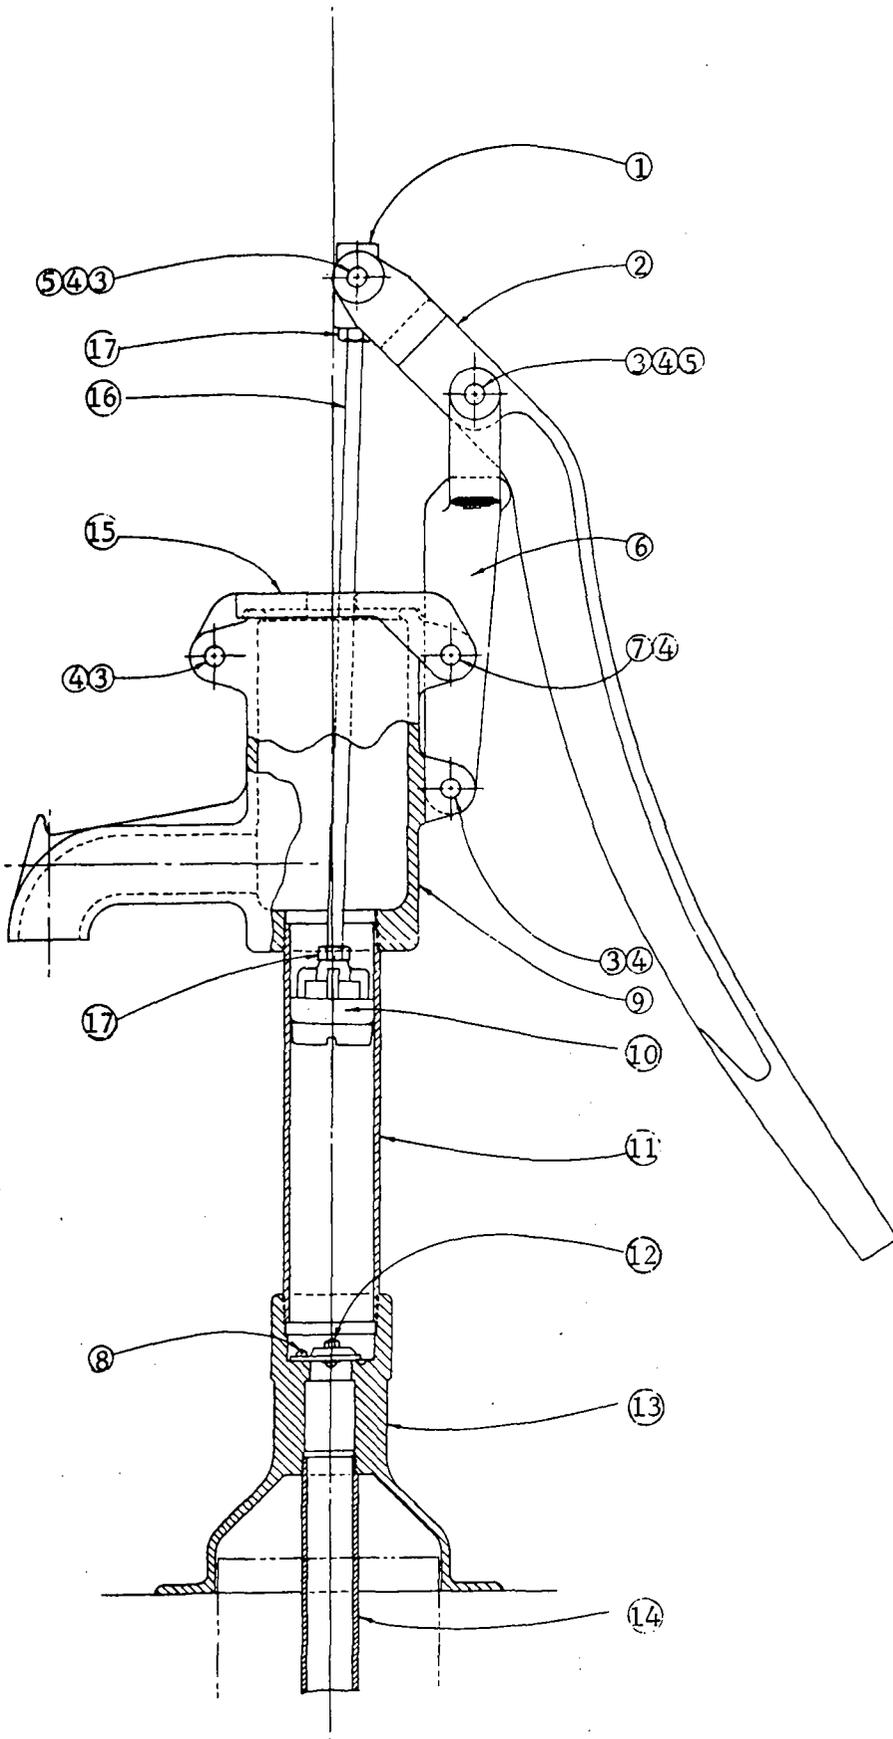
FIGURE A-1. SHALLOW-WELL PUMP

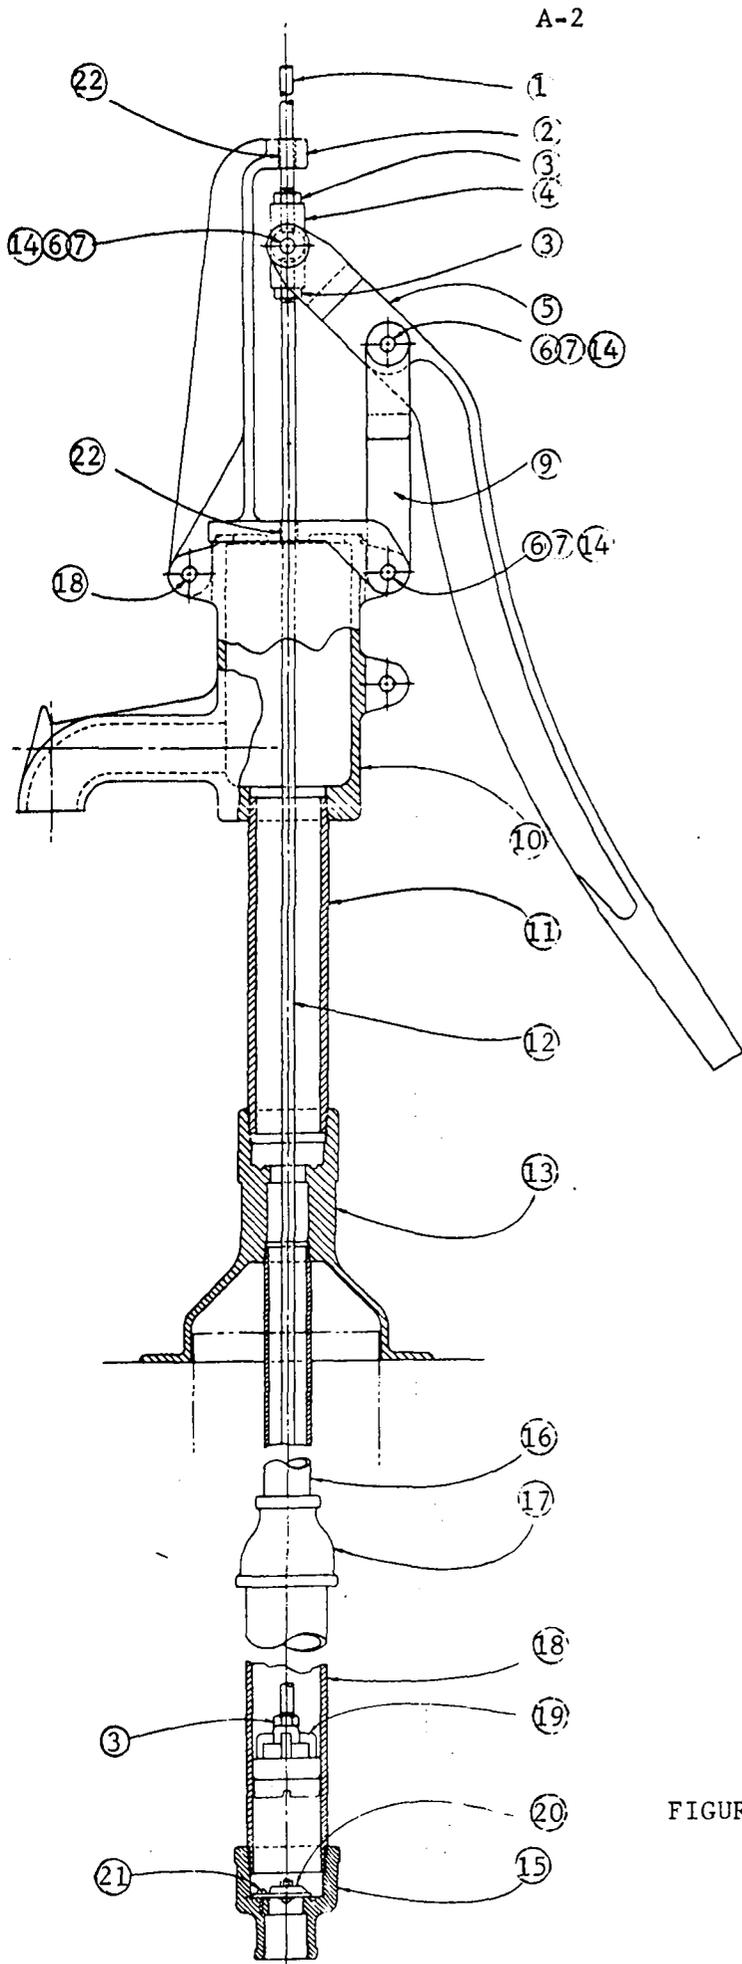
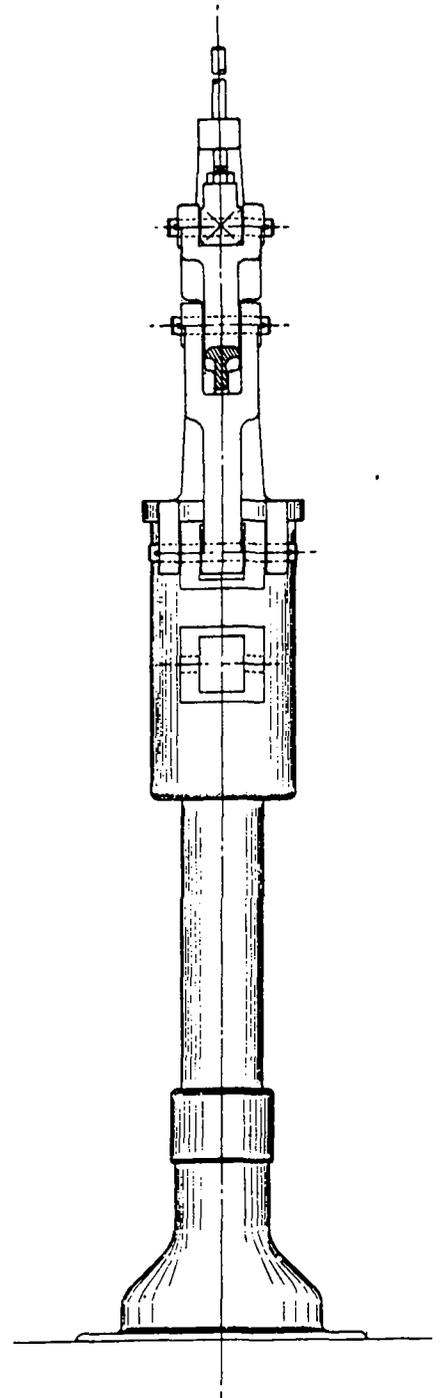
FIGURE A-2. DEEP-WELL PUMP
