Ecological sanitation in Sri Lanka

Varuna Rathnabharathie and Ganga Kariyawasam

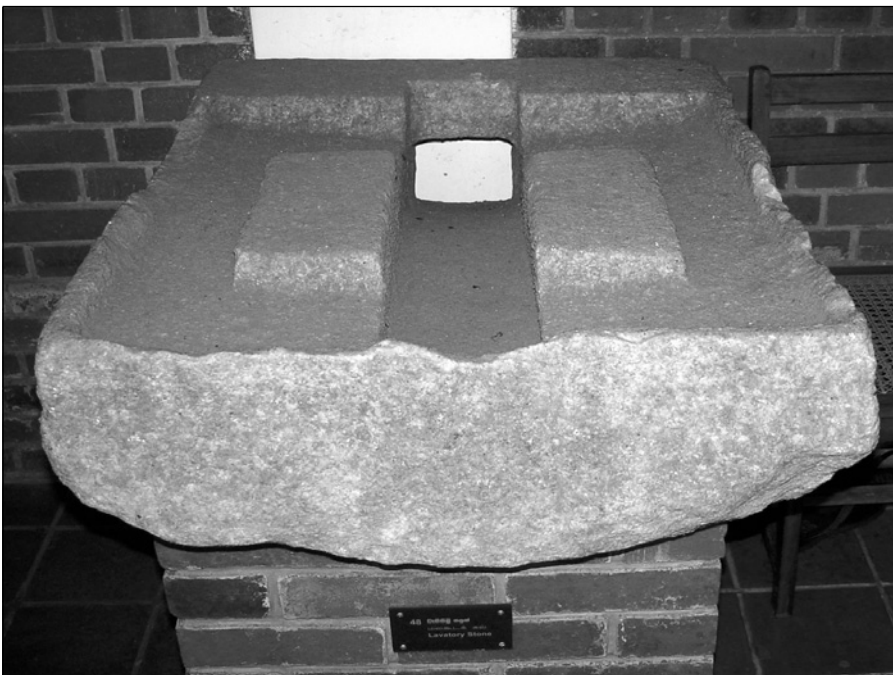
The squatting pan with hole at the back for defecation

separate stone apparatuses for defecation, urination and anal cleansing. The stone structure for faecal matter was connected to a tank where decomposition took place. There is evidence of the addition of ash to treat faecal matter.

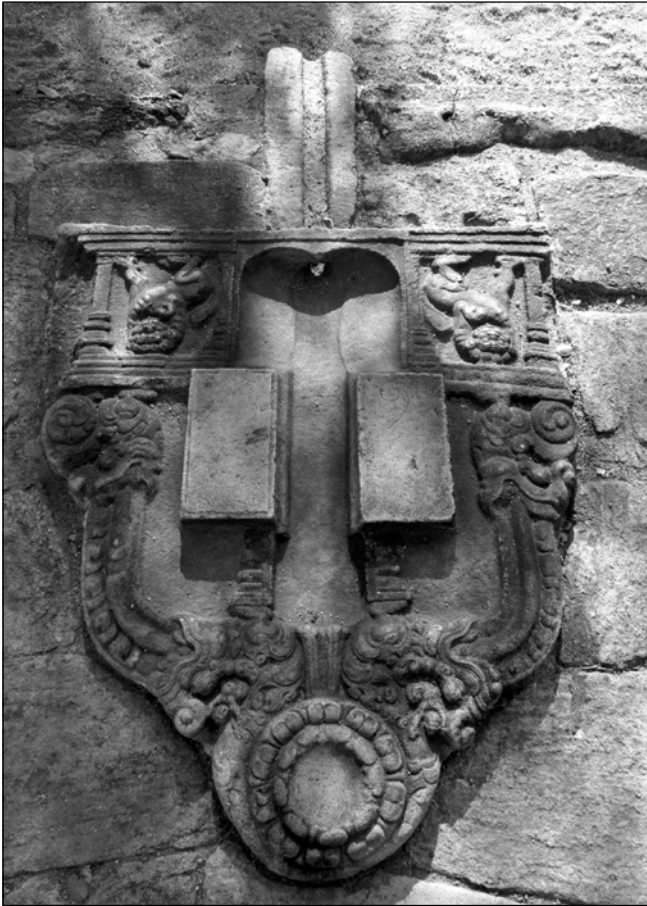
A historical urinal made out of stone. The channel at the top of the picture would take the urine into the filtering system of three clay pots buried under the earth

The urine was directed to a urine filtering system, from the urinal. This filtering system was buried under the soil and consisted of three pots containing sand, lime and coal, through which the urine filtered. Therefore the urine was treated before it reached the soil. It is believed that such care was taken due to the Buddhist religious belief of not causing harm or polluting the habitat of even an earthworm.

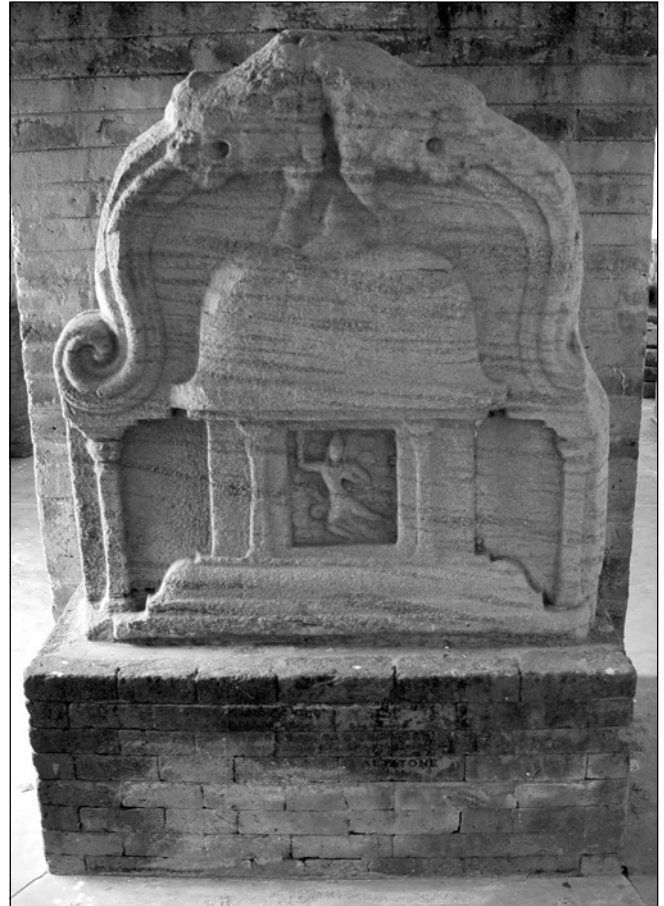
A guard stone screens the user

In addition there were guard stones to cover and give privacy to the toilet user. These stones were interestingly inscribed with religious messages and verses reflecting the impermanence of life and all material things (including food and drink).

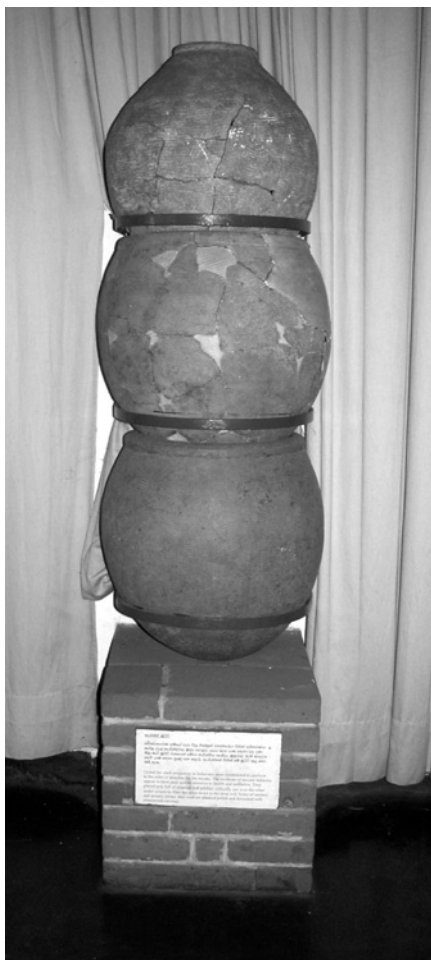
The fourth-century three-tier urine filtering system. Urine entering the top is filtered through first sand, then lime, then charcoal

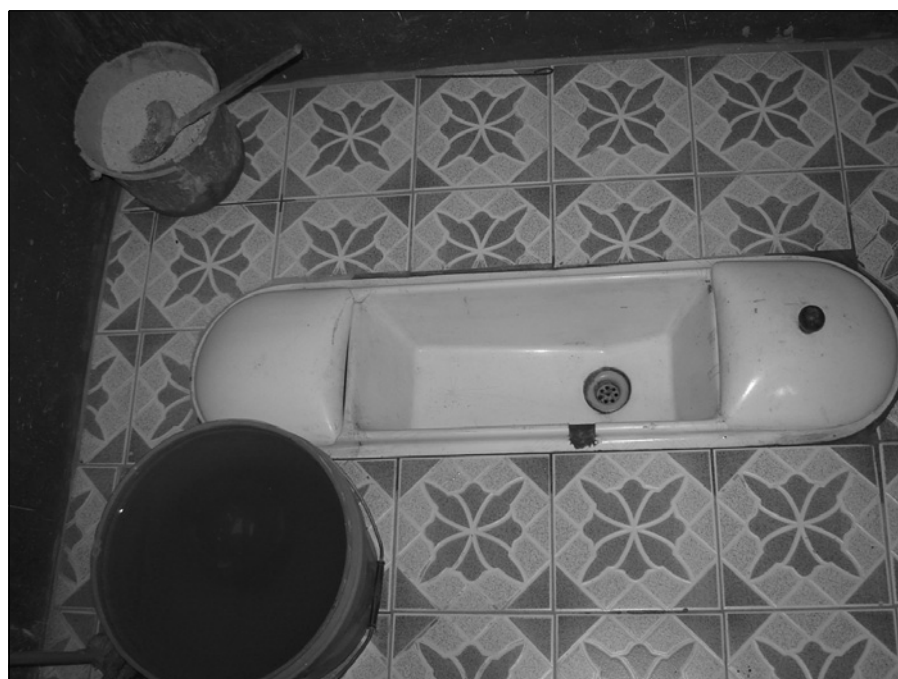
The compost toilet (eco solution, India model) showing on one side the water bucket and on the other an ash bucket

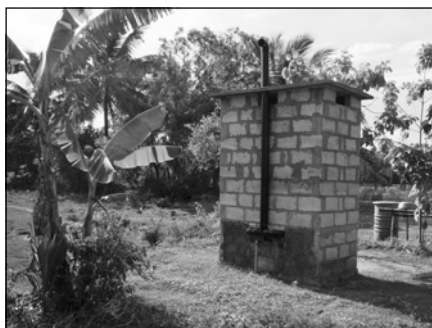
A compost toilet built in Hambanthota, 2006

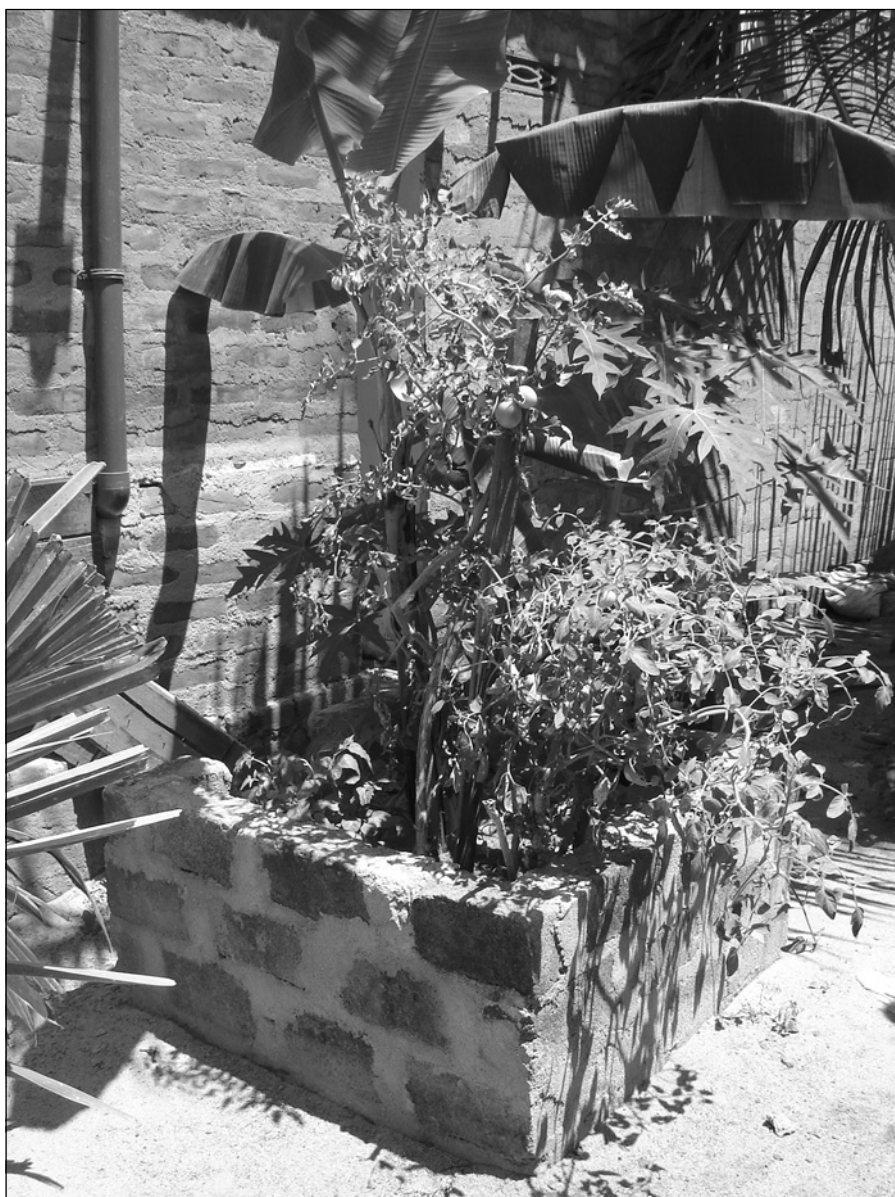
Banana plants are fed by urine and wash water (Ampara ecosan toilet, 2007)

- A flush toilet takes much more time, effort and money to build, than a compost toilet. A compost toilet takes three to four working days by two builders, and is 60 per cent of the cost of a conventional flush-type squatting pan toilet.
- The daily water and nutrient supply to the plant bed from the urine was considered as an additional water source for plants in water-scarce areas.
- Rural households with no toilets opted for an eco-san toilet on their premises, as defecation in the open is unsafe for women and hazardous during the rainy season and at night.
